Filling-up mine spaces of »Block 1« and »Block 2« in the Uranium mine Žirovski vrh from the surface and remediation of a damaged cementation of well for filling-up mine spaces

JURIJ ŠPORIN¹, ŽELJKO STERNAD¹, ŽELJKO VUKELIČ², BORIS LIKAR³, IVAN GANTAR³

Received: June 21, 2007 **Accepted:** July 10, 2007

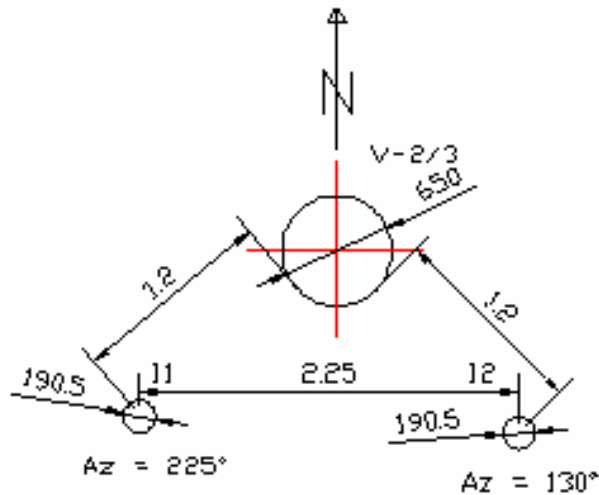
Figure 1. Arrangement of injecting wells
Slika 1. Razporeditev injekcijskih vrtin

Drilling of injection wells was implemented in striking-rotational manner using depth hammers and compressed air. The performer of the drilling and injecting works was ROVS d.o.o. from Ljubljana. Arrangement of injecting wells is shown in Figure 1.

According to the data about geology, direction of the underground water stream and factors of the drilling it was determined that injecting of the well V-2/3 area with two 58 m deep injecting wells will be carried out. The injecting will be performed in phases with a cement suspension MB25 and WC=0,4.

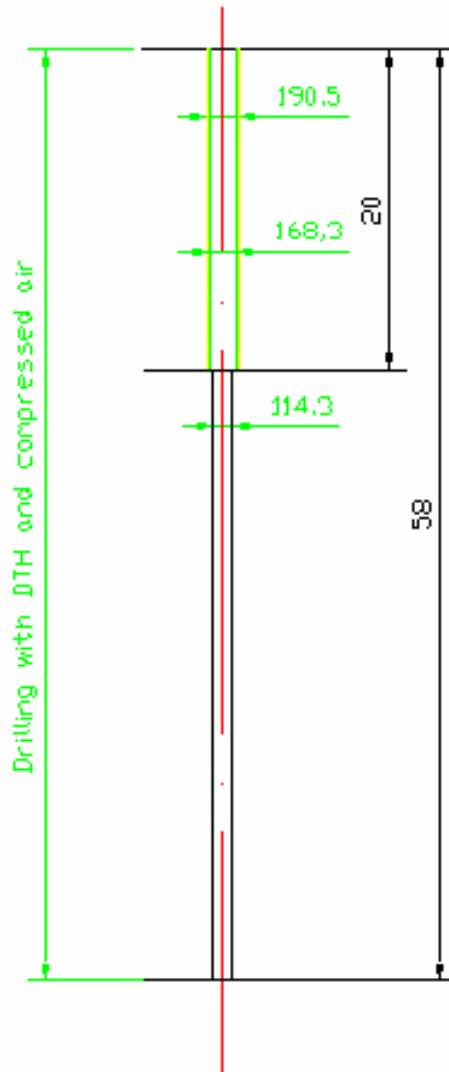
Figure 2. Construction of the injection well
Slika 2. Konstrukcija injekcijske vrtine

During the drilling process it was necessary to follow losses and interruptions of the circulation of the rinsing media. In particular it was necessary to be careful about sections where losses of the rinsing media occurred during the drilling of the V-2/3 well. Construction of the injection well is shown on Figure 2.

Up to 20 m an introduction column was implemented in order to prevent losses of the cement suspension and consequently pressure drop in upper decayed zone. Drilling of the introduction column was carried out with the drilling tool $\varnothing 190.5$ mm (7 1/2").

In the well a steel tube $\varnothing 168.3 \times 4$ mm (6 5/8") was built-in. Junctions among tubes were welded using electro-welding. The tube of the introduction column had to be quality cemented. Cementation was done according to Perkinson method. Influx of the introduction column was equipped with a flange, a manometer for controlling pressure and a valve.

From the depth of 20 m to the anticipated final depth of 58 m, the well was drilled using a drilling tool $\varnothing 114.3$ mm (4 1/2"). During the drilling of the first injection well presence of a geologist, who defined the final depth of the wells was assured. Tubing of the technical column was not necessary.
