## ROOT-CAUSE ANALYSIS OF SUPERHEATER-TUBE FAILURE

Martin Nad', Jiří Buzík, Tomáš Létal, Pavel Lošák

Brno University of Technology, Faculty of Mechanical Engineering, Institute of Process Engineering, Technická 2,  
616 69 Brno, Czech Republic  
nad@fme.vutbr.cz*Prejem rokopisa – received: 2016-07-15; sprejem za objavo – accepted for publication: 2016-09-15*

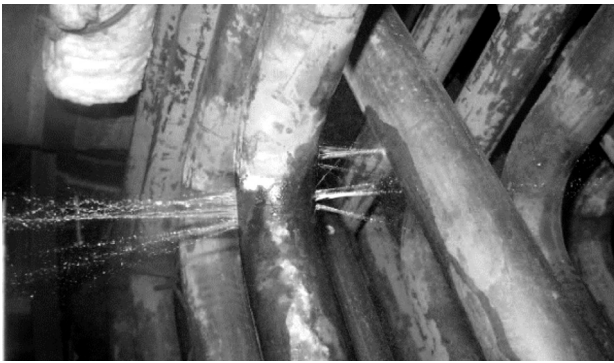
As mentioned, there are two main problematic areas. One of them includes the crack and the leakage on the superheater-P2 pipe bend (Figure 4).

**Figure 4:** Leakage on superheater-P2 pipe bend  
**Slika 4:** Puščanje na P2 pregrevalniku na krivini cevi

The first sample was taken from the pipe-bend area because the visual inspection revealed a horizontal crack (length 25 mm) on the pipe bend. This kind of crack cannot have been caused by the bending process. However, the manufacturing process should have influenced the material structure by lowering its corrosion resis-

As can be seen on **Figure 9**, the stress intensity is crucial in the pipe bends, the exact location where the crack and leakage were discovered.

In order to avoid financial losses caused by repeated shutdowns and repairs, multiple corrective measures were proposed. The modification of the supports, which led to a stress reduction at the crucial areas, was performed. It was achieved by increasing the spring stiffness, which influenced the BC displacement. Due to this modification, each displacement was reduced by almost a half of the previous value (10 mm, 20 mm and 35 mm). Unfortunately, the results proved that the stress intensity decreases insufficiently and the spring modification is not sufficient to fix the problem. Another improvement could take the form of minimizing the displacements or removing the bottom support, identified as problematic. This would lead to a further decrease in the stress levels in the critical areas. However, these analyses are not included in the article.

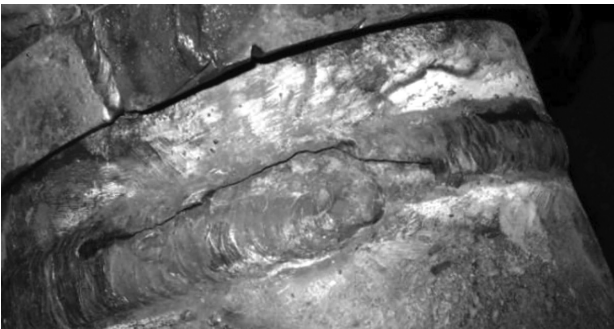
Another problem was the crack near the weld on the superheater collector with the U-shaped transition pipe (Figure 5). This problematic part had been repaired several times in the past, which can be seen in the figure.

**Figure 5:** Crack near weld on the superheater-P2 collector metallurgical analysis  
**Slika 5:** Razpoka blizu zvara na pregrevalniku P2 metalurška analiza zbiralnika

An improper use of the supports was confirmed by a higher stress intensity at the second problematic location including the collector and the U-shaped transition-pipe weld joint (**Figure 10**).

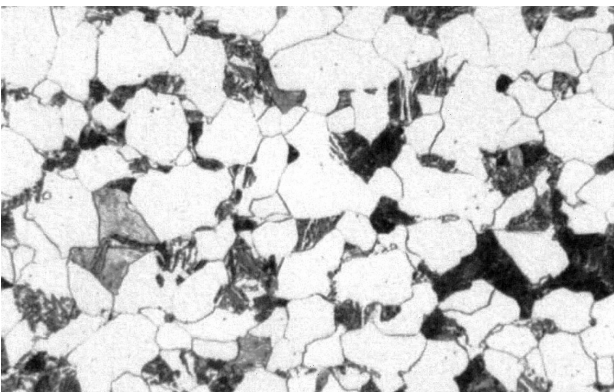
**Figure 6:** Micrograph of the basic material (500× zoom, etched with Nital)<sup>3</sup>  
**Slika 6:** Posnetek osnovnega materiala (500× povečava, jedkano z Nitalom)<sup>3</sup>

tance. The purity results of the analyses proved the material to be of a very good quality.

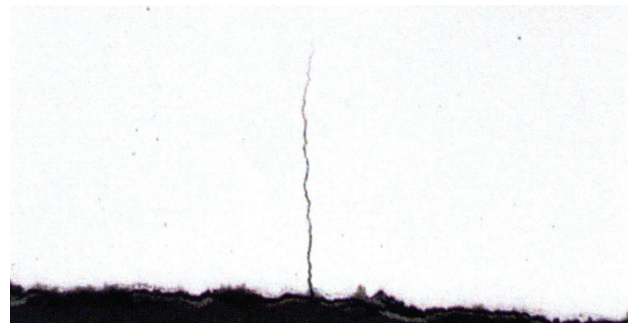
**Figure 7:** Crack located on the inner surface of the pipe (50× zoom)<sup>3</sup>  
**Slika 7:** Razpoka, locirana na notranjostipovršine cevi (50× povečava)<sup>3</sup>

Afterwards, the corrosion that was found on both surfaces of the pipe was examined. Pitting and small sharp projections were found on the inside. Some of the pits already had a character of small cracks (**Figure 7**), caused by a combination of corrosion and stress. Based on these findings, it was expected that the cracks had started on the outside of the pipe, in the area where the material was weakened by the small cracks from the inner side. Stress and the medium flow might be important during the process of crack growth and will be further examined.

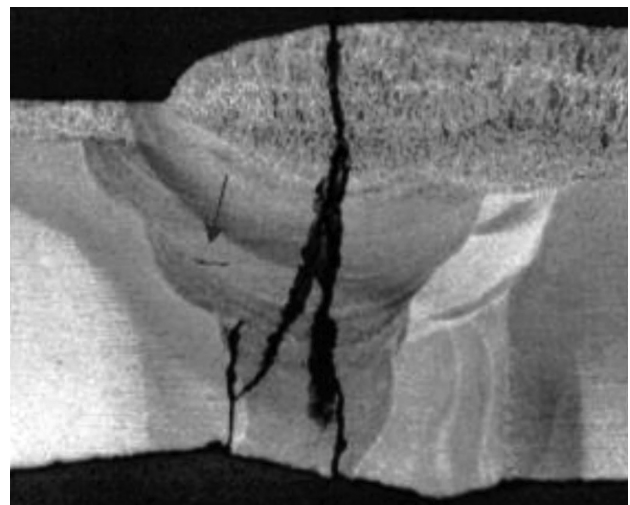
The second tested sample was taken from the area where the collector is welded to the U-shaped transition pipe. The crack goes through the whole weld and is divided into two branches in the middle of the cross-section (**Figure 8**). The crack is open mainly in the middle part and even with the microscope analyses, the direction of the crack formation could not be determined.

**Figure 8:** Weld macrosection with the crack (5× zoom)<sup>3</sup>  
**Slika 8:** Prerez zvara z razpoko (5× povečava)<sup>3</sup>

defects were found (see the black arrow in **Figure 8**). As mentioned above, this weld was repaired several times in the past so it was obvious that there was some problem with the equipment geometry (e.g., supports locations), stress and temperature dilatation.

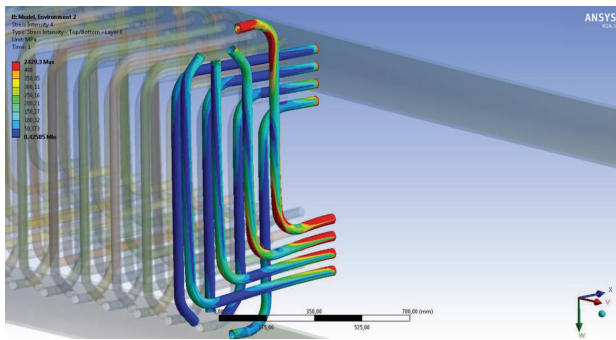
**Figure 9:** Stress intensity for bent pipes  
**Slika 9:** Intenzivnost napetosti na zvite/zavoje cevi

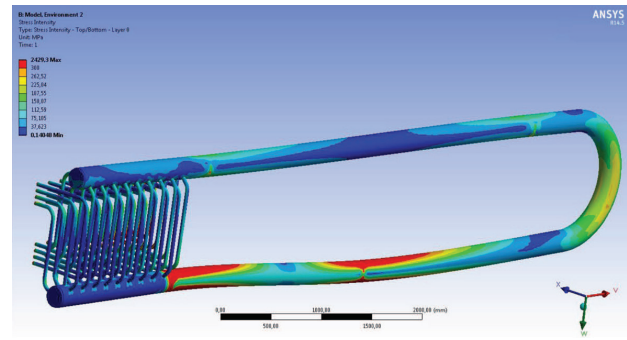
**Figure 10:** Stress intensity for the whole computational model  
**Slika 10:** Intenzivnost napetosti za celoten model

Based on these results, it was obvious that the problematic parts were the supports. They allow higher values of the total displacement of the U-shaped transition pipe that induce higher moments and stresses. Also, there is one support at the bottom part, which behaves like the center of rotation; thus, an additional stress is induced. The other crucial elements were the fixed supports of the collectors, located too close to the weld-joint location.
