THERMAL-POWER-PLANT CONDENSER-TUBE CORROSION ANALYSIS

Jakov Batelić¹, Vedrana Špada², Marko Kršulja^{3*}, Sanja Martinez⁴

¹HEP Production 52234 Plomin luka, Plomin luka 50, Sector for Thermal Power Plants, Plomin Power Plant Operation, Croatia

The thermal-power-plant condenser tubes, conducting cooling seawater, experienced frequent leakages, prompting the hereby presented failure analysis. Visual inspection of the corroded/ruptured tube segments revealed that localized corrosion may be linked to seawater sediments and thick layers of corrosion products at the tube water side. Sediments were found along the tube bottom and thick corrosion products were found adjacent to the point of contact between the baffle plates and the exterior tube walls. Underdeposit corrosion, accelerated due to sulphate-reducing bacteria, was diagnosed based on the excess sulphur found at the pit bottom using EDX, the FT-IR spectrum indicating the presence of biofilm and SEM determining the featuring corrosion products based on the biofilm. It was proposed that the corrosion initiating deposits were linked to the condenser shutdown and startup periods. Results showed that pitting corrosion occurred unde

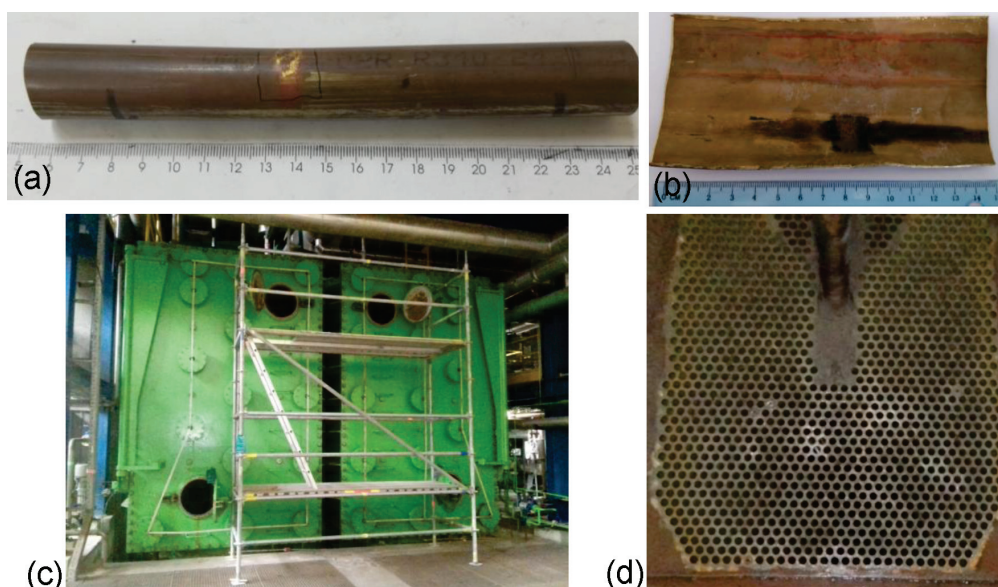
Two tube segments were examined visually and microscopically, one with a rupture and one without any rupture. Photographs of both tube segments are shown in **Figures 1a** and **1b**, the condenser is shown in **Figure 1c** and the positioning of tubes in the condenser is shown in **Figure 1d**. In general, the entire steam side of the investigated tube segments was covered with a uniform, brown, thin and well-adhering layer of copper patina except for the areas with a partially faded oxide band, showing that the tubes were in direct contact with the baffle plate. Also, the ruptured-tube shape indicated a tube bending over the baffle plate. No other corrosion or erosion defects were found at the steam side of the tubes.

The rupture was situated within the faded oxide band; the thickness of the tube was around 1 mm. The steam

Figure 1: Photographs of: a) the ruptured tube segment, b) the interior of the non-ruptured tube segment, c) condenser, d) tubes in the condenser

At the water side of the tubes, adjacent to the supposed contact with the baffle plates, the areas of red and black discolouration were visible below the golden-brown cracked layer (**Figure 1b**). The circumference position of these thick corrosion-product deposits varied depending on the baffle-plate contact spot. On the supposedly bottom part of the tube, from approximately 5:00–7:00 hours, a reddish-brown layer extended along the tube. Shallow pitting damage was evident within that area in the form of individual pits or clusters of smaller pits.

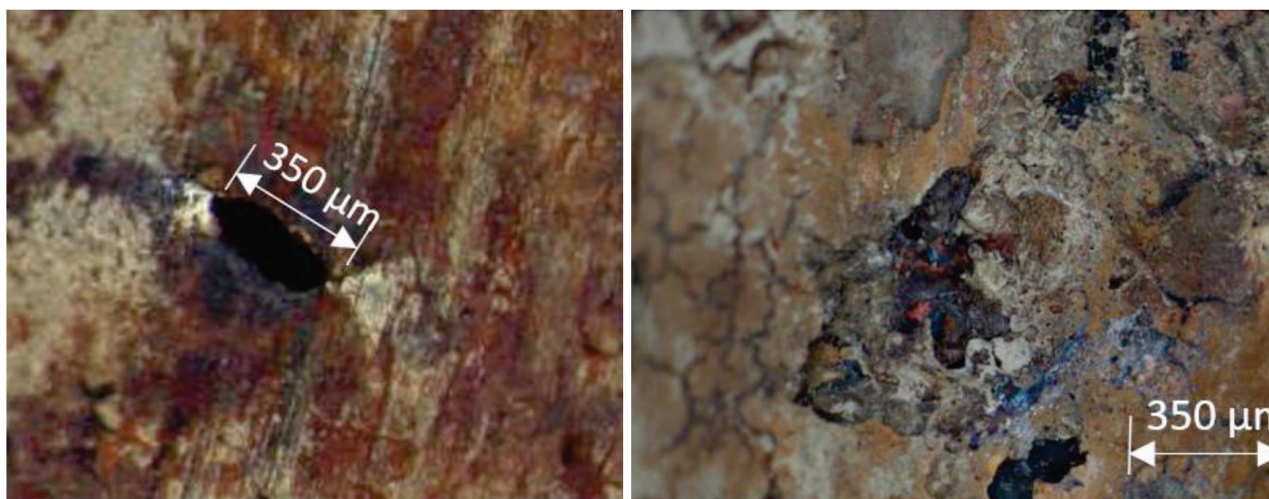
Figure 2: Microscopic images of the investigated rupture at: a) the steam side of the tube and b) the water side, magnification of 50×

side of the tube in the immediate area of rupture is shown enlarged in **Figure 2a**. At the water side of the tube, the same rupture was observed within the localized pit of an irregular shape (**Figure 2b**), while the rest of the surface in the immediate vicinity was covered by a cracked light-brown layer of corrosion products, through which red and black sublayers were visible. The bottom of the pit was black.

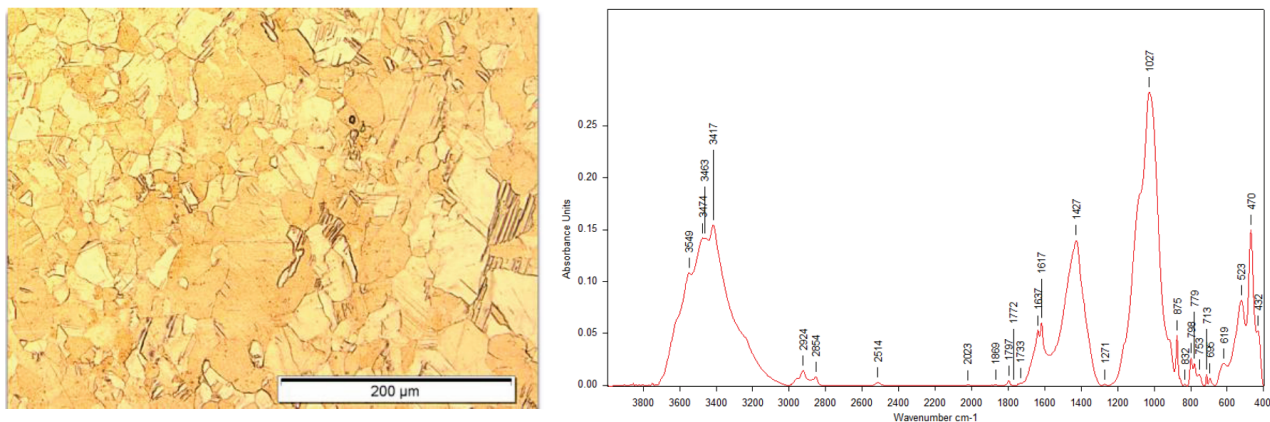
A metallographic sample was cold cut, ground and polished in several steps to achieve a flat surface, cleaned and etched with the ASTM No. 30 reagent for 30 seconds and then dried before measuring. A metallographic analysis of the tube material has shown that the investigated brass consisted solely of the α phase (**Figure 3 a**), which is a solid solution of zinc and other alloying elements in copper. No aggregates or precipitates were observed. At a magnification of 200 \times annealing twins were observed, indicating that the metal was heat treated⁸. The grain size was in a range of 10–50 μm as prescribed by the HRN EN ISO 12451 standard for the CuZn20Al2As alloy.⁹ This type of brass microstructure was proven to be the most resistant to corrosion.¹⁰

Figure 3: a) Microscopic image of the metallographic sample, b) the FT-IR spectrum of corrosion products

of the ruptured-tube segment, from around the rupture site (Figure 3 b).

The spectrum largely corresponds to the illite mineral (clay material) with a composition of $(K_2H_3O)(Al_2Mg_2Fe)_2(Si_2Al)_4O_{10}[(OH)_2,(H_2O)]$, which probably originates from the seawater. The bands at (798, 875,

1427, 1797) cm^{-1} and the bands in the range of 2800–3000 cm^{-1} coincide with the spectrum of calcium carbonate. The bands at (713, 875, 1027, 1271, 1427, 1617 and 1637) cm^{-1} correspond to the spectrum of the standard biofilm containing polysaccharides and proteins¹¹.

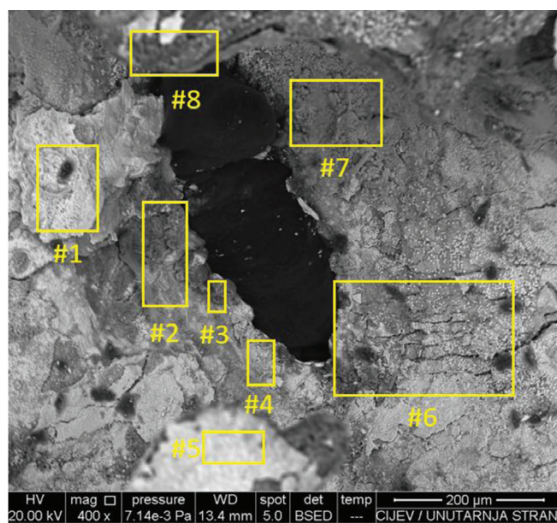
Figure 4: Composition obtained with the EDS microanalysis of the tube water side

SEM micrographs and EDS chemical composition of the immediate vicinity of the rupture site for the water side are shown in **Figure 4**, and for the steam side, they are shown in **Figure 5**. Eight measuring points were added to better observe the difference in the chemical composition of different areas of the surface and obtain the mean values. The most common elements found with the EDS analysis were copper, zinc, carbon and oxygen (Cu, Zn, C and O), indicating the composition of the substrate, and probably the formation of oxides and carbonates of copper. There is also Al, which probably originates from the substrate and is known to be embedded into the protective brass patina⁷ in the form of Al₂O₃. Silicon (Si) and sulphur (S) are also components of the alloy, but both of them, in particular S, occurred in the EDS analysis in excess compared to their alloy content (**Table 1**). Therefore, these elements are also likely to originate from the environment, along with calcium (Ca), magnesium (Mg), potassium (K) and chlorine (Cl). Iron may originate from the previous treatments with ferrous sulphate that forms a protective layer of lepidocrocite (γ – FeOOH) on the copper surface.

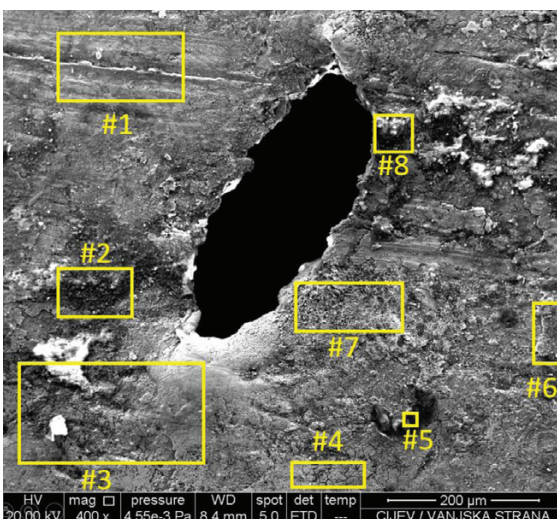
Figure 5: Composition obtained with the EDS microanalysis of the tube steam side

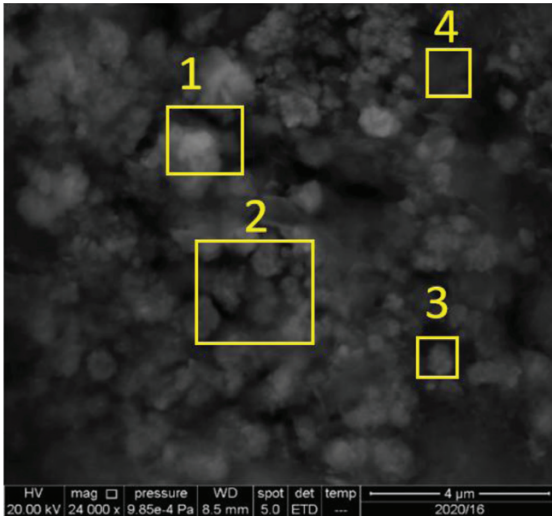
Figure 6: Black corrosion-product layer on the water side

The SEM micrograph of the black corrosion-product layer on the water side, shown in **Figure 6**, features blurred areas that probably correspond to the biofilm.

The EDS elemental composition recorded at four sites over a larger area than that shown by the micrograph has again demonstrated high sulphur concentrations.

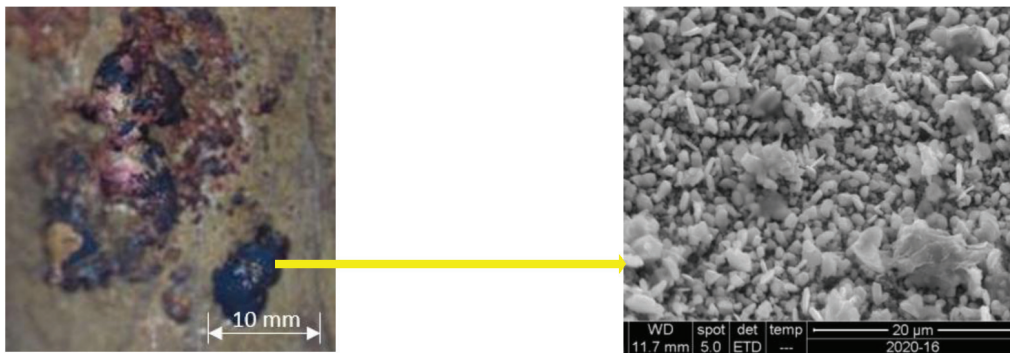
Figure 7: Sample cleaned a) in 10 % citric acid, b) in 2 M HCl

The ruptured sample was further subjected to cleaning in 10 % citric acid and then in 2 M HCl. The residual black deposits at the bottom of the previously investigated pit (**Figure 7 a**) were further analysed with SEM/EDS (**Figure 7 b**). The deposits consisted of polygonal crystals and their composition is presented in **Table 2**.

The absence of all other elements, except the elements present in the substrate and the extremely high percentage of sulphur, however, indicates the likely presence of sulphide at the bottom of the pit.¹²
