Characterization of Impact Damage in Composite Plates

Bibi Intan Suraya Murat¹ – Paul Fromme² – Marco Endrizzei³ – Alessandro Olivo³

Keywords: low-velocity impact, composite plates, X-ray, ultrasonic C-scan, guided waves

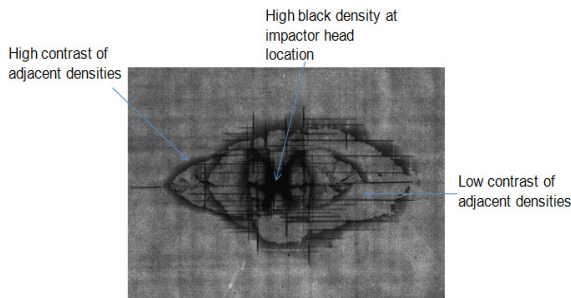
Fig. 1 shows a conventional X-ray image of an impacted cross-ply composite plate, provided by collaborators from the Composite Systems Innovation Centre, University of Sheffield. It should be noted that the X-ray testing was performed on a different, but similar plate to the specimens. The oval shape and the marking out of the damage extremities can be clearly seen. The high black density region is significant compared to other regions, which identifies the location of the impactor head. This could correspond to a small degree of fiber fracture under the impactor head. The high contrast region marked the boundaries between the undamaged and damaged regions, which could be contributed to delamination and matrix cracks. The low contrast regions correspond to the undamaged regions, where no significant changes could be detected. Based on the report by the collaborator, the extended length beyond the impactor-located damage area (15 mm in diameter) were estimated to be approximately 20 mm and 25 mm respectively on the left and right sides, making the total length of the defective region approximately 60 mm (in x -direction). Due to the oval shape, the widths (minor diameters) varied from 5 mm to 30 mm across the defective region. Unfortunately there was no scale provided on the image.

Fig. 1. X-ray images of composite plate impacted at 7.4 J with impact damage; provided by collaborator in Composite Systems Innovation Centre, University of Sheffield

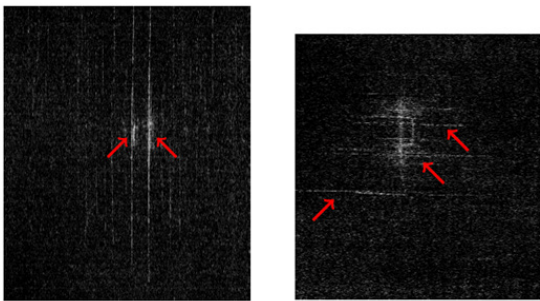
Fig. 2 presents the reconstructed X-ray images on one of the two tested composite plates that are based on the edge-illumination technique, performed in the Department of Medical Physics and Biomedical Engineering, University College London. The method enables dark-field imaging by using incoherent illumination and operates with broadband radiation [11]. The same composite panels were used in their studies and it is expected that these results could provide some extra information about the impact damage. As a preliminary demonstration, the extracted images show a strong differential contrast for the composite plate. The presence of the high contrast of

adjacent densities can be clearly observed from both vertical and horizontal X-ray scattering, which reveal defects inside the plate. The bright lines could indicate local fiber debonding and the two small bright areas which nearly resemble the shape seen in Fig. 2 could probably mark the area of matrix cracks in the plate. This bright area could be used to approximate the size of impact damage in the plate. However, no further information is obtained from the collaborator since this project is still under development. Overall, the damaged region, shape and the extent of the impact damages were observed from the X-ray analysis.

Fig. 2. X-ray images of composite plate impacted at 7.4 J with impact damage; a) vertical scattering; and b) horizontal scattering

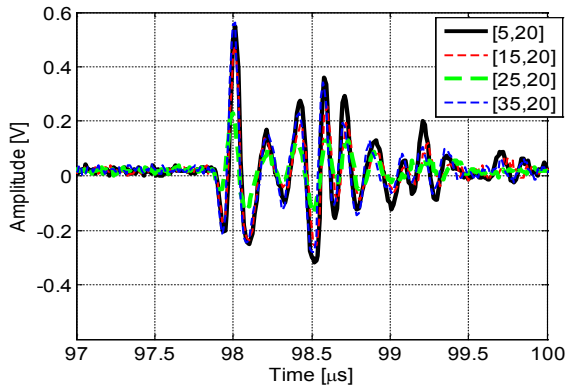
Fig. 3 presents typical received time traces measured from the front surface. The time traces were obtained at four locations, all located at $y = 20$ mm, but x positions were varied: 5 mm, 15 mm, 25 mm and 35 mm. The signal monitored at position ($x = 5$ mm, $y = 20$ mm) represents a signal collected at the undamaged area. The green dashed line ($x = 25$ mm, $y = 20$ mm) corresponds to the reflection from the dented and cracked area (caused by the impact). Measuring the time of flight from the front surface reflection and knowing the thickness and wave speed of the material (approximately 2700 m/s ± 10 %), one can determine the arrival time of the reflection from the back-wall surface. Since the front surface reflection (first echo) arrived at 98 μ s, the back-wall reflection was calculated to arrive at approximately 99.5 μ s ± 10 %. The time interval of echoes from every layer cannot be detected as the wavelength (0.54 mm) is larger than the nominal thickness of each layer (0.25 mm thick). Fig. 3 shows three groups of reflections that can be observed based on their arrival times. These groups correspond to the reflections from (i) the surface, (ii) within the plate thickness and (iii) back-wall of the plate.

Fig. 3. Comparison of response signals at various locations; signal at location $x = 5 \text{ mm}$, $y = 20 \text{ mm}$ corresponds to the undamaged signal; pulse-echo mode; focused; 5 MHz frequency

From Fig. 3, it can be observed that the lowest reflected amplitude (0.2 V) was obtained from the signal measured at the center of the impacted area ($x = 25 \text{ mm}$, $y = 20 \text{ mm}$). The other three signals have higher amplitudes (0.6 V) of the surface reflection, which described the undamaged and smoother surface. For the second group of the reflections within the plate, multiple peaks of reflections occurred, which can be due to local higher scattering from within the plate. Again it can be observed that the lowest reflection amplitude (0.1 V) was obtained at the impacted area. This shows that the irregular surface (at the impactor location) greatly degraded the normal incident and reflected waves. Meanwhile, the other three signals have inconsistencies in their amplitudes. This may be related to the variations and changes in the interlaminar condition caused by the impact on the surface. What is interesting in this data is that the assumed undamaged signal (based on visual inspection on the surface area) also produced multiple reflections as the other signals. The highest reflected amplitude was observed at $98.5 \mu\text{s}$. Briefly, the arrival time matches approximately to a quarter of the plate thickness. This could indicate the through-thickness location of the delamination as the delamination is normally located in-plane between plies, which produces high reflections. Turning now to the last reflected group (the back-wall reflections), it can be observed that the highest amplitude reflection was obtained from signal monitored at the undamaged area ($x = 5 \text{ mm}$, $y = 20 \text{ mm}$). This could be due to less wave attenuation and scattering between the plies. Meanwhile, the back-wall reflections from the damaged area are lower than that observed in the undamaged location, which relates to the scattering by the impact damage within the plate.

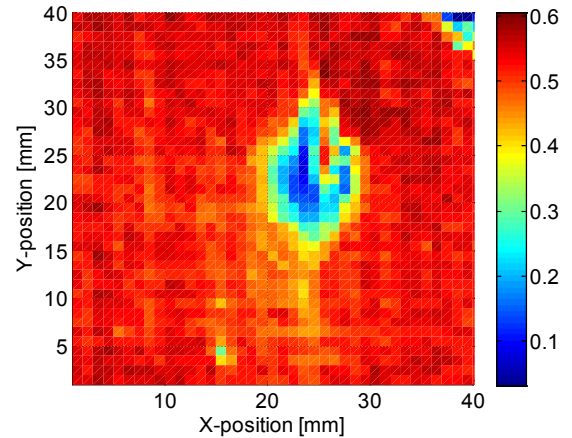
Fig. 4. C-scan image of the front surface of the 2 mm cross-ply specimen; 40 mm \times 40 mm scanned area; 5 MHz frequency; 76.2 mm transducer focal length

Fig. 4 shows the C-scan image of the front surface of the test plate (that has a smoother surface compared to the back-wall surface). This image was generated using the maximum peak amplitude of the first reflection. Referring to Fig. 3, the first reflection is mainly a reflection from the plate surface and therefore it is expected not to be sensitive to the internal defects. From Fig. 4, the impact damage is located in the middle of the scanned area. The oval shape region reasonably matches the 15 mm diameter of the hemisphere shaped impactor head. The oval shaped section with lower amplitude region, ranging from 0.1 V to 0.4 V, can be clearly observed with an approximate length of 10 mm (x -axis) and width of 15 mm (y -axis). This lower amplitude at the impacted area can be explained by the fact that the incident wave encounters the dented surface, which causes the wave to be reflected back at different angles and causes energy loss due to the scattering at the surface. Meanwhile, the rest of the area has a consistently higher and uniform reflected amplitude within a range of 0.5 V to 0.6 V due to the smooth plate surface.

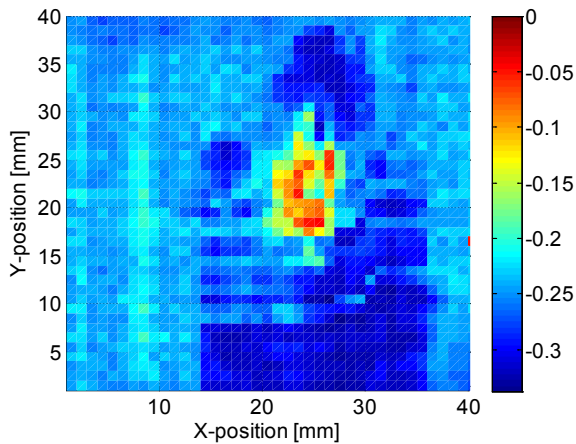
Fig. 5 shows a C-scan image of the same section as Fig. 4, but plotted using the minimum negative amplitude, time gated after the surface reflection. This image represents the internal reflections from within the plate. From the figure, the oval shape with relatively low minimum amplitude (0 V to 0.2 V) as similarly obtained from Fig. 4 can be seen. This shows that the surface indentation not only reduced the normal incident wave but also the reflected wave from within the plate. It also appears there is another large region (half oval shape) with the highest negative amplitude (0.2 V to 0.3 V). This is not observed in Fig.

Fig. 5. C-scan image of negative peak amplitude measured from the frontal surface of the 2 mm cross-ply panel; 40 mm × 40 mm scanned area; 5 MHz frequency; 76.2 mm transducer focal length

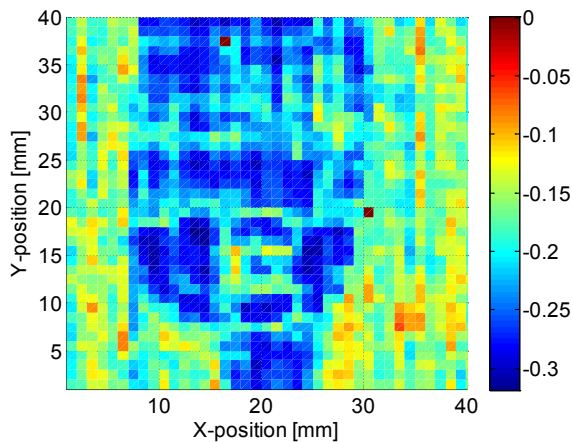
Fig. 6. C-scan image of negative peak amplitude measured from the back-wall surface of the 2 mm cross-ply panel; 40 mm × 40 mm scanned area; 5 MHz frequency; 76.2 mm transducer focal length

The same time gating (after surface reflection; negative minimum amplitudes) was also used from the back wall surface (rougher surface compared to the front surface). Fig. 6 shows an approximately similar pattern as obtained in Fig. 5, although the sharp oval shape area (0 V to 0.2 V) was not observed in this figure as the back surface was not dented. The extent of the impact damage (0.2 V to 0.3 V) is reproducible although the surface of the back-wall is rougher. This time gated approach seems to be more sensitive to the extent of the impact damage in the composite laminate. The possible defective area is much larger, about 20 mm and 40 mm in the x - and

y -axis respectively, and the damage level (indicated by different amplitude relative to the neighborhood area) is significant. However, the width of the damaged area could be larger than the scanned area, and may spread in a similar oval-shaped pattern. In relation to that point, Sohn et al. [13] have found that the impact response and damage states in flat composite panels is dependent on the diameter of the spherical impactor head. Although this result does not give full information about damage distribution through the thickness, it has provided a useful approximation of size and depth of the impact damage in the composite plate. It is worthwhile at this stage to use this information for the comparison between the numerical predictions and the experimental results of the guided wave scattering at impact damage.

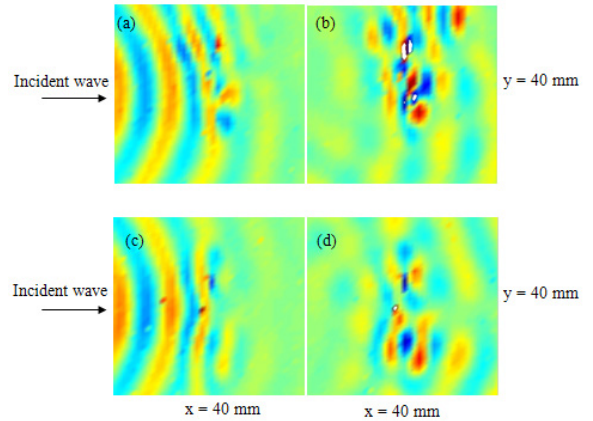
Fig. 7 presents the guided wave fields at various time snapshots, respectively for damaged composite plate 1 and 2. It can be seen that the incident wave interacts with the impact damage and causes scattering within the damaged region. Relatively weak scattering by the damage is present when the incident wave arrives (Figs. 7a and c), then a significant increase of the scattering is apparent when wave has travelled past the damaged area (Fig. 7b and d). Based on the FE study, a significant portion of the waves is also

reflected back from the exit of the impact damage. These reflected waves travel within the damaged region and keep reflecting back at both entrance and exit of the impact damage. As a consequence of these multiple reflections, a considerable amount of guided wave energy is trapped inside the impact damage area. This causes an increase in the amplitude of the wave in that region.

The amplitude of the transmitted waves diminished noticeably after passing through the impacted area. Similar wave behavior was also observed by Sohn et al. [13], where the measurement was performed on a quasi-isotropic composite plate. This finding however is contradictory to some of the FE simulation results [12], where a large amount of transmitted wave can be observed. However, some FE results have demonstrated the reduction in the amplitude past the delamination area. The FE simulations for the delamination placed at 0.5 mm depth is in agreement with this experimental measurement. Comparing both specimens, which were impacted with same 7.4 J impact energy, it can be seen that guided wave scattering in both plates are unique and such variations are expected due to the complexity in the failure mechanism of impact damage.

Fig. 7. Guided wave displacement fields in two composite plates; Plate No. 1, snapshot time; a) 20 μ s and b) 30 μ s; Plate No. 2, snapshot time; c) 20 μ s and d) 30 μ s; 7.4 J impact; 40 mm \times 40 mm scanned area

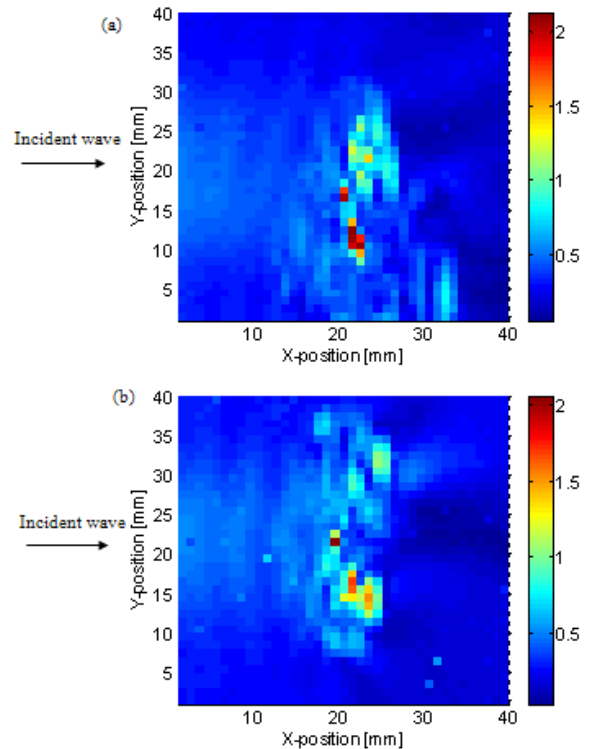
Fig. 8 presents the image of the maximum amplitude of the signal envelope over the damaged areas in both composite specimens. Areas of higher amplitudes can be seen, that occur close to the impact location center ($x = 20$ mm, $y = 20$ mm). This indicates the presence of severe damage such as a delamination or fiber and matrix cracking, and matched reasonably well with the visually observed size of the impact damage on the plates as well as the X-ray and C-scan images. Meanwhile, the undamaged area is represented by the low amplitude distribution. From the figure, three different zones can be observed and each zone has its own wave propagation behavior; (i) Zone 1: before the impact damage ($x < 15$ mm), (ii) Zone 2: across the impact damage (15 mm $< x < 25$ mm), and (iii) Zone 3: behind the impact damage ($x > 25$ mm).

The first zone (before damage) shows the incident waves propagating towards the impact damage location. It is also can be seen there were reflected waves propagating back towards the excitation source. Some periodical increase and decrease of the amplitude is visible in the region around $x = 15$ mm, potentially indicating the interference between the incident and the reflected waves at the impact damage. In zone 2, high amplitudes of the A0 mode signals are visible, which could indicate the multiple reflections

and scattering events within the impact damage area. Meanwhile, in zone 3, the transmitted waves propagating out from the damaged area are seen to be blocked in certain direction with significantly reduced signal amplitudes. Considerable waves transmitted

Fig. 8. Maximum amplitudes of guided wave pulse across damaged area of composite plate: a) Plate 1; b) Plate 2; frequency 100 kHz; 40 mm \times 40 mm area with impact location at center ($x = 20$ mm, $y = 20$ mm)

across the impact damage indicate that probably little mode conversion occurred as has been observed from the FE simulations. The cross-section of the impact damage in Plate no. 1 can be roughly approximated with length of 10 mm (x -axis) and width of 20 mm (y -axis), identified by the higher amplitude maxima. For Plate no. 2, the cross section area of the impact damage can be estimated to be about 10 mm \times 25 mm.
