# INITIATION OF STRESS CORROSION CRACKING IN BRASS COMPONENTS FOR DRINKING WATER SYSTEMS: SELECTED CASE STUDIES

Mirjam Bajt Leban\*, Tadeja Kosec

Slovenian National Building and Civil Engineering Institute, Dimičeva ulica 12, 1000 Ljubljana, Slovenia

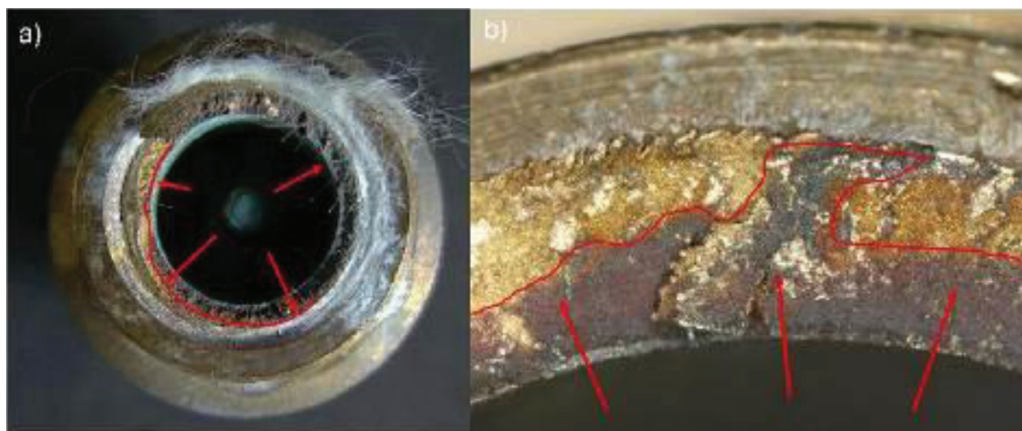
**Brass component A:** Examination of the fractured surface of this component (**Figure 2a**) showed that the main crack originated from the pipe interior. On some of the failed elements, stepwise crack propagation is present (**Figure 2b**). The main crack surface is, based on additional EDS mapping analysis, enriched with Zn and oxygen, indicating the presence of dezincification products (**Figure 3**).

**Figure 2:** Photographs of the fractured surface of failed component A. The red line indicates the transition between SCC and ductile final fracture. The red arrows indicate the SCC mode of fracture.

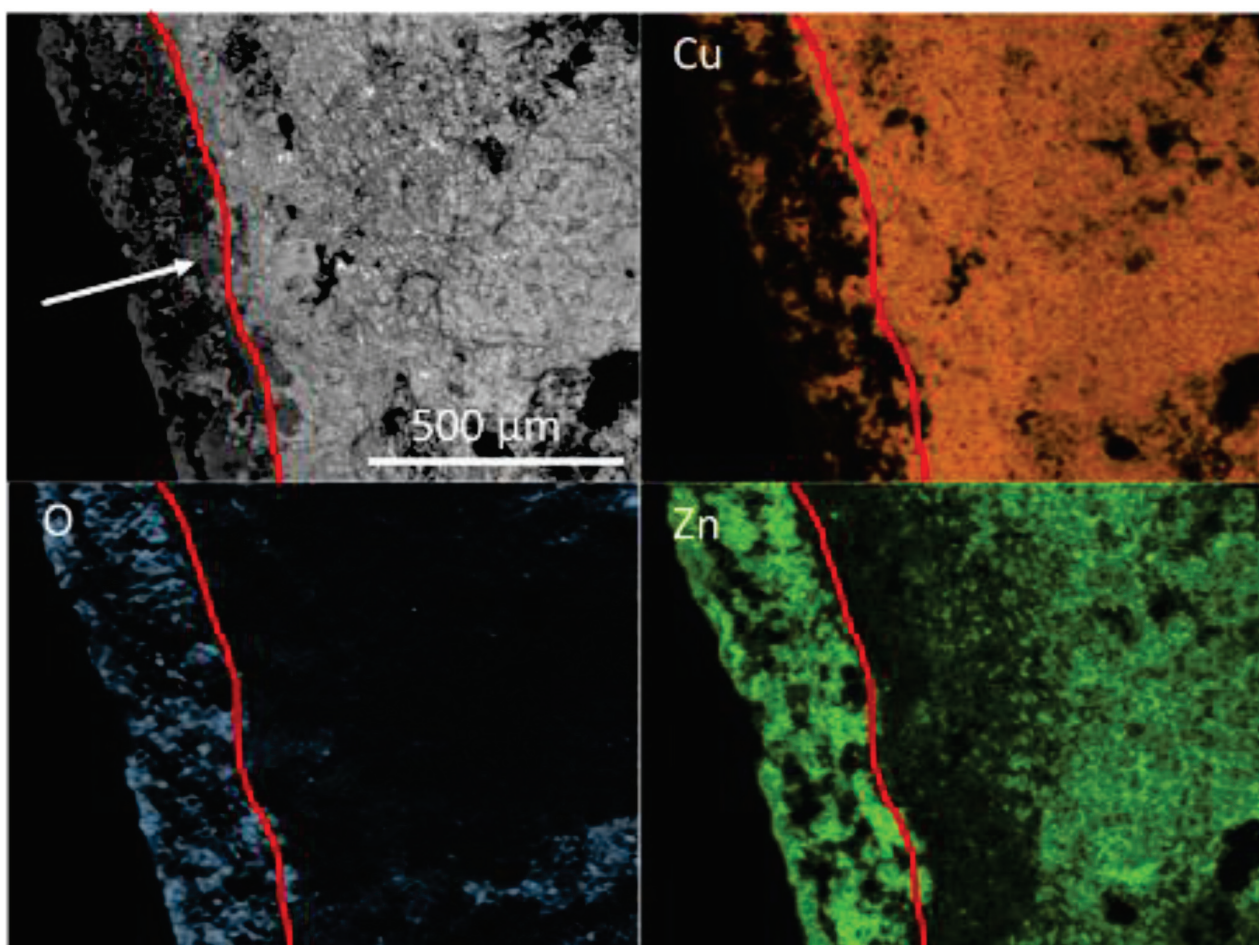
**Figure 3:** SEM-BSE (top left) and EDS mapping analysis for Cu, Zn and O of the cracked surface of specimen A

corrosion was also indicated by the EDS analysis presented in **Figure 3**. Cracks propagate either transgranularly through  $\beta'$ -grains or intergranularly between  $\alpha$  and  $\beta'$  grains (**Figure 7d**).

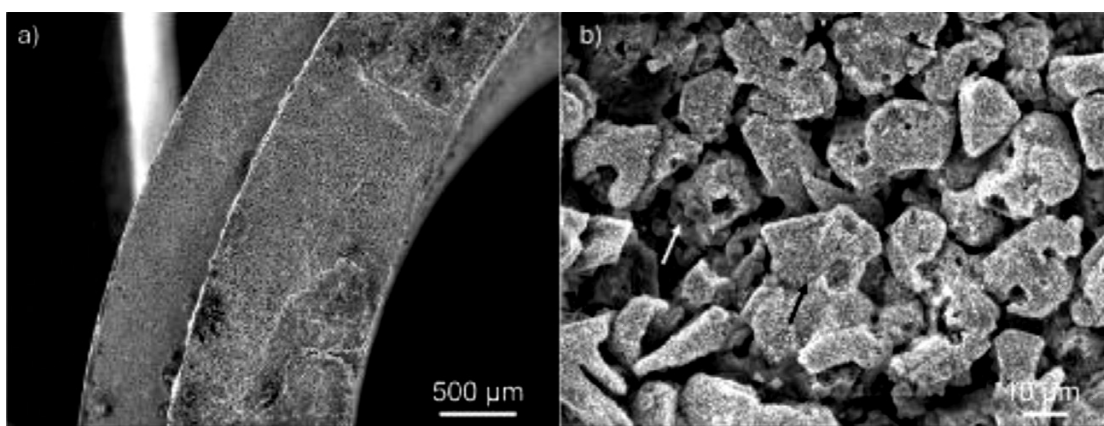
fracture (**Figure 5**) consists of Cu-rich grains (identified by EDS and marked with a black arrow in **Figure 5b**) and Sn-rich cubic crystals, marked with a white arrow in **Figure 5b**. The Zn-rich phase is absent, indicating a dezincification process in which its products, unlike those in building A, were not hydrolysed, but dissolved.

**Figure 5:** SEM photo of the fracture surface of press fitting B

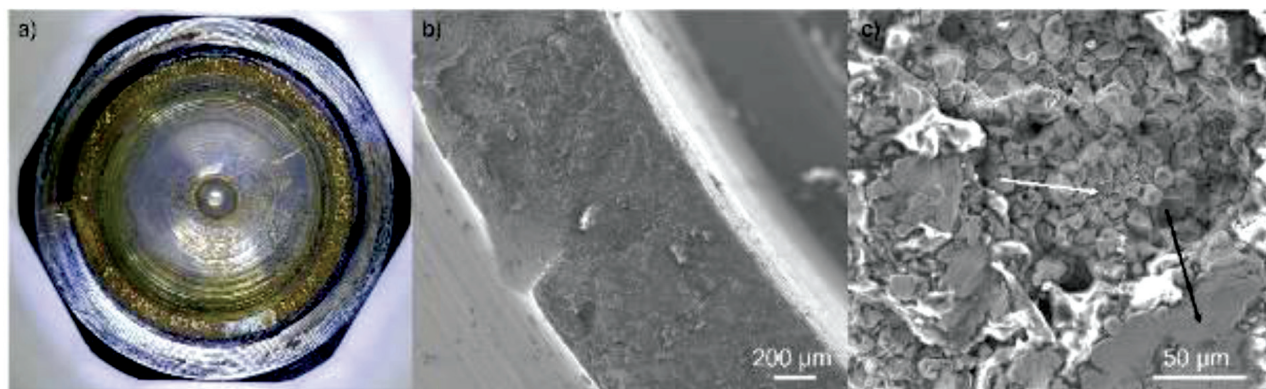
Brass component C: Numerous steps are visible on the fractured surface of this element (**Figure 6a**). SEM analysis of the fracture revealed flat facets (**Figure 6c**, black arrow), probably caused by the friction between the fracture surface and the opposite side after the break, as well as intergranular corrosion between the grains present at the fracture surface, indicating the presence of intergranular corrosion (**Figure 6c**, white arrow).

**Figure 6:** Fractured surface of angle valve plug with visible corrosion damage of nickel (Ni) coating at the bottom (a), and SEM images with details of the fractured surface (b and c)

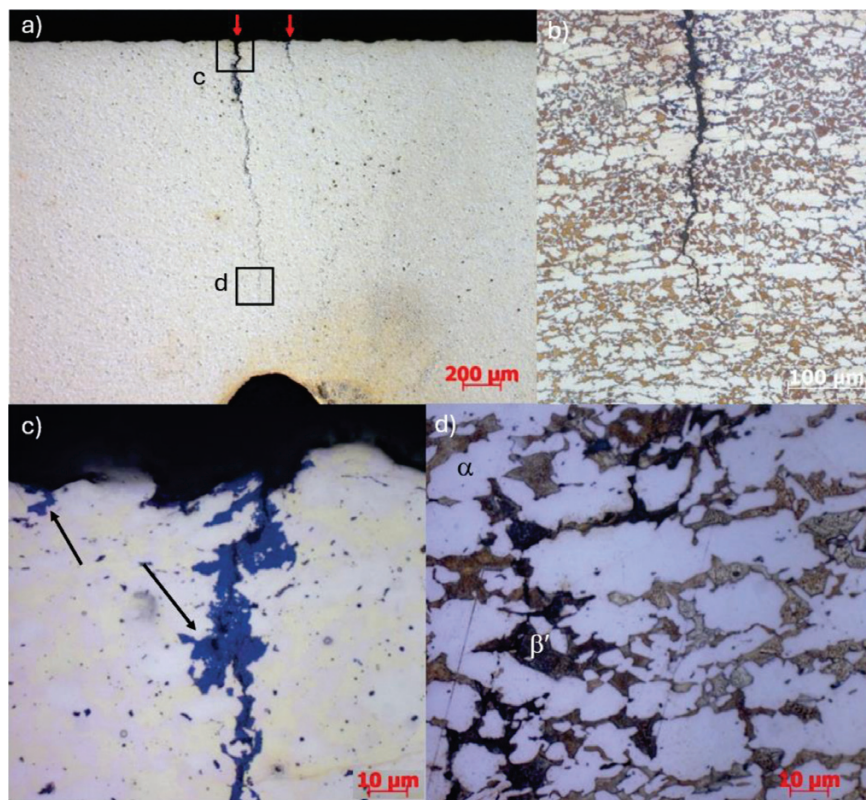
Brass component A: As shown by metallographic analysis (**Figure 7**), the microstructure (**Figure 7b**) exhibits distinctly elongated  $\alpha$  grains aligned with the deformation direction, while the  $\beta'$  phase is distributed in narrow, banded regions, characteristic of cold-deformed, non-recrystallised  $\alpha + \beta'$  brass. Several cracks propagated across the cross-section of the wall of the component (**Figure 7a**). Stress-corrosion cracks propagated from the internal wall of the joining component towards the externally threaded brass component. The primary

crack propagation direction is in the  $\beta$ -phase, which is richer in zinc. Near the initiation site (**Figure 7c**), cracks are more open and the crack walls consist of a Zn-rich product; areas of dezincification are grey, similar to those described by Zhang et al.<sup>23</sup> This particular type of

**Figure 7:** Metallographic cross-section of a cracked site with two visible cracks in brass component A (initiation sites marked with red arrows a); microstructure near the main crack b); initiation sites of the cracks filled with grey products c); the end of the crack which propagated mainly between  $\alpha$  and  $\beta'$  phases, or through  $\beta'$  phase d)

In the case of brass component A, cracks initiated on the inner side in contact with water and propagated through the material towards the nearest thread root. As the crack approaches the end, its branching is visible (**Figure 7c**). Similar crack propagation was observed for the failed brass component B, with the exception that the initiation site was at the outer surface, which was not in contact with drinking water (**Figure 8c**). On the other hand, in the case of the brass component A, the walls of the opened part of the crack (around 200  $\mu\text{m}$ ) were filled with grey Zn-containing products (**Figure 3**), which were not observed within the crack walls of the brass component B. However, some secondary cracks near the main crack of brass component B began to propagate from such grey products at the surface. These products consist of porous, redeposited  $\text{ZnO}/\text{Zn}(\text{OH})_2$ , formed as a result of dezincification<sup>25</sup> due to the presence of water (or high humidity) in the cementitious material, in which this component was installed. Usually, such products dissolve, leaving a Cu-rich phase; however, for the elements investigated, it is very likely that the chemical properties of the water (pH, chlorides) did not permit this.

However, a detailed view of the cross-section of the crack in this component near its initiation (**Figure 7b**) reveals selective corrosion of the  $\beta'$  phase.

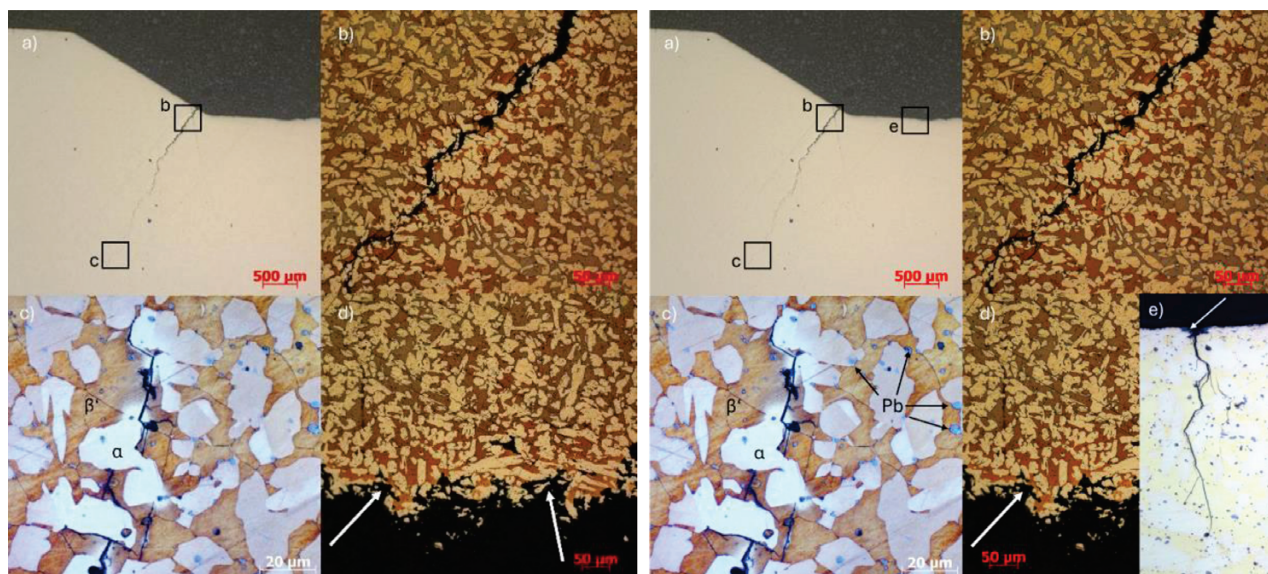
**Figure 8:** Metallographic cross-section of the cracked site, showing a visible crack initiated at the geometric transition of brass component B (a); initiation site of the crack (b); the end of the crack, which propagated mainly between the  $\alpha$  and  $\beta'$  phases or through the  $\beta'$  phase, with light grey Pb particles marked by black arrows (c); the inner side of the fitting with dezincification, marked by a white arrow (d); secondary cracks near the main fracture with a visible initiation site on Zn corrosion products (white arrow) (e).

Brass component B: As shown in **Figure 8b**, the microstructure is recrystallized, with evenly distributed  $\beta$ -phase, and rounded, polygonal  $\alpha$  grains. The crack propagated transgranularly across  $\beta'$ -grains, and also intergranularly between  $\alpha$  and  $\beta'$  grains near its end (**Figure 8c**), most likely due to cyclic bending (fatigue) of the fitting. **Figure 8d** presents a metallographic image of the inner side of the fitting, indicating that the microstructure is surface-dezincified – the  $\beta'$  phase (darker appearance) is absent from the surface, having dissolved in the water during the dezincification process. Only the  $\alpha$  phase, which is resistant to dezincification, remains at the edge.

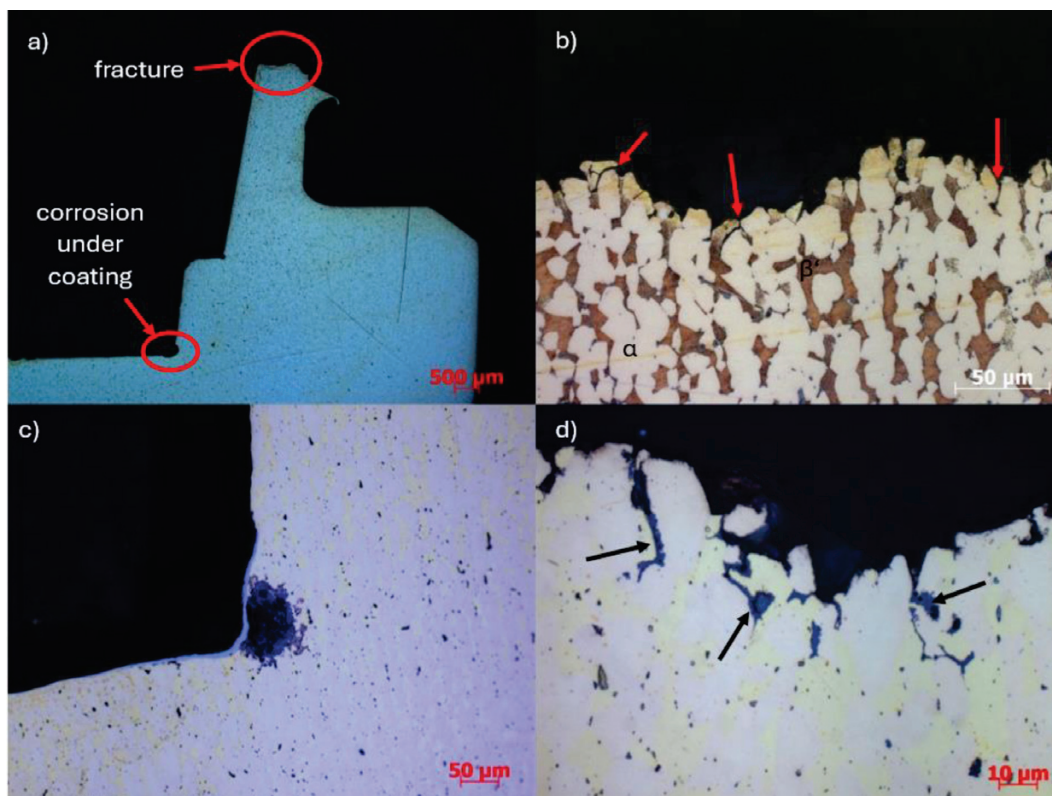
Brass component C: The microstructure (**Figure 9b**) consists of clearly separated  $\alpha$  and  $\beta'$ -phases with relatively coarse, equiaxial grains, indicating a heat-treated (annealed) condition in the  $\alpha + \beta$  range. Two types of corrosion failures were observed: intergranular corrosion between  $\alpha$  and  $\beta'$  grains (**Figure 9b**), and corrosion under the nickel coating (**Figure 9c**). In the vicinity of both types of corrosion, Zn-rich products of grey colour are visible (**Figure 9d**).

**Figure 9:** Metallographic photos of an angle valve plug a); with a visible intergranular fracture from the fractured surface – intergranular crack propagation marked with red arrows b); interior corrosion under coating c); dezincification inside intergranular corrosion, marked with black arrows d)
