Main damages on upper die in industrial hot forging

LEJLA LAVTAR^{1,*}, MILAN TERČELJ¹, MATEVŽ FAZARINC¹, GORAN KUGLER¹

¹University of Ljubljana, Faculty of Material Science and Engineering, Department of Materials and Metallurgy, Aškerčeva cesta 12, SI-1000 Ljubljana, Slovenia

Abstract: An analysis of main damages on industrial hot-forging die, made of Dievar hot-working die steel is presented. Die was previously gas nitrided, sectioned and examined after its service life. The measurements of microhardness depth profiles and optical microscopy of nitrided layers were applied in analysis of wear, cracks and failures on the most loaded sections of tool. In order to prolong die service life some improvements were suggested.

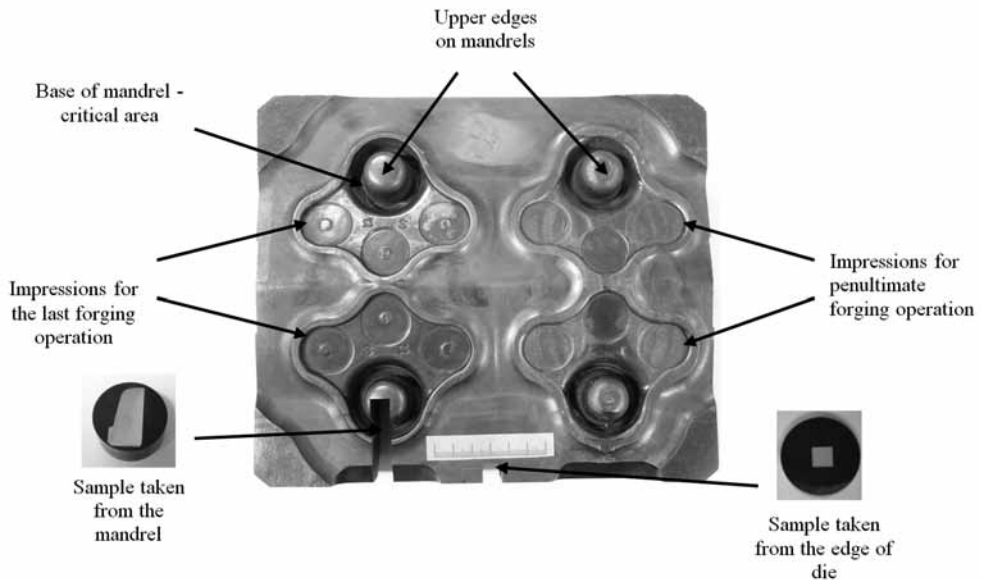
The main damages of die (Figure 1) with two impressions for penultimate forging operation and two impressions for the last forging operation were analysed after its service life. However, analysis was predominately focused on the impression used for the last forging operation since it gave final shape and dimensions of the product (see Figure 2). This shape was achieved in five sequential forging operations. Upper and lower parts of die had similar design of impressions. Essential difference between the upper and the lower die was height of mandrels. With regard to reference,^[1] it could be supposed that the die surface temperature was in the range of 600–700 °C and contact pressure exceeded the value of 1000 MPa. Lubricant that was used was water suspension of graphite.

Die life is determined by surface quality of forged product as well as by its shape and dimensions. In our case customer had special demands for forged product in respect of the quality of impression surface, and the shape and dimensions at the base of mandrels. These areas were considered as critical areas of the hot-forging die (see Figure 1). The die with higher mandrels failed after 45 766 forging strokes due to change of shape of forged product in the depression around high mandrels.

Figure 1. Upper die after 45 766 strokes; two impressions for penultimate forging operation and two impressions for the last forging operation with mandrels

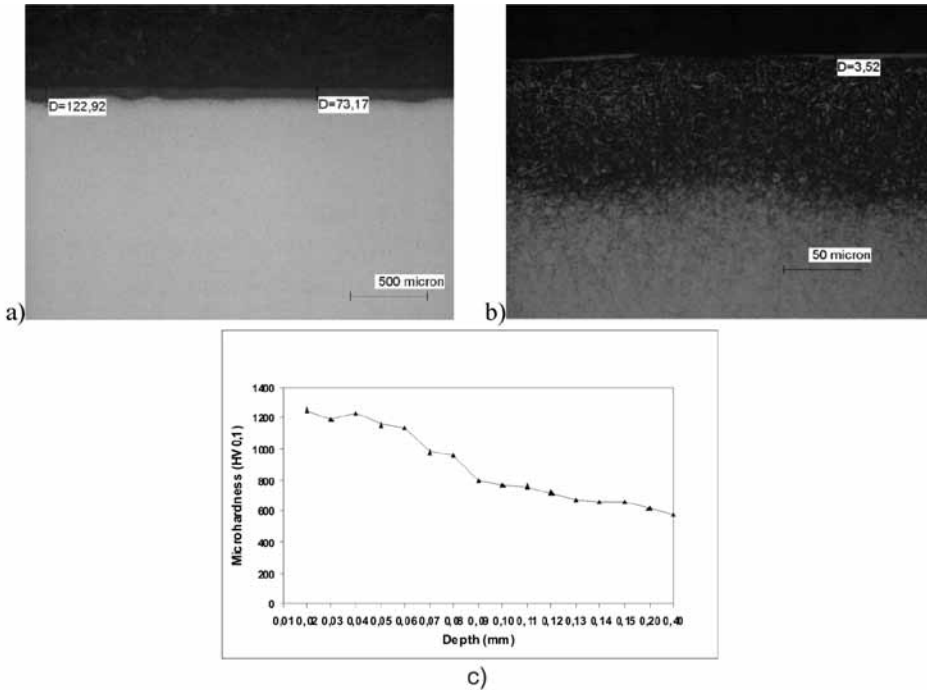
**Figure 3.** Microstructures and microhardness profile on cross-section of the die edge: nitrided diffusion layer with compound layer (a-b), microhardness profile (c)

Diffusion layer can be well seen on cross-sections of the surface edge (Figure 3a). The depth of diffusion layer is not homogenous and it is thick from 73 μm to 122 μm (see Figure 3a). This nonhomogeneity could be attributed to unappropriate preparation of die surface before the nitriding process that resulted in different adsorption abilities of nitrogen into the die surface layer.

Thickness of compound layer was in the range of about 0–3.5 μm (Figure 3b). Further, presence of nitrides was visible on grain boundaries. It was also remarked that microstructure was slightly overnitrided (nitrides on grain boundaries were in that area perpendicular to diffusion front and parallel to die surface) that could result in premature spalling of die material from the die surface layer. Figure 3c gives microhardness profile; max. values were above $HV = 1200$.

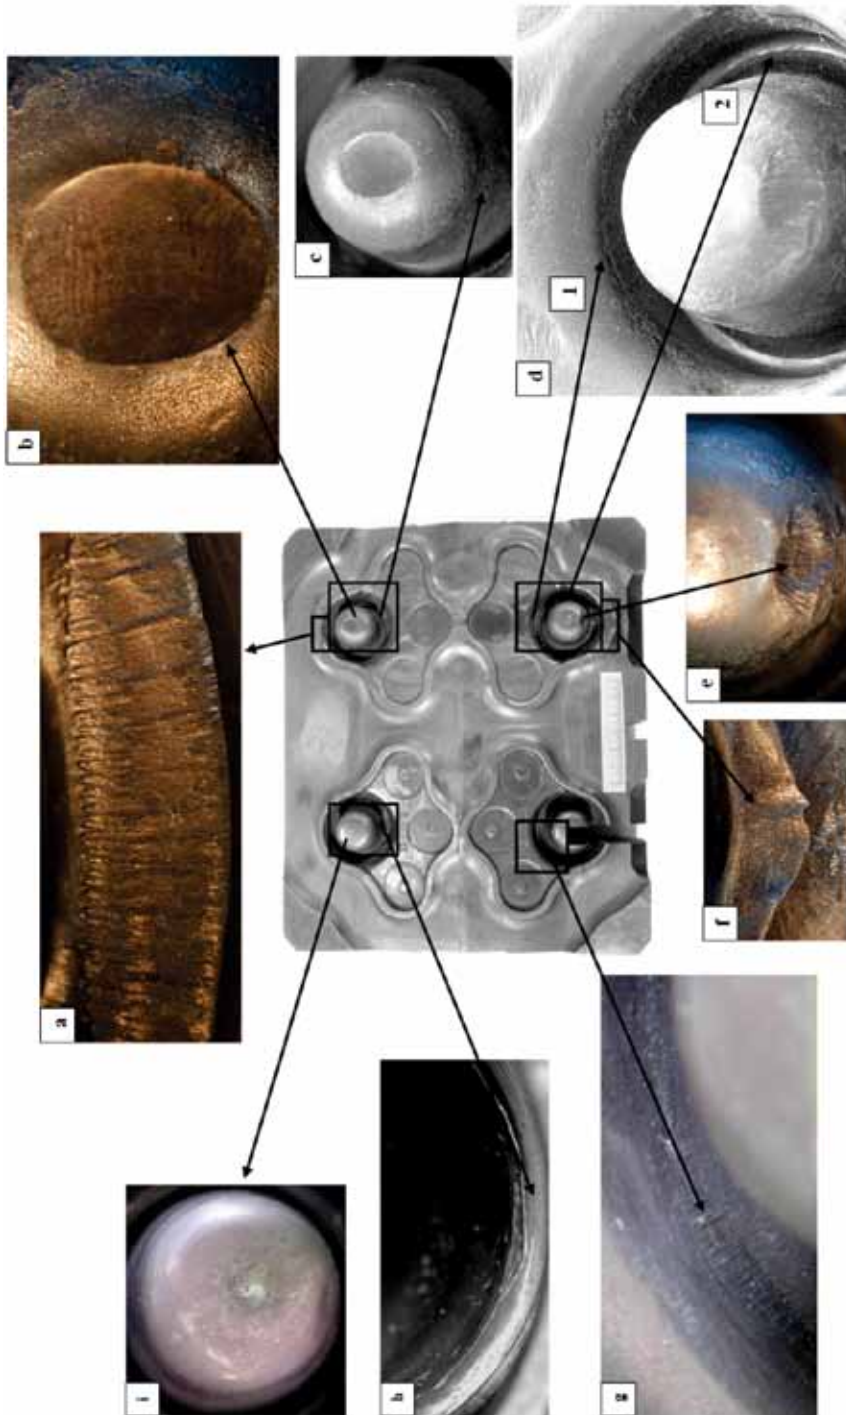
The main damages of the die on macro level are shown in Figure 4. The relatively sharp edges of the upper die impression around mandrels show wear usually combined with plastic deformation and spalling (see Figures 4c, 4e, 4f). On these edges high contact pressures as well as large sliding lengths between deformed material and die surface took place. These conditions led to higher heating and consequently to higher tempering of the die surface layer that favoured wear, spalling of fragments of nitrated layer and plastic deformation. Spalling of relative large fragments is seen on the upper edge of mandrels (Figures 4c, 4e) for penultimate forging impressions. Mentioned spalling of fragments was, next to higher contact pressures that prevailed on these surfaces, also consequence of presence of nitrides on grain boundaries of the diffusion layer (see Figure 3b) that decreased toughness of die steel. But spalling on mandrels took place only on one mandrel (Figure 4e) while on the other one only emphasized wear was observed (Figure 4b). Further, also spalling on top of mandrel (see Figure 4i) was detected. This occurrence of spalling could be attributed to thermal fatigue in combination with high contact pressure. On impression radii shown in Figures 4g and 4d1 plastic deformation was not observed

but only furrows as consequence of abrasion were visible. Namely contact pressures on this surfaces were relatively lower since radius of mandrel was greater. The base of mandrels previously indicated as critical areas in the hot-forging die (see Figure 1) is also critical for service life of dies and the quality of forged products. In these areas, due to pressure of forged material on both depression surfaces and consequently due to bending load on bottom of die depression, stress concentrations took place. These repeating mechanical loads resulted in formation of cracks at the base of mandrel (see Figure 4h) that caused surface, geometry and shape inadequacies of forged products. For comparison, such damage was not observed on similar area of die impression for penultimate forging sequence (see Figure 4d2). This indicated that the last impression was subjected to comparatively higher bending loads, and that required changes of impression design at the mentioned five sequential forging steps. In Figures 4a and 4f abrasion wear close to outer area of die impression as consequence of higher sliding length was observed. For further explanation and analysis of surface damages the cross-sectional microstructures especially of critical areas, i.e. on top, on upper and bottom edge as well as in the middle area of mandrel, will be presented.

Figure 4. Damages of the die after 45 766 strokes; plastic deformation (a, f), mechanical deformation (b, c, d, e, g), spalling (d, e), cracks (d, h), wear (i).

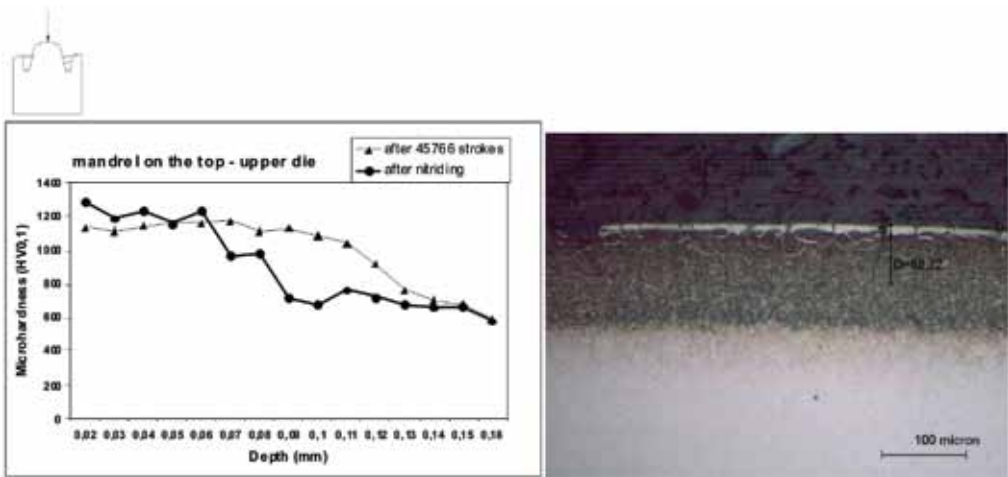
Damages on mandrel cross-sections
 Cross-sections of mandrel for the last forging operation revealed compound layer on the mandrel top (Figure 5) and in its middle area (Figure 7), while compound layer on the upper (Figure 6) and the bottom edge (Figure 8) was removed during the

Figure 5. Hardness profile and cross-sectional microstructure on the top of mandrel

As already mentioned, cracks were also found in the diffusion layer on the upper edge having lengths of about 96 μm (Figure 6) and on the top of the mandrel with lengths of about 69 μm (Figure 5). Compound layer on the top of the mandrel also exhibited cracking as consequence

of thermal fatigue and presence of higher contact pressures (compare Figure 5 with Figure 4i). Relative sliding between the die surface and the deformed material was reduced in these areas thus surface material was removed by spalling. Effective nitriding depths on all the cross-sections were in range of about 150–160 μm . Microhardness measurements showed the highest drop of hardness values from $HV_{0.1} = 1292$ on the edge of die after the nitriding process, to $HV_{0.1} = 1044$ (see Figure 6) on the upper edge of the high mandrel after die failure.

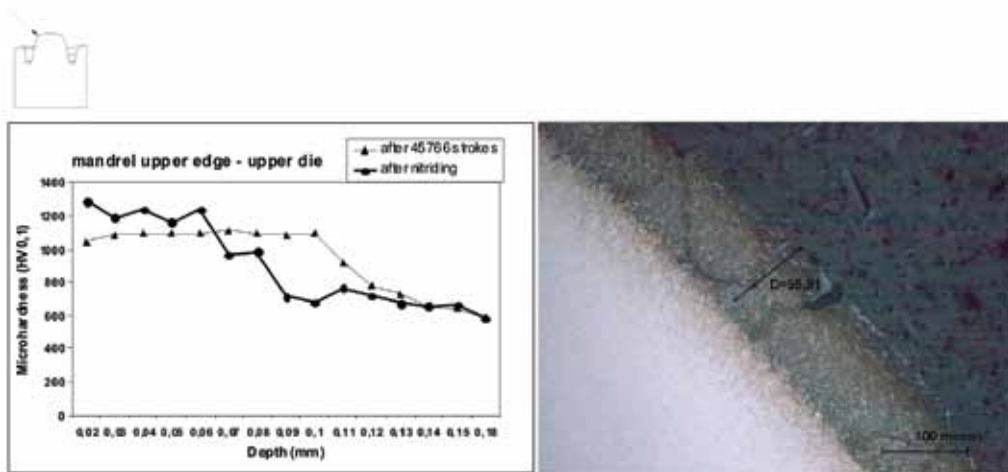
forging process; furthermore, formation of cracks in the diffusion layer was observed (see Figures 5 and 6). Removal of compound layer could be attributed to higher contact pressures and sliding lengths that prevailed in these areas and they led first to its cracking and then

Figure 6. Hardness profile and cross-sectional microstructure on the upper edge of mandrel

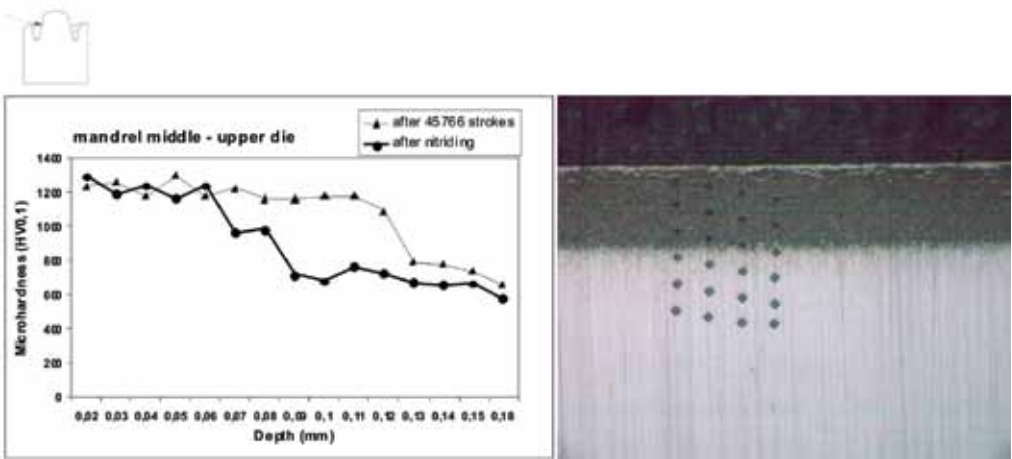
Figure 7. Hardness profile and cross-sectional microstructure in the middle part of mandrel

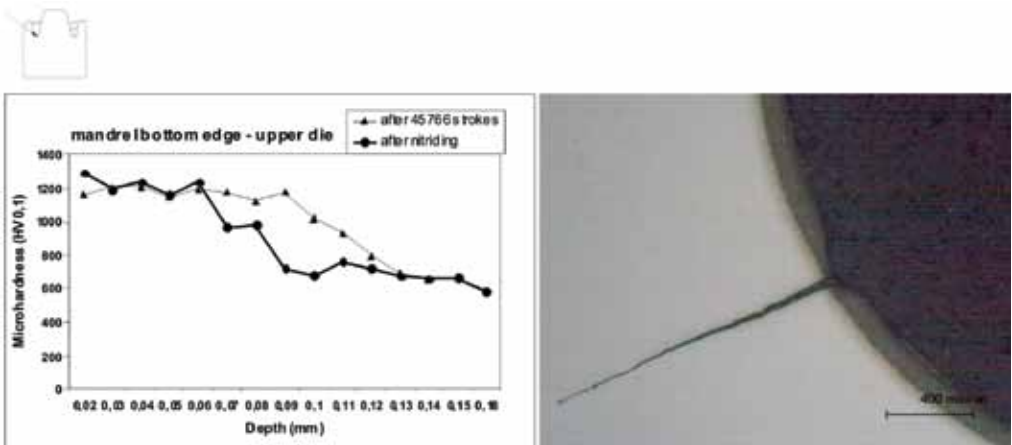
Figure 8. Hardness profile and cross-sectional microstructure on the bottom edge of mandrel.

Furthermore, crack with length of about 1.5 mm at the base of mandrel was detected (Figure 8, compared with Figure 4h). In this figure also more intensive spalling of diffusion layer on the surface at the beginning of crack was observed. In fact, this surface damage limited die life since the surface quality and shape of forging did not fulfil demands of customer.

- Mechanical fatigue cracking occurred at the base of mandrels and it was decisive mechanism that was influencing die service life. Crack with length of about 1.5 mm was observed on the bottom edge of mandrel. This damage could be avoided by reducing the pressure of deformed material on die surface in the depression, i.e. by optimizing deformation sequences (steps) in forging.
