# Staranje cevi uparjalnikov v Jedrski elektrarni Krško

## Aging of Tubes in the Krško Nuclear Power Plant's Steam Generators

Leon Cizelj · Ferdo Androjna

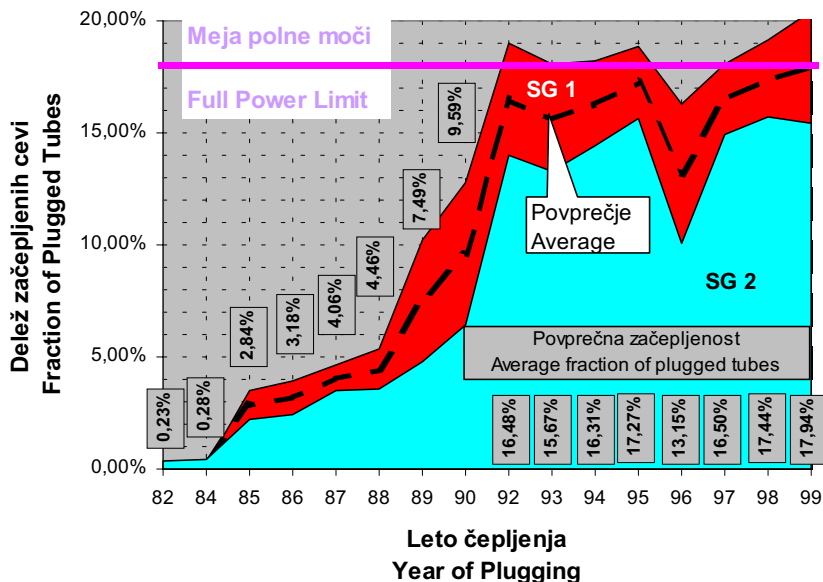
Sl. 1. Potek začepjenosti  
Fig. 1. History of tube plugging

The history of the tube repairs in both steam generators is depicted in Figure 1. The full lines denote the fraction of the tubes plugged in SG 1 (upper) and SG 2 (lower), while the dashed line shows the average fraction of plugged tubes in both steam generators.

V letih 1993 in 1996 opazimo pomembno zmanjšanje števila začepjenih cevi, ki je predvsem posledica vstavljanja tulcev v nekatere ponovno usposobljene-odčepljene-cevi.

A major drop in the number of plugged tubes can be seen in 1993 and 1996. This was a result of the reactivation and sleeving of some of the already plugged tubes.

V obdobju po letu 1994 je bilo število na novo začepjenih cevi dokaj stabilno. Izjema je le nenadno povečanje v letu 1997. Pojasnilo je najti v [10].

The repair rates have been relatively stable since 1994, with the exception of in 1997. The explanation for this is attempted elsewhere [10].

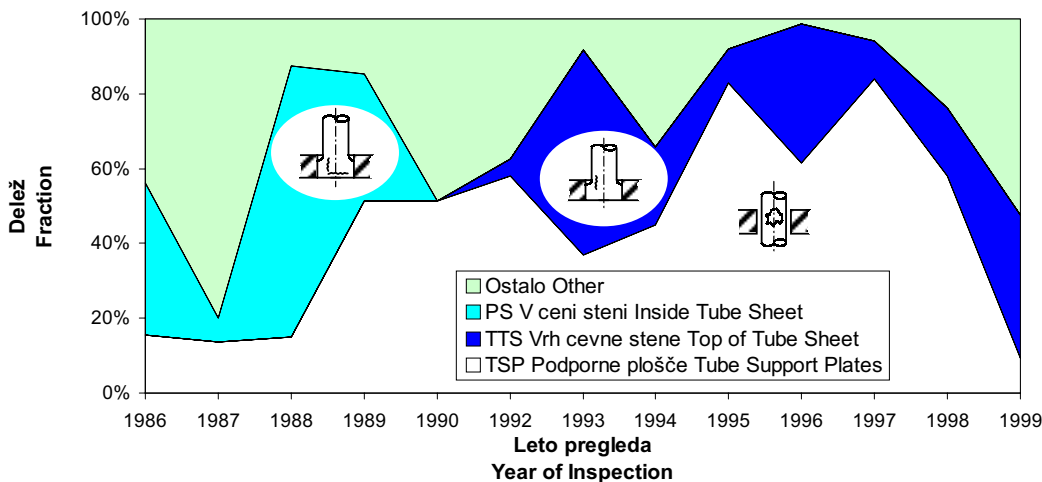
Sl. 2. Glavni vzroki za popravila cevi (SG 1 in SG 2)  
Fig. 2. Major causes of tube repair (SG 1 and SG 2)

The major degradation mechanisms that required the repair of the tubes are compared in Figure 2. More than 80% of tube repairs during the lifetime

**PS** označuje tretji najpomembnejši vzrok za popravila cevi (sl. 2), ki je prevladoval pred letom 1988. To so bile napetostnokorozijske razpoke, ki so v celoti znotraj cevne stene. Varnostne analize, opravljene v letu 1990, so pokazale zelo majhno verjetnost odpovedi cevi zaradi takih poškodb (razdelek 2.2 in [4]).

**PS** denotes the third major cause of tube retirement shown in Figure 2. It stands for stress corrosion cracks located entirely within the tube sheet, which dominated tube repairs until 1988. Safety analyses performed in 1990 showed the very low likelihood of tube failure caused by such defects (see Section 2.2 and [4]).

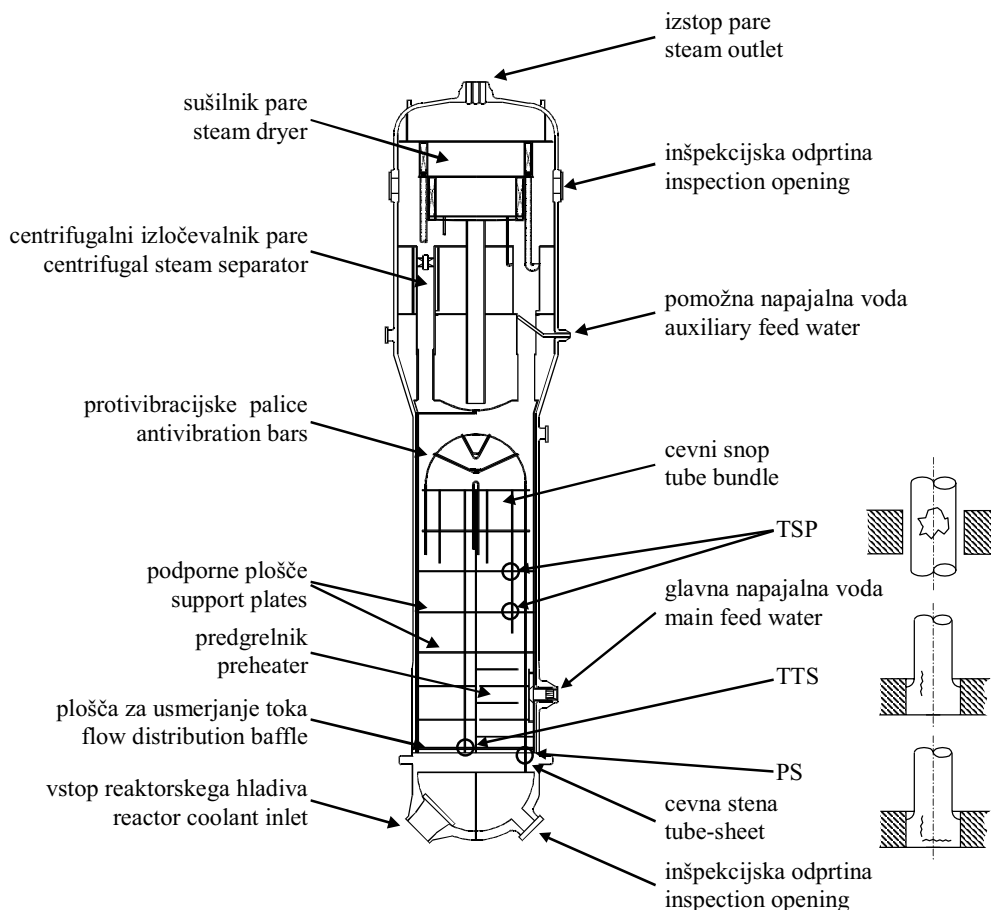
Sl. 3. Skica uparjalnika z lego najpogostejših vrst poškodb  
 Fig. 3. Sketch of a steam generator with the locations of dominant degradation mechanisms

of the steam generators and more than 90% of repairs during the recent outages are attributed to only two degradation mechanisms (Figure 3):

- **TTS:** axial stress corrosion cracking in the expansion transitions at the top of the tube sheet (TTS) caused 24% and 17% of the repaired tubes in SG 1 and SG 2, respectively. The allowable defect size is described in Section 2.3
- **TSP:** outside diameter stress corrosion cracking (ODSCC) at the tube- support- plate intersections (TSP), caused about 56% and 63% of the repaired tubes in SG 1 and SG 2, respectively. The allowable defect size is described in Section 2.4.

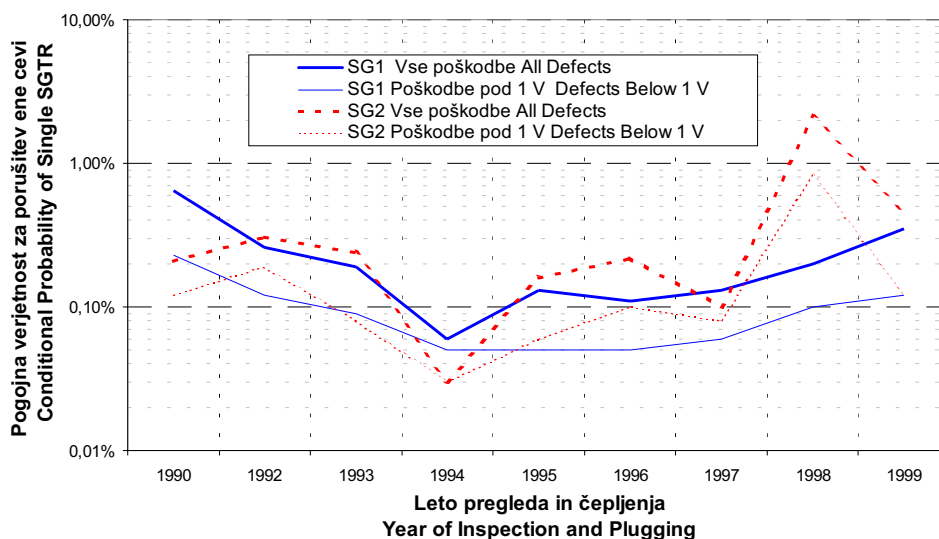
Sl. 4. Pogojna verjetnost porušitve ene cevi med hipotetičnim zlomom parnega voda  
Fig. 4. Conditional probability of single SGTR given a hypothetical SLB accident

Figure 4 depicts the development of a single tube rupture probability in both steam generators during the period 1990 to 1999. The depicted probability is conditional and is assumed to follow a rather unlikely occurrence of a hypothetical design accident Steam Line break. Two cases are considered for each steam generator: (1) "All defects", which means that no credit was taken for tube repair and (2) "defects below 1 V", which represents the tube repair following the recommendations of [13]. The tube repair performed at Krško NPP was between both

Two different trends may be observed in Figure 4. In the period 1995 to 1999, the probability of tube rupture decreases, which is consistent with the growing population of ODSCC defects. On the other hand, the period 1990 to 1994 exhibits a decreasing probability of tube rupture. The main reason for this is a change in the non-destructive examination technology: the first implementation of [13] compliant NDE methods dates back to 1994. Consistent results are therefore obtained only for the period 1995-1999.

The average conditional single-tube-rupture probability of both steam generators (“All defects”) was well below the reportability threshold of 1% which is foreseen in NRC GL-95-05 [13] during the period depicted in Figure 4. The probability of multiple tube rupture was at least two orders of magnitude lower in all the analysed cases. It may therefore be concluded that Krško NPP operated with degraded, but safe, steam generators.

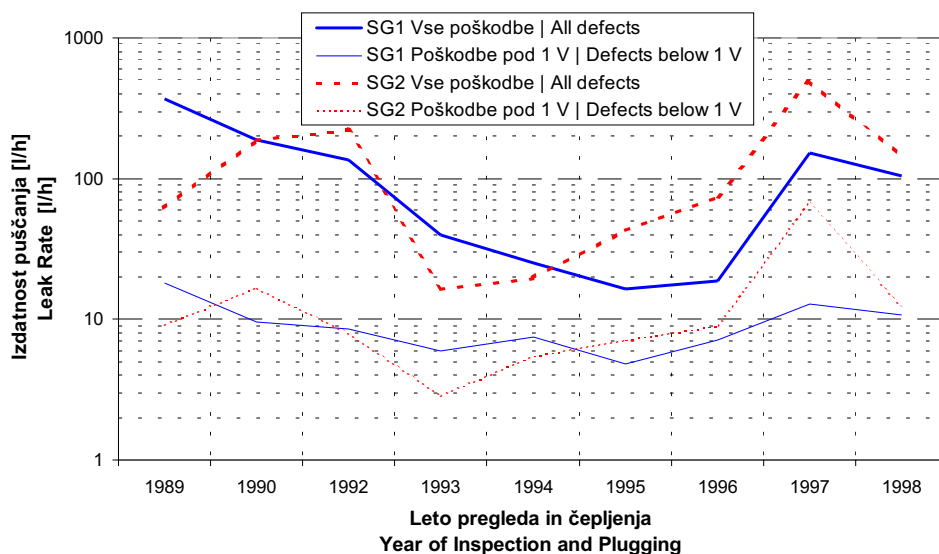
Sl. 5. Ocenjene izdatnosti puščanja ob hipotetični nezgodi zlom parnega voda  
Fig. 5. Estimated leak rates given a hypothetical SLB accident

Figure 5 depicts the development of estimated accidental leak rates in both steam generators in the period 1989 to 1998. The depicted leak rates are conditional and are assumed to follow a rather unlikely occurrence of a hypothetical design accident Steam Line break. Two cases are considered for each steam generator: (1) “All defects”, which means that no credit was taken for the tube repair and (2) “defects below 1 V”, which represent the tube repair

Two different trends may be observed in Figure 5. In the period 1995 to 1999, the leak rate through both steam generators was increasing, which is consistent with the growing population of ODSCC defects. On the other hand, the period 1990 to 1994 exhibits a decreasing leak rate. The main reason for this is a change of the non-destructive examination technology: the first implementation of [13] compliant NDE methods dates back to 1994. Consistent results are therefore obtained only for the period 1995-1999.

The conservatively predicted highest accidental leak rates for both steam generators are in the order of 0.2 m<sup>3</sup>/h in SG 1 and 0.5 m<sup>3</sup>/h in SG 2 for 1997. This is well below the recommended maximum leak rate of 19 m<sup>3</sup>/h [14], allowed during a hypothetical SLB. For comparison, the Krško NPP is licensed to operate normally with a leakage of up to 40 l/h through any of the steam generators. It may therefore, again be concluded, that Krško NPP operated with degraded, but safe, steam generators.
