Macro and Micromorphology of in Service Cracking and Fracture of Turbine Blades

F. Vodopivec*, B. Ule, L. Vehovar, J. Žvokelj, Institute of Metals and technologies, Ljubljana, Slovenia

After the break down cracked and fractured blades were extracted from the turbine and the macro and micromorphology of cracks and fractures surface were investigated.

Three modes of propagation were identified: stable propagation by HISC, stable propagation by HISC and fatigue and instable brittle and ductile propagation. The micromorphological characteristics of the different modes of propagation are explained.

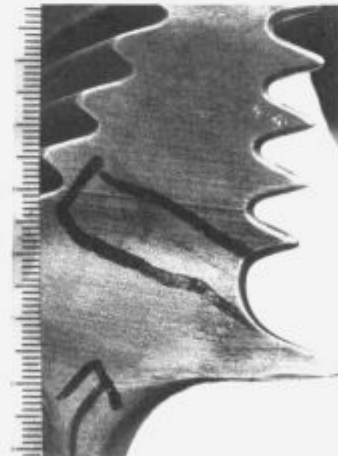
Figure 1: Crack on the trailing edge in the first root groove of blade 436.

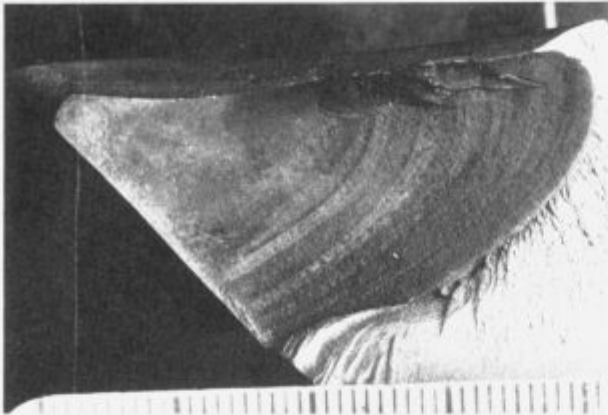
- surface showing near the initial point no fatigue striations but with such striations on the remaining area of the crack (fig. 2 and 6).
- surface of cracks without fatigue striations (fig. 3), and
- surface with fatigue striations from the starting point of cracks propagation.

Figure 2: Surface of a crack with areas with and without fatigue striations.

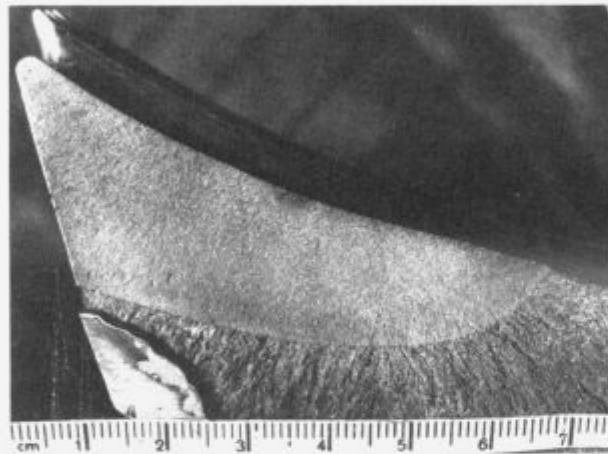
Figure 3: Surface of a crack without fatigue striations.

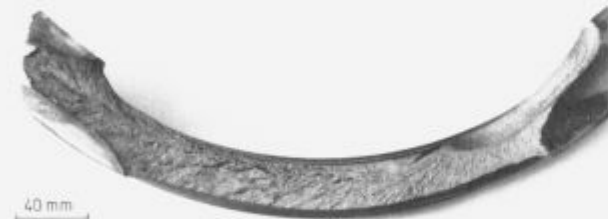
Figure 4: Fracture of the blade 447 extracted from the disc after the break down. The initial crack is on the left side.

granular (**fig. 17**). Virtually identical was the micromorphology of the fracture of blade 434, which failed in service probably at the same time and in similar stress conditions. Also the micromorphology of the brutal fracture of blades 442 (**fig. 4**) and 447, two blades broken in service or during the break down and precracked in the first groove of the root is similar as that in area III of blade 379.

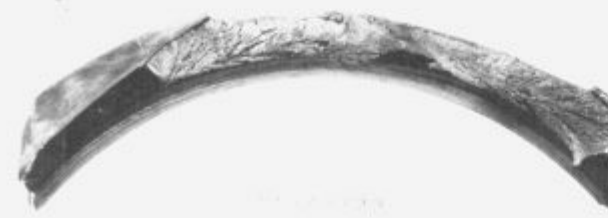
Figure 5: Fracture of the blade 379 extracted from the disc after the break down.

Brutal in service fracture was observed on blades 379, 434, 442 and 447. **Fig. 16** shows the micromorphology of the fracture in area I on blade 379 fractured without precrack and shown in **fig. 5**. The micromorphology shows a quasi ductile propagation under shearing stress with very rare intercrystalline details. In area II of the same blade the micromorphology is identical. In area III, where the propagation occurred in conditions of plane strain (I), the micromorphology is brittle, mixed trans and inter-

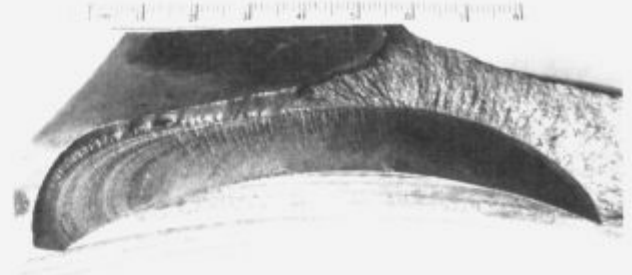
Figure 6: Surface of the crack on the blade on fig. 4.

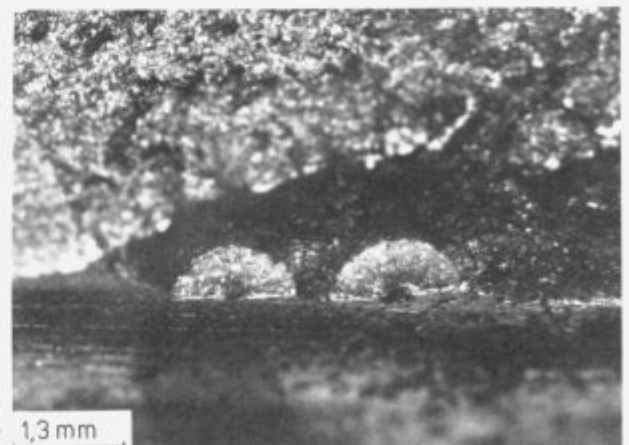
Generally, the surface of cracks near the initial point was covered with corrosion products and also after a very careful cleaning it was rarely possible to find at SEM observation reliable details, which would characterize the mechanism of initiation. An exception was the specimen in fig. 7, where several crack initials with a perfectly clean surface were found. Near the tip of the pitting with a size of appr. 0,25 mm the fracture surface is brittle trans and intergranular (fig. 8) without fatigue striations. The micromorphology of the transgranular surface is featherlike and similar to that reported frequently for high strength steels with a martensitic microstructure and with an increased content of hydrogen. This suggests that in presence of the pitting the nucleation of the crack was induced by the overcharging of the steel with hydrogen produced by the corrosion process at the tip of the pitting. A similar detail of micromorphology of fracture surface near the nucleation point was observed also on the blade 436 (fig. 9). It shows mixed propagation and small contamination with corrosion products, visible more clearly on the intergranular surface. On the clean part of cracks surface without striations near the border of the brutal fracture the micromorphology was similar as in fig. 8 and 9 and it showed mixed trans and intergranular propagation with the featherlike surface of transgranular cleavage (fig. 10).

Figure 7: Fracture initials on blade 450.

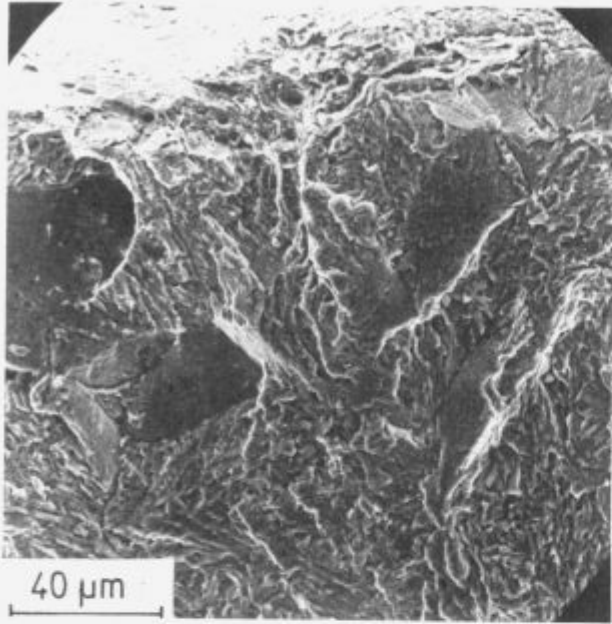
Figure 8: Surface of one of the cracks in fig. 13 near the bottom of the pitting.

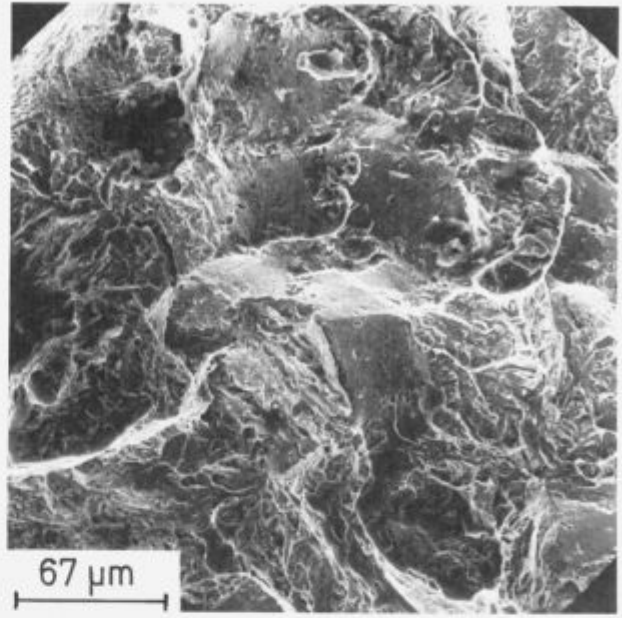
Figure 10: Surface of the crack in fig. 3 near the border line of the brutal rupture of the blade.

In all cases when the cleaning was sufficient to reveal details the surface of cracks without fatigue striations showed a micromorphology similar to that in fig. 10, thus brittle trans and intergranular propagation.

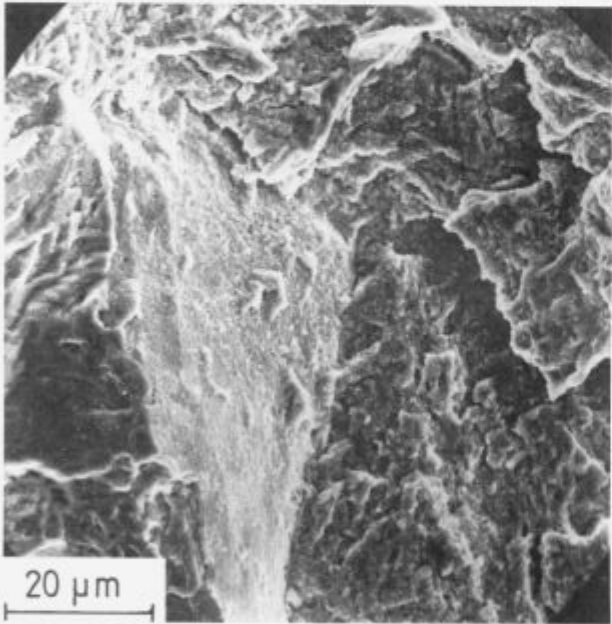
Figure 9: Detail of the crack surface without fatigue striations.

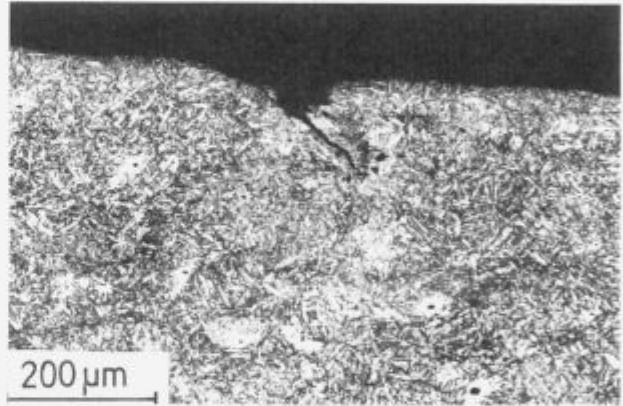
Figure 11: Pitting and microcrack in the first root groove.

Corrosion pits were the initials of all the cracks in the first groove of the root, also pitting as small as 0,05 mm (fig. 11).

As already shown, all the findings indicate that the initials of cracking in the first groove of the root were corrosion pits, also pits as small as 0.05 mm (fig. 11). The steel at the top of the pits was charged with hydrogen, that decreased its fracture toughness and cracks with mixed trans and intergranular propagation were

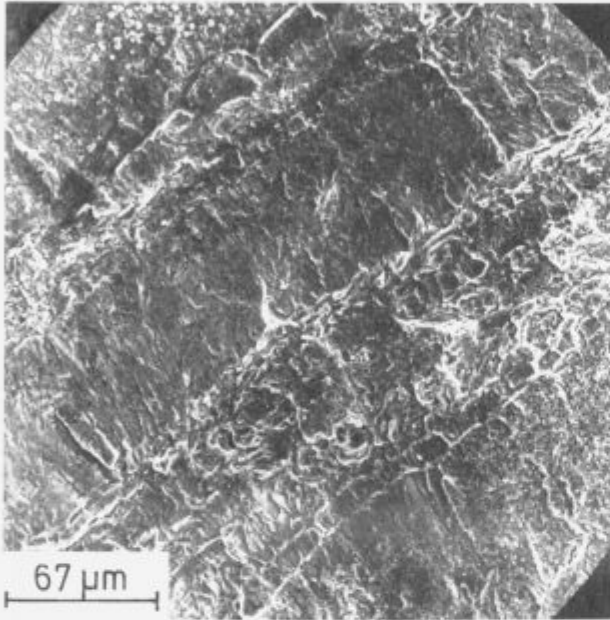
fatigue with striations of different width (fig. 12) was found only in the crack situated in the rounded passage between the root and the leaf of the blade. The propagation is transgranular and the micromorphology is independent upon the width of the striation. The main feature are striations and small edges oriented in the direction of crack propagation. It seems safe to conclude that the cause for propagation was the amplitude of fatigue stress and that large striations represent the operation of the turbine in range of critical number of revolutions. Also the width of the narrowest striation is considerable (0,01 mm) and indicates a relatively high amplitude of dynamic stress. In the second case the crack surface showed by macroscopic observation an apparent pure fatigue propagation. By appropriate magnification is SEM a mixed micromorphology was observed (fig. 13). It consisted of groups of steps and microcracks orthogonal to the direction of propagation alternated with wider bands where the surface indicates a specific mechanism of transgranular propagation. Microridges parallel to the direction of the propagation of cracks trespassed sheafs of steps and microcracks orthogonal to the

Figure 12: Surface of the fatigue crack in the rounded area of the transition from the root to leaf of the blade.

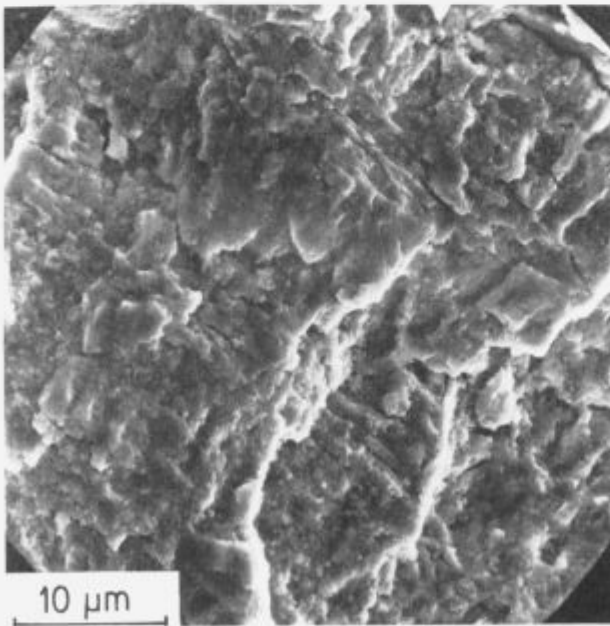
Figure 13: Microdetail of the crack surface in fig. 2 in the area of fatigue striations.

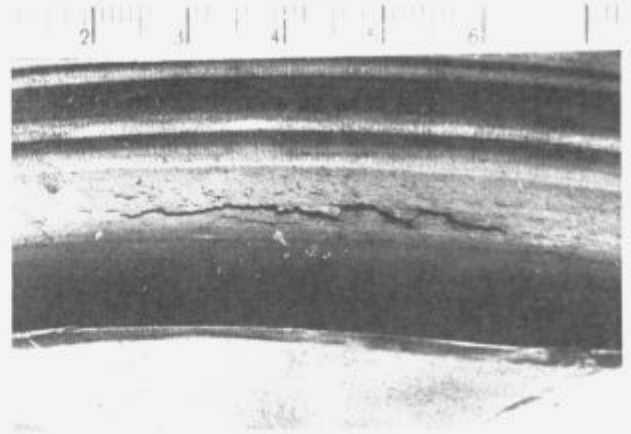
Figure 14: Step like crack on the working side in the first root groove. Blade 435.

initiated because of static or dynamic stresses. The initiation took place either on several points and single microcracks coalesced in a steplike macrocrack (fig. 14) or in one point and the microcrack did grow in a harline slightly curved macrocrack (fig. 15). If the corrosion process was continued, the crack continued to propagate by the same mechanism and a crack surface without striations was obtained. If the intensity of corrosion was diminished or the corrosion was stopped, the propagation continued by sufficient stress amplitude in conditions of pure fatigue.

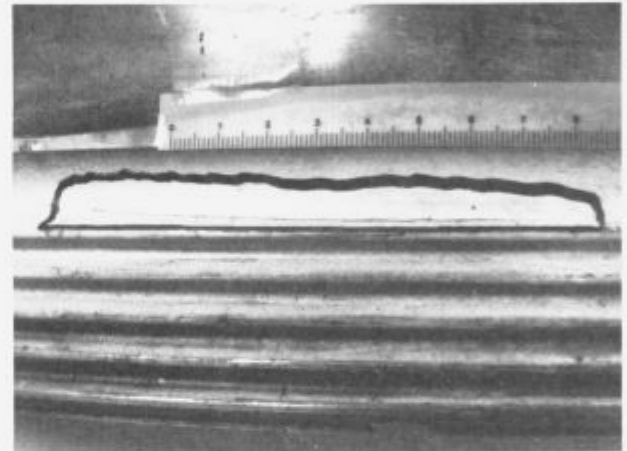
Figure 15: Straight crack on the working side in the first root groove of blade 411.

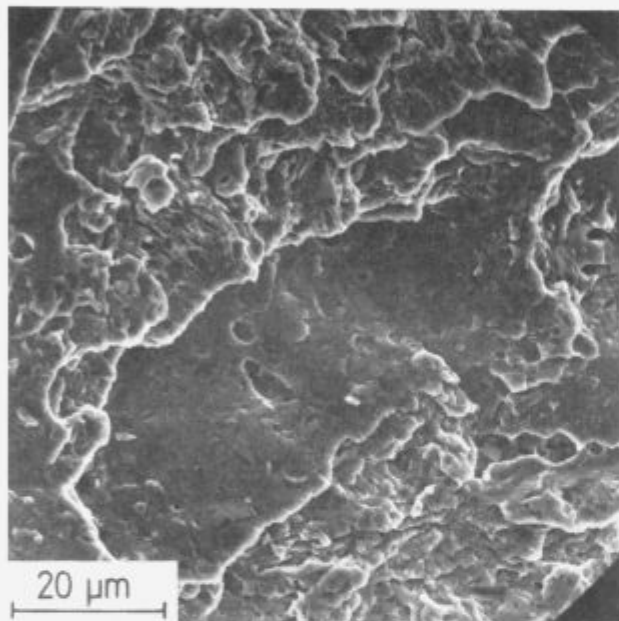
Figure 16: Microdetail of the rupture surface of the blade on fig. 5 in area I.

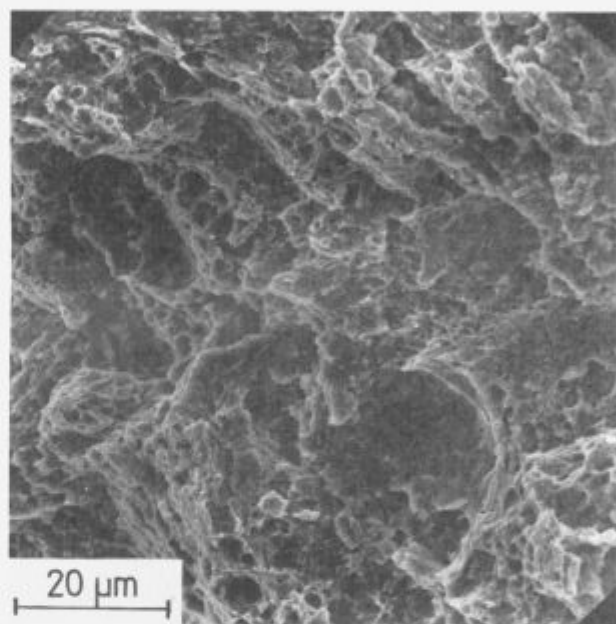
On notch toughness specimens the more intercrystalline brittle propagation was found the lower was the value of notch toughness. By a level of 70 J and more the propagation was ductile (**fig. 18**) with mostly small dimples, which indicate that only a thin layer of metal both sides of the crack lips was deformed

Figure 18: Fracture surface by a notch toughness of 110 J.

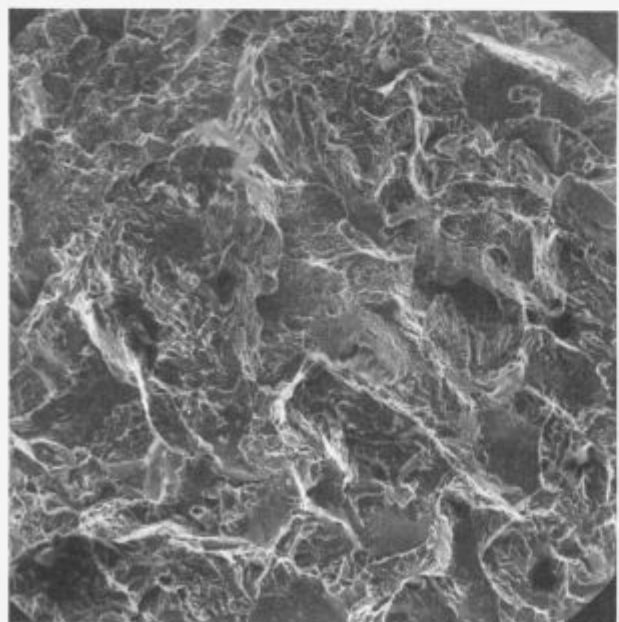
Figure 17: Microdetail of the rupture surface of the blade on fig. 5 in area III.

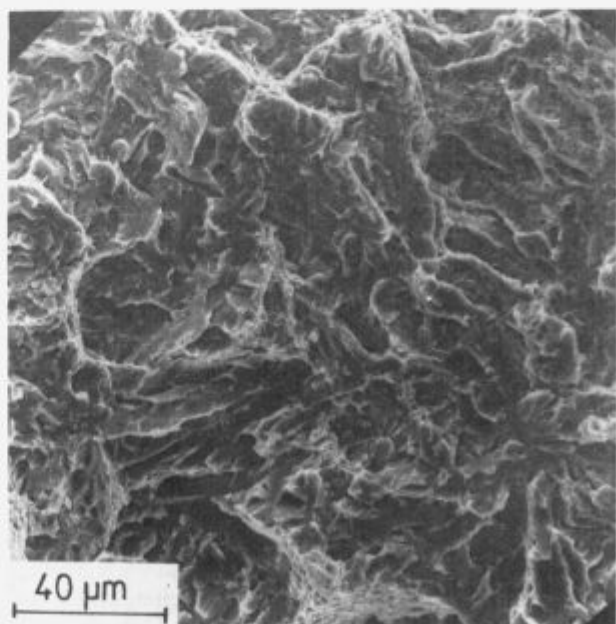
Figure 19: Fracture surface by a notch toughness of 52 J.

during the formation of the voids. Below a toughness of 60 J the surface shows a quasi brittle propagation with frequent areas of propagation through martensite platelets lying in the plane of the fracture and rare ductile details (fig. 19). By a notch toughness of 34 J in a similar transcrystalline matrix intergranular facets are found (fig. 20) and by a notch toughness of 24 J the intergranular brittle propagation predominated (fig. 21). It seems thus that the diminution of toughness below a level of appr. 35 J is connected to an increasing part of intergranular brittle crack propagation. The micromorphology of fracture toughness and of notch toughness specimens of the same steel was virtually identical.

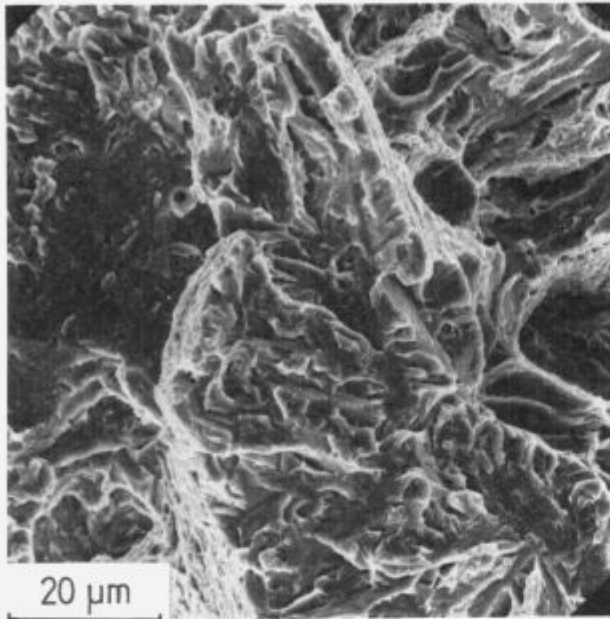
Figure 20: Fracture surface by a notch toughness of 35 J.
Slika 20: Prelomna površina pri zarezni žilavosti 35 J.

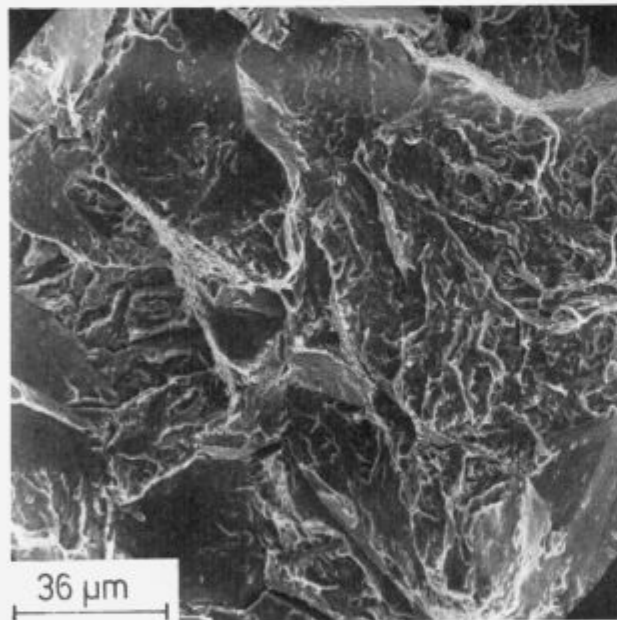
Figure 21: Fracture surface by a notch toughness of 22 J.
Slika 21: Prelomna površina pri zarezni žilavosti 22 J.

poorly marked (fig. 22). By intermediate toughness level the particles of carbide are smaller, frequently aligned along grain boundaries and along martensite platelets, and the habitus of martensite is well marked (fig. 23). By a very low notch toughness of 20 J the microstructure is similar. A careful evaluation indicates that the difference in notch toughness and the increasing part of intergranular fracture can not be explained only in terms of microstructure. The tempering temperature required for a high limit of elasticity for this type of steel is in the range of reversible intergranular segregation of some elements, especially phosphorus (5). It seems thus that the intergranular fracture by low toughness is partly due also to the brittleness produced by intergranular segregation. This conclusion is confirmed by the fact that frequently intergranular facets are perfectly smooth (fig. 21), thus typical for intergranular brittleness produced by reversible intergranular segregation (5).

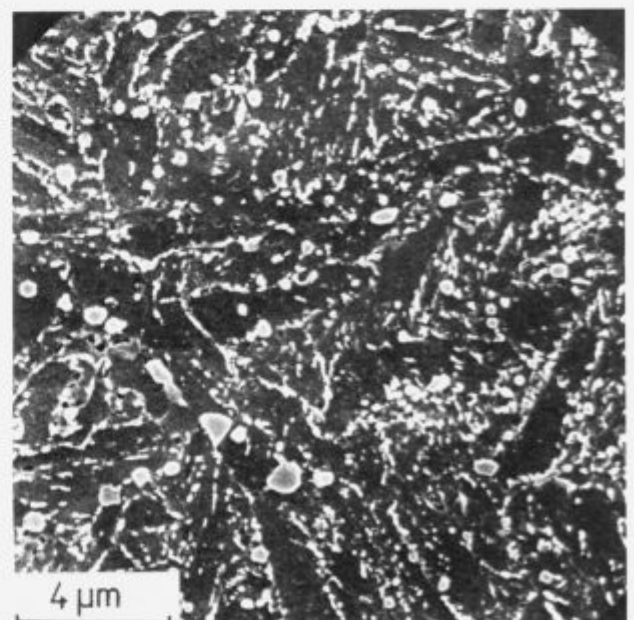
Figure 22: Microstructure by a notch toughness of 110 J.
Slika 22: Mikrostruktura pri zarezni žilavosti 110 J.

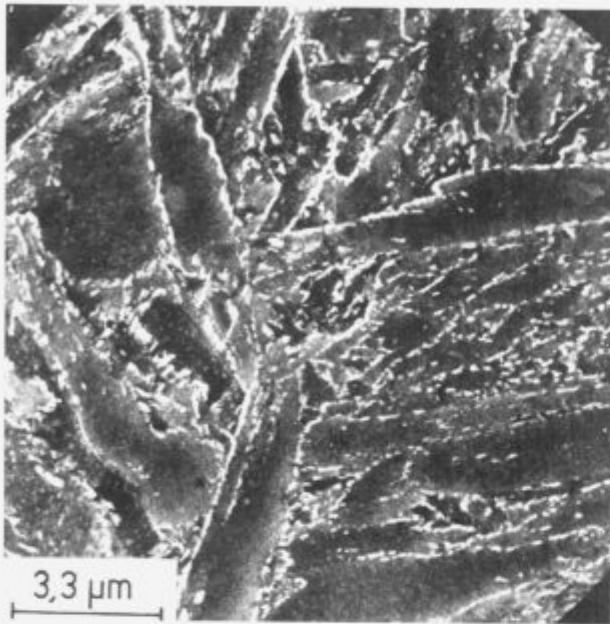
Figure 23: Microstructure by a notch toughness of 35 J.
Slika 23: Mikrostruktura pri zarezni žilavosti 35 J.
