# The Use of Computed Tomography to Analyse Grinding Smudges and Subsurface Defects in Roller Bearing Rings

Andrzej Zbrowski\* – Krzysztof Matecki

National Research Institute, Institute for Sustainable Technologies, Poland

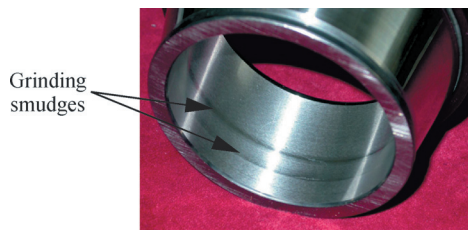
Visible symptoms of the existence of inner defects in the structure of the investigated material are surface smudges stemming from the grinding process (Fig. 1).

Fig. 1. Grinding smudges on the inner ring of the roller bearing

Such material defects resulting from the rolling, forging or casting processes are usually filled with impurities from metallurgical or forging processes. The grinding wheel opens up the material discontinuities, extracts the impurities, and smudges them over the ground surface, which creates smudges of different colours and lustre. The size of the smudge depends on the kind, shape, and location of the discontinuity. The greater the size of the discontinuity, the wider and clearer the smudge. Even when the opening in the discontinuity of the material is small, the smudge can be visible to the naked eye, not to mention specialised optical inspection systems. A roller bearing ring with the detected defect in form of a grinding smudge should be excluded from any further manufacturing process.

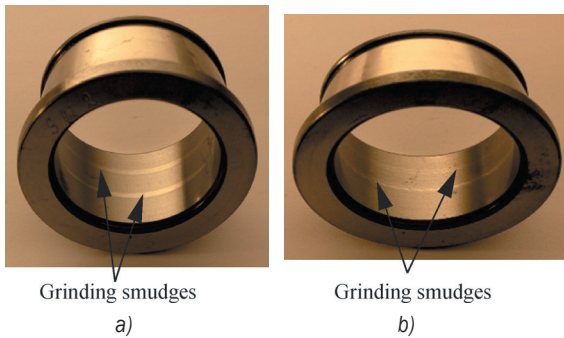
The A and B roller bearing rings with visible grinding smudges made of the 100Cr6 steel were tested (Fig. 2). The hardness of the surface after the heat treatment was 58 to 62 HRC.

Fig. 2. Test objects for rings: a) A and b) B

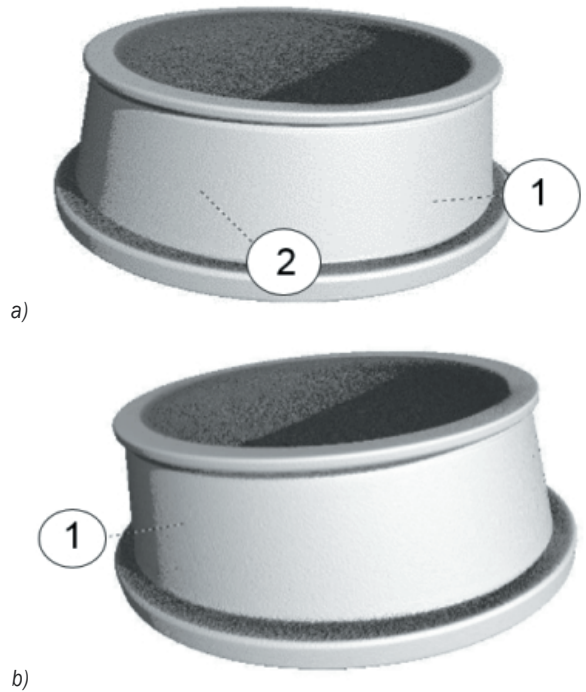
3D images were obtained for both A and B rings. A method of computed tomography was used (Fig. 4) to detect the location of the defect (marked with numbers 1 and 2).

Fig. 4. Tomography reconstruction image for rings a) Ring A and b) Ring B

In the case of Ring A, two discontinuities were detected; whereas only one defect was detected in the case of the other ring. In order to enable a more detailed description of the defects, three perpendicular sections of the reconstructed objects were created. They allowed the determination of the character, orientation and the topography of the discontinuity. The examples of the images of Defect 1 in Ring A in the defined axes are depicted in Fig. 5.

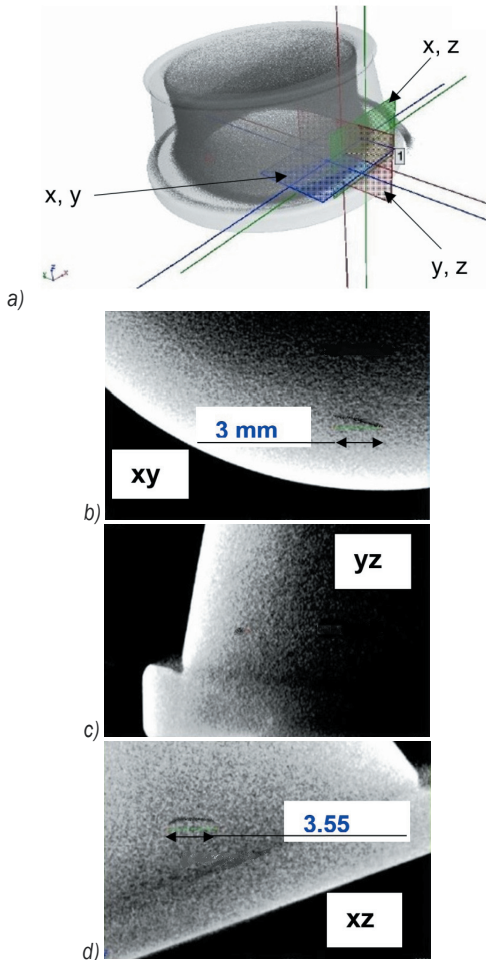
**Fig. 5.** Selected images of sections in xyz axes of Defect 1 in the reconstruction of a) ring A, b) xy intersection, c) yz intersection, d) xz intersection

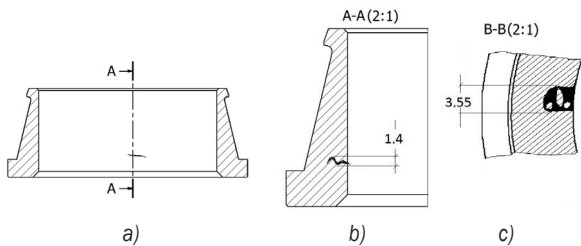
Discontinuity 1 in Ring A is similar to the crack or the flattened cavity with extended topography in the direction perpendicular to the inner surface of the ring (Fig. 6).

**Fig. 6.** Cross-sections and a draft of the defect propagation - Defect 1, Ring A - dimensions in mm: a) intersection, b) part section A c) part section B

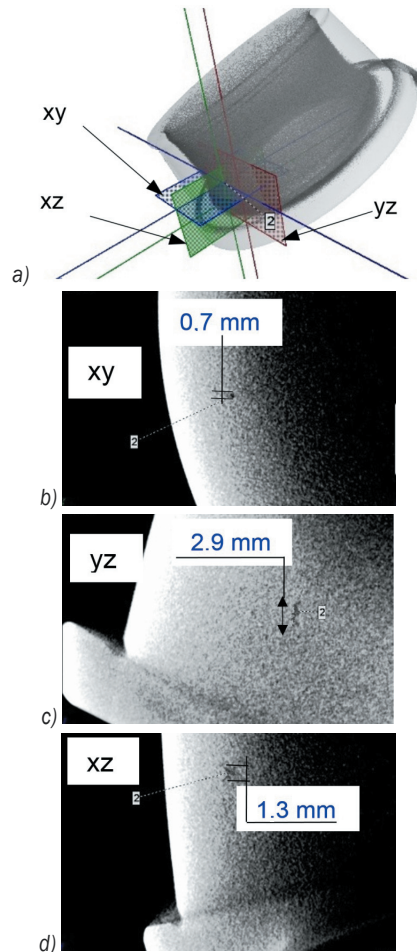
The examples of the images of the area in which Defect 2 was observed for Ring A are shown in Fig. 7.

**Fig. 7.** Selected images of Defect 2 cross-section in planes XY, YZ, XZ in reconstruction of Ring A: a) ring A, b) xy intersection, c) yz intersection, d) xz intersection

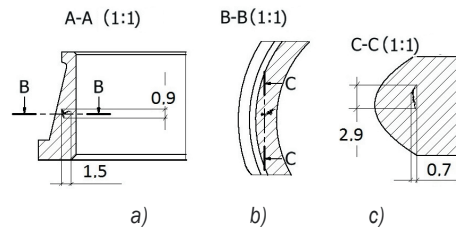
Defect 2, similar to Discontinuity 1, has the form of a crack or a flattened cavity. It is smaller than Defect 1, and its shape is more irregular (Fig. 8).

**Fig. 8.** Cross-sections and a draft of the defect propagation - Defect 2, Ring A - dimensions in mm: a) intersection, A b) part section B c) part section C

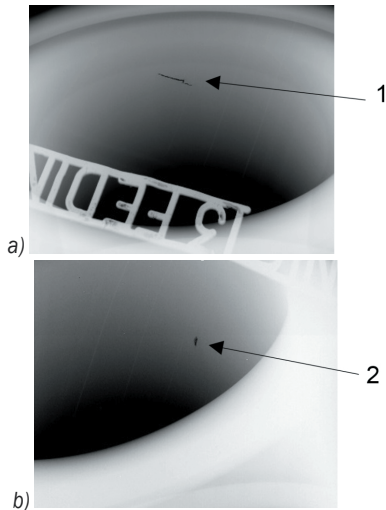
Fig. 9 depicts the radiographs for Ring A with a clearly visible Defect 1 and a tiny, even at greater magnification, Defect 2.

Fig. 9. Radiograph for Ring A: a) defect 1, b) defect 2

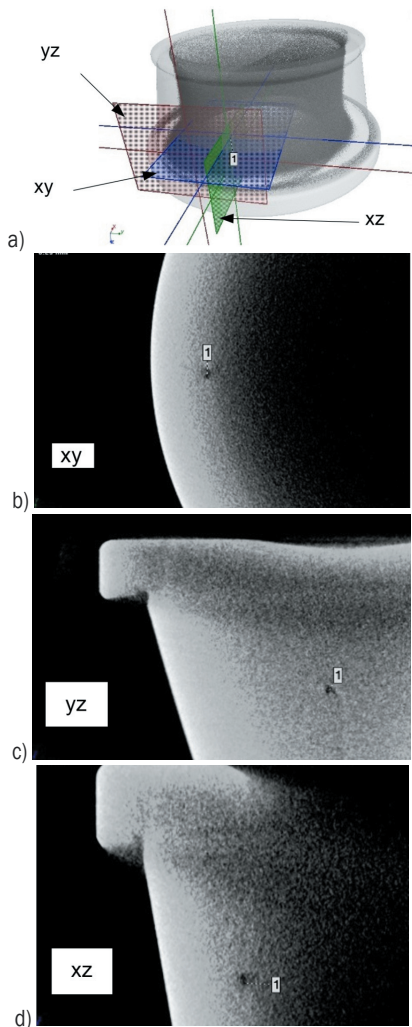
In the central part of Ring B, a discontinuity of extended structure was observed. The middle of the defect has the form of a cavity in which the propagating discontinuities (crack-like) are rooted (Fig. 10).

Fig. 10. Selected images of Defect 1 cross-section in planes XY, YZ, XZ in reconstruction of Ring B: a) ring B, b) xy intersection, c) yz intersection, d) xz intersection
