CORROSION INVESTIGATION OF THE PREŠEREN MONUMENT IN LJUBLJANA

Mirjam Bajt Leban, Viljem Kuhar, Tadeja Kosec, Andraž Legat

Slovenian National Building and Civil Engineering Institute, Dimičeva 12, 1000 Ljubljana, Slovenia
mirjam.leban@zag.si

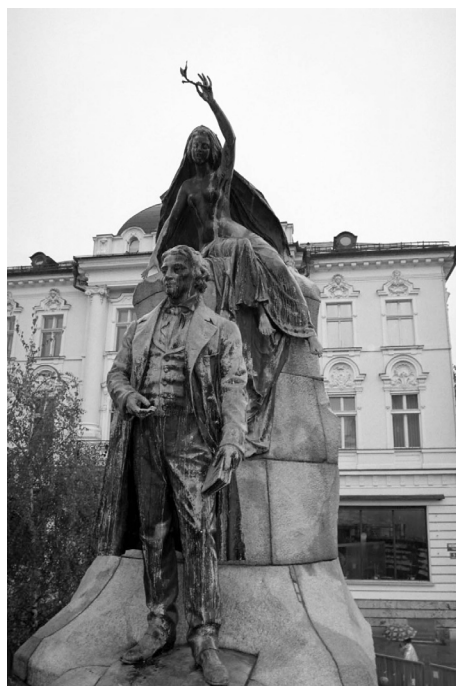
Figure 1: Statue of the poet France Prešeren, with the statue of the poetry Muse above, holding a sprig of laurel in her hand
Slika 1: Kip pesnika Franceta Prešerna s kipom pesnikove Muze, ki drži v roki lovorjevo vejico

of the patina consisted of cuprite (Cu₂O). The external layer consisted mostly of copper sulphates (bronhanite and antlerite), copper chloride–hydroxide (atacamite) and other compounds originating from environmental contamination¹³. On some hardly accessible sites (the Prešeren and Muse statues), where the leaching action of the acid rain (pH < 5) was not as strong, the layer of secondary corrosion products was very thick (up to 0.5 mm).

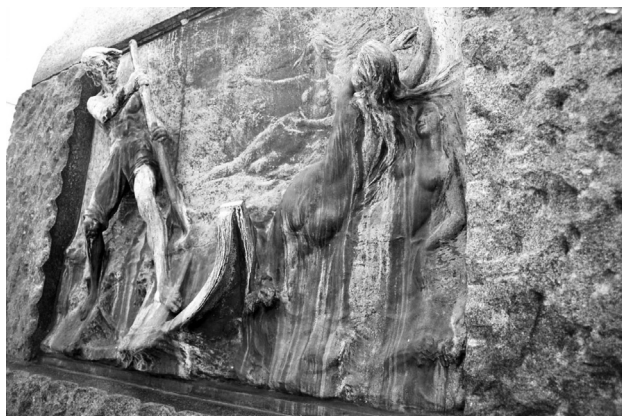
Figure 2: Relief "Fisherman"
Slika 2: Relief "Ribič"

Flow-off water zones of light green colour were formed on the sites of the intensive corrosion products. A minor area on the south side of the monument, known as *Ribič* relief, has a red-brown bronze surface. The internal patina layer consists mostly of cuprite, whereas the secondary layer is very thin. The patina in the vertical zones is primarily of soluble corrosion products consisting of copper carbonates.

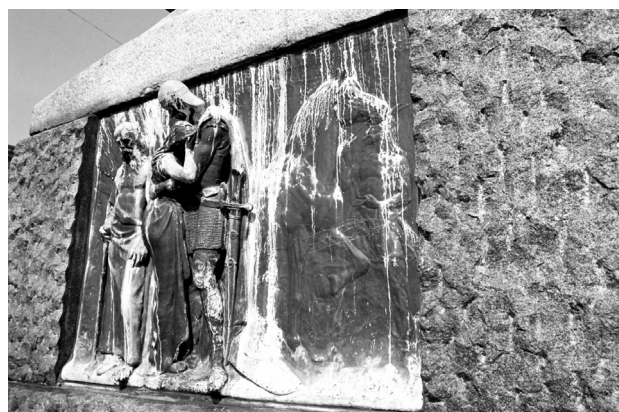
Figure 3: Relief "Črtomir's Farewell to Bogomila"
Slika 3: Relief "Slovo Črtomira od Bogomile"

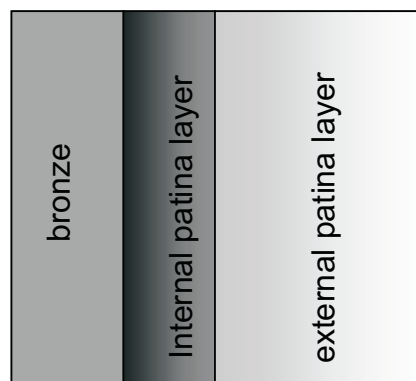
Figure 4: Schematic presentation of patina layers on bronze
Slika 4: Shematska predstavitev plasti patin na bronu

In the secondary-external layer of brown-black, black-green and green-white patina, the following predominant compounds were found: copper oxides, copper hydroxysulphates, as well as sulphides, chlorides and carbonates of copper and its alloying elements.
