OSSEOINTEGRATION AND REJECTION OF A TITANIUM SCREW

Grega Klančnik¹, Miro Zdovc², Uroš Kovšca², Borut Praček³, Janez Kovač³, Janez Rozman⁴

In the present study, a rejected titanium implant, an orthopaedic screw removed from a patient, was investigated. The screw was implanted into the metacarpal bone for one year and was removed due to irritation. The first signs of irritation were indicated three months after the implantation. After the removal, the signs of irritation disappeared. AES and EDS analyses showed that the surface of the screw was significantly different from the bulk material. The high contamination of the surface layer was found to be caused by the screw-manufacturing process, which is considered to be the main reason for the rejection of the implant.

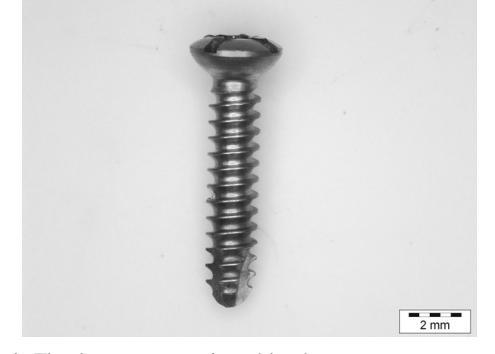
Figure 1: Titanium screw - rejected implant Slika 1: Titanov vijak – zavrnjeni implantat

Due to the golden-like colour of the surface of the screw and the nitrogen found with the AES analysis, it can be concluded that the surface of the screw was nitrided (Figure 1, 3 a). This titanium nitride provides a relatively stable surface (better wear resistance and hardness). The presence of aluminium and silicon could be assigned to the technology of the production (blasting the surface with alumina and silica particles, contamination with silicon oils, etc.). Furthermore, the high concentration of silicon on the surface of the screw could possibly result from an unintentional deposition during the manufacture. This fact was confirmed by the corresponding concentration gradient over the sputtering time. Siliconization increases the resistance of titanium to oxidation because it dissolves in the TiO₂ surface layer and reduces the diffusion rate of the oxygen atoms through this layer.⁶ Nevertheless, silicon increases the activity of osteoblasts and favours the formation of the appatite layer.

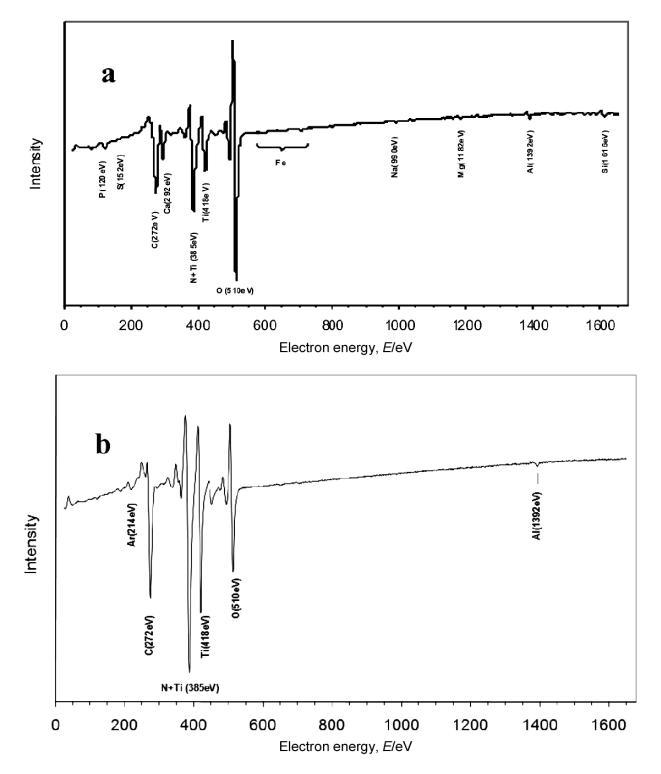
Figure 2: AES spectrum of the screw surface: (a) surface before and (b) after ion sputtering

The AES analysis of the retrieved screw surface after one year of implantation is shown in **Figure 2a**, **b**.

Calcium and phosphorus were both found to be the electrolyte constituents of the body fluid, and both are related to the formation of calcium phosphate. The presence of oxygen, nitrogen, titanium, silicon, aluminium and iron was also established (**Figure 2 a**). However, the last recorded AES spectrum, at the end of the ion etching inside the oxide layer, did not reveal the presence of iron (**Figure 2 b**). A trace of argon was found, because of the ion etching with Ar^+ . The presence of carbon on the screw's surface is related to the atmospheric contamination. The AES depth profile in **Figure 3 a** shows a high concentration of carbon, which is a result of backscattering.

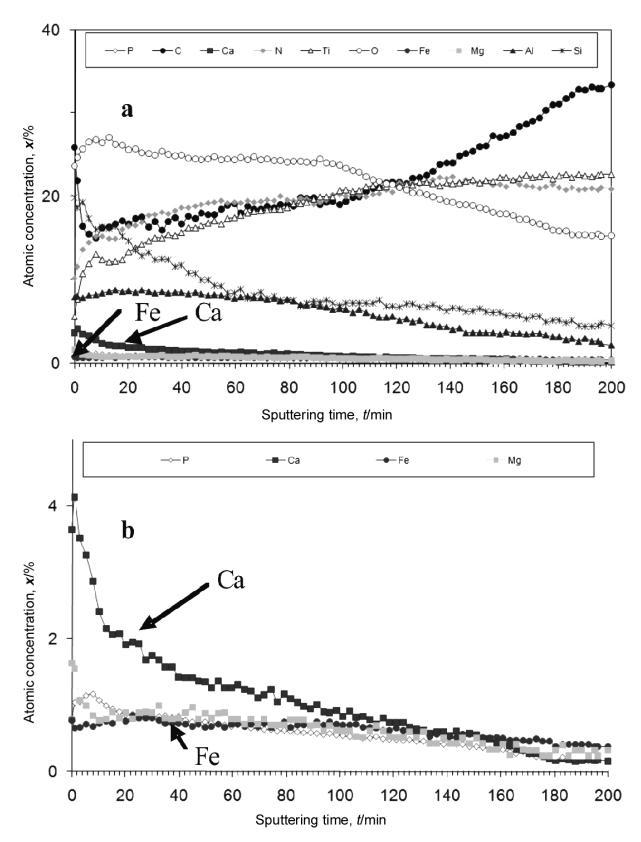
The presence of an oxidized surface suggests a strong affinity for oxygen (Figure 3a). The AES depth profile of the titanium screw's surface revealed a surface contaminated with iron deep inside the oxide layer (**Figure 3 b**). However, the AES spectrum of the bulk material, in **Figure 4**, does not show the presence of any iron.

Figure 3: AES analysis: (a) depth profile of titanium screw (b) contamination with iron

The penetration depth of the calcium and phosphorous was determined to be over 400 nm and shows the quality of the osseointegration. From the AES spectrum in **Figure 3 b**, the presence of iron was not detected deeper than 0.4 μ m, and iron was not detected in the basic (inner) material (**Figure 4**).

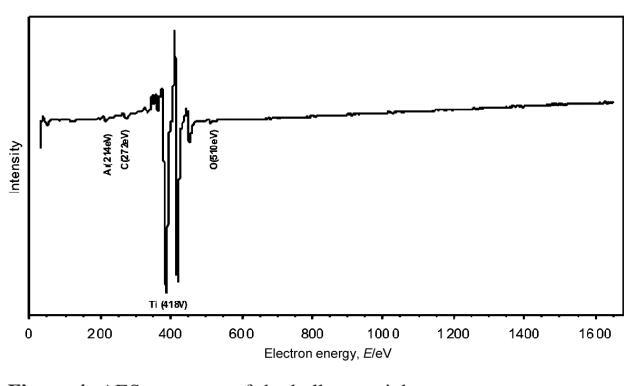
Oxygen is always present in trace amounts. **Figure 4** shows that inside the screw, in the titanium, an alpha structure is also present. The bulk of the screw was investigated with SEM and EDS (**Figure 5**).

EDS analysis (**Figure 5 a**) and AES spectrum of the bulk material (**Figure 4**) revealed no aluminium, silicon or iron in the bulk material. The chemical composition of

Figure 4: AES spectrum of the bulk material Slika 4: AES-spekter osnovnega materiala

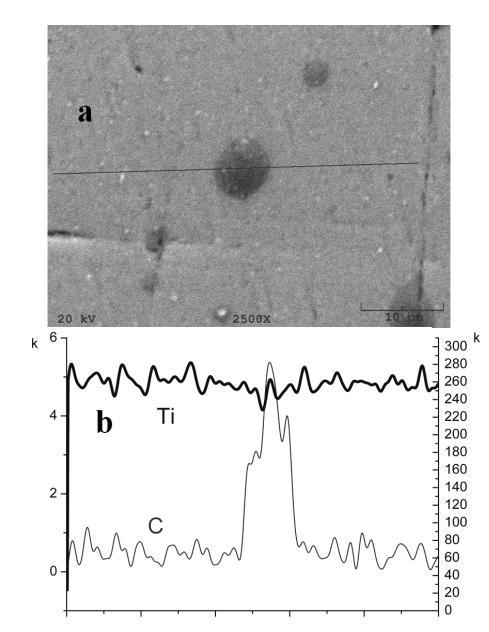
The EDS analysis of the precipitates also revealed the presence of carbon (**Figure 5 b**). The detection of the x-ray signal with the EDS system is difficult for carbon on account of its low atomic number. The results from the EDS analyses in **Figures 5 and 6** hint at the presence of titanium carbides. The micrograph in **Figure 5** revealed a 14- μ m-thick layer of titanium with a reduced presence, or absence, of precipitates. As already discussed, the absence of other elements was established.

Figure 6: EDS line analysis: (a) SEM micrograph and (b) EDS line analysis

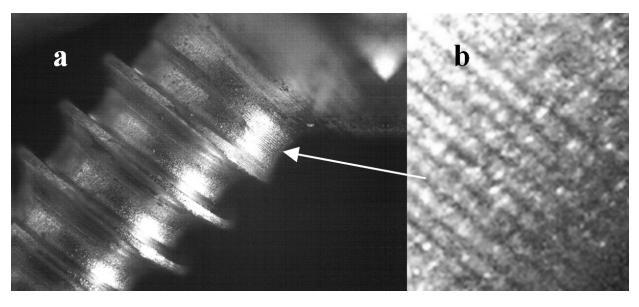
Figure 7: Macrograph of titanium screw: (a) surface and (b) turning grooves of the screw

The evidence of the machining of the screw is represented in **Figure 7**. The shape of the grooves indicates that the screw was not polished before the implantation.
