**META KRŽAN, univ. dipl. inž. grad.**

**EKSPERIMENTALNE IN NUMERIČNE PREISKAVE ZA  
DOLOČITEV KONTROLIRANEGA ODZIVA  
VEČSLOJNE KAMNITE ZIDOVINE**

**PERFORMANCE BASED EXPERIMENTAL AND  
NUMERICAL ASSESSMENT OF MULTI-LEAF STONE  
MASONRY WALLS**

Doctoral thesis No.: 247

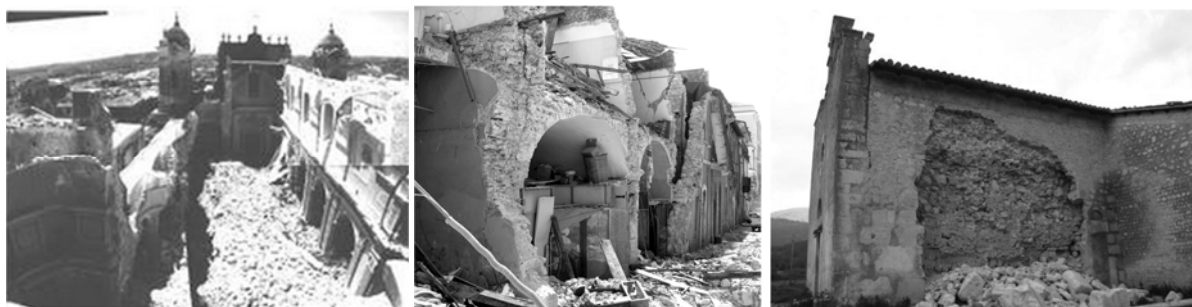
Figure 1.2: Ruins of the Noto Cathedral after 1996 collapse [5] (left), out-of-plane failure mechanism due to poor connection of the structural elements (middle, [http://db.nzsee.org.nz/Seminars/2014/Lagomarsino\\_Wellington\\_2014-2-20.pdf](http://db.nzsee.org.nz/Seminars/2014/Lagomarsino_Wellington_2014-2-20.pdf)) and out-of-plane collapse of masonry wall due to poor connection of the masonry [6] (right) in L'Aquila, Abruzzo, Italy

In the last decades severe damage and even collapse of multi-leaf masonry structures during or following an earthquake have occurred. A sudden and unexpected collapse of the famous Noto Cathedral in 1996 happened six years after earthquake due to creep, induced by the long term subjection to compressive stresses (due to dead load) and the weakened masonry characteristics of severely damaged pillars, which were the result of the recent and previous earthquake events. Severe damage was found also in the Santissimo Crocifisso in Noto and Santissima Annunziata Church in Ispica [4]. On the other hand in the recent earthquake events in Italy as the result of poor masonry connectivity also numerous out-of-plane collapses of the external leaves of historic masonry buildings

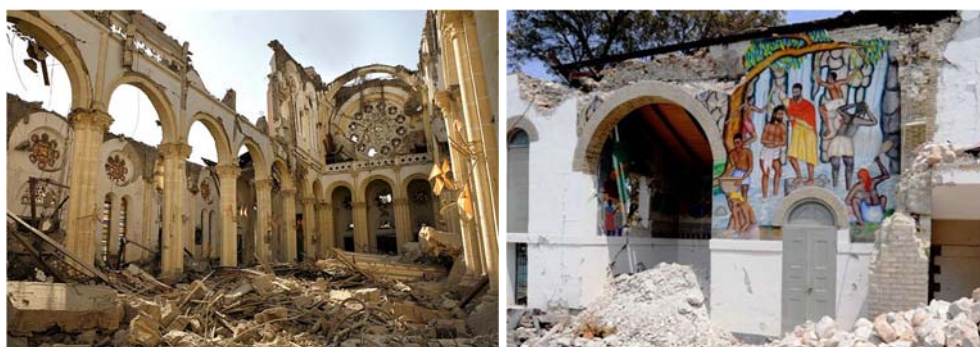
Figure 1.3: Ruins of the Port-au-Prince Cathedral in Haiti after 2010 earthquake (left, photo from [haitian-truth.org](http://haitian-truth.org), <http://blogs.nd.edu/classicalarch/2012/04/14/design-competition-for-a-new-cathedral-in-port-au-prince-haiti/>), the remains of mural at the Holy Trinity Cathedral in Port-au-Prince (right, Thony Belizaire/AFP/Getty Images, <http://www.wqxr.org/#!/story/60698-art-conservators-resurrect-haitian-masterpieces/>)

Through these and other seismic events also some very important heritage was lost. In Figure 1.3, the ruins of Port-au-Prince Cathedral in Haiti and the remains of mural at the Holy Trinity Cathedral in Port-au-Prince, which were destroyed in 2010 earthquake, are presented. The earthquake destroyed or buried much of Haiti's cultural heritage.

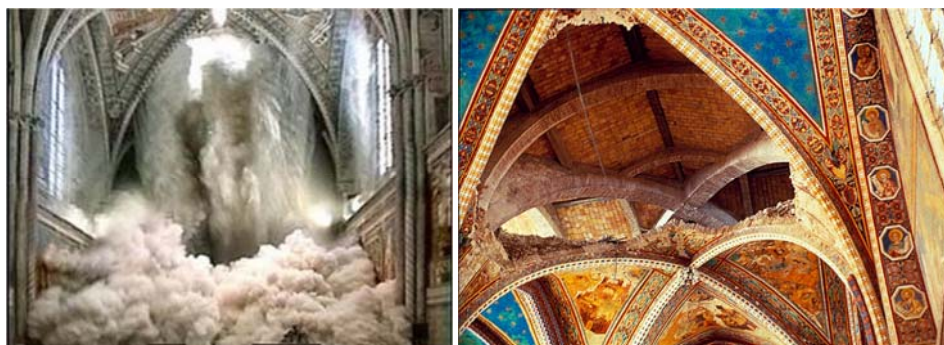
**Figure 1.4:** Collapse of the St Francis of Assisi Basilica ceiling during 1997 Umbria-Marche earthquakes (left, <http://projecthistoryitalia.altervista.org/26-settembre-1997-terremoto-nelle-marche-e-in-umbria/>), destroyed Cimabue fresco vault ceiling in the Assisi Basilica (right, [http://it.wikipedia.org/wiki/File:Volta\\_Cimabue.jpg](http://it.wikipedia.org/wiki/File:Volta_Cimabue.jpg))

The loss of an iconic building and artefacts can itself result in a social trauma [7]. A cultural trauma emerged after the 1997 Umbria-Marche (Italy) earthquake, where the Basilica of St Francis of Assisi was damaged and the majestic aquamarine ceiling painted with frescoes of Giotto and Cimabue collapsed [7]. The collapse itself and the damage are presented in Figure 1.4.

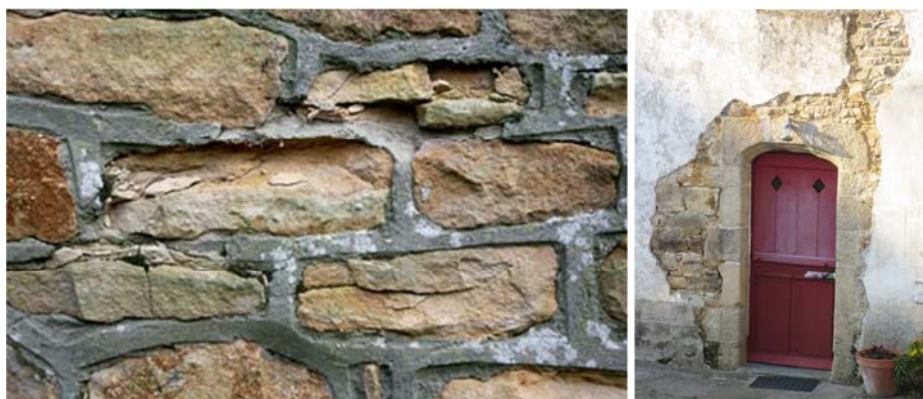
Figure 1.5: Spalling as a result of cement mortars used for pointing (left, <http://www.periodliving.co.uk/renovation/expert-advice/exterior-wall-maintenance>), delaminating cement render over granite and clay mortared walls on a part of the 16<sup>th</sup> century manor in St Jean du Doight, Bretagna, France (right, <https://jontybarrett.wordpress.com/vernacular/traditional-building-methods/>)

unsuitable for historic structures. Some modern measures are not just inefficient but have also induced additional damage. One of such examples is the introducing of too stiff materials and structural elements. Use of Portland cement for (re)pointing of old stone (or brick) lime mortar masonry caused leaching of salts and consequent chemical corrosion in the material and water collecting at the joints caused mechanical deterioration due to freeze–thaw action. “For masonry construction, lime mortar separating the stones or bricks is softer than the structural material and allows the building to move and settle differentially without cracking. Lime mortar is also more breathable than these materials, so the majority of evaporation is through the joints.” [12]. Inappropriate in practice was also the use of cement for rendering (causing delamination) and for grouting of lime mortar masonry (causing earlier cracking damage under induced loading and changing the load distribution reflecting in significant alternation of the structural behaviour). Development of strengthening methods applicable for historic structures is still in need.

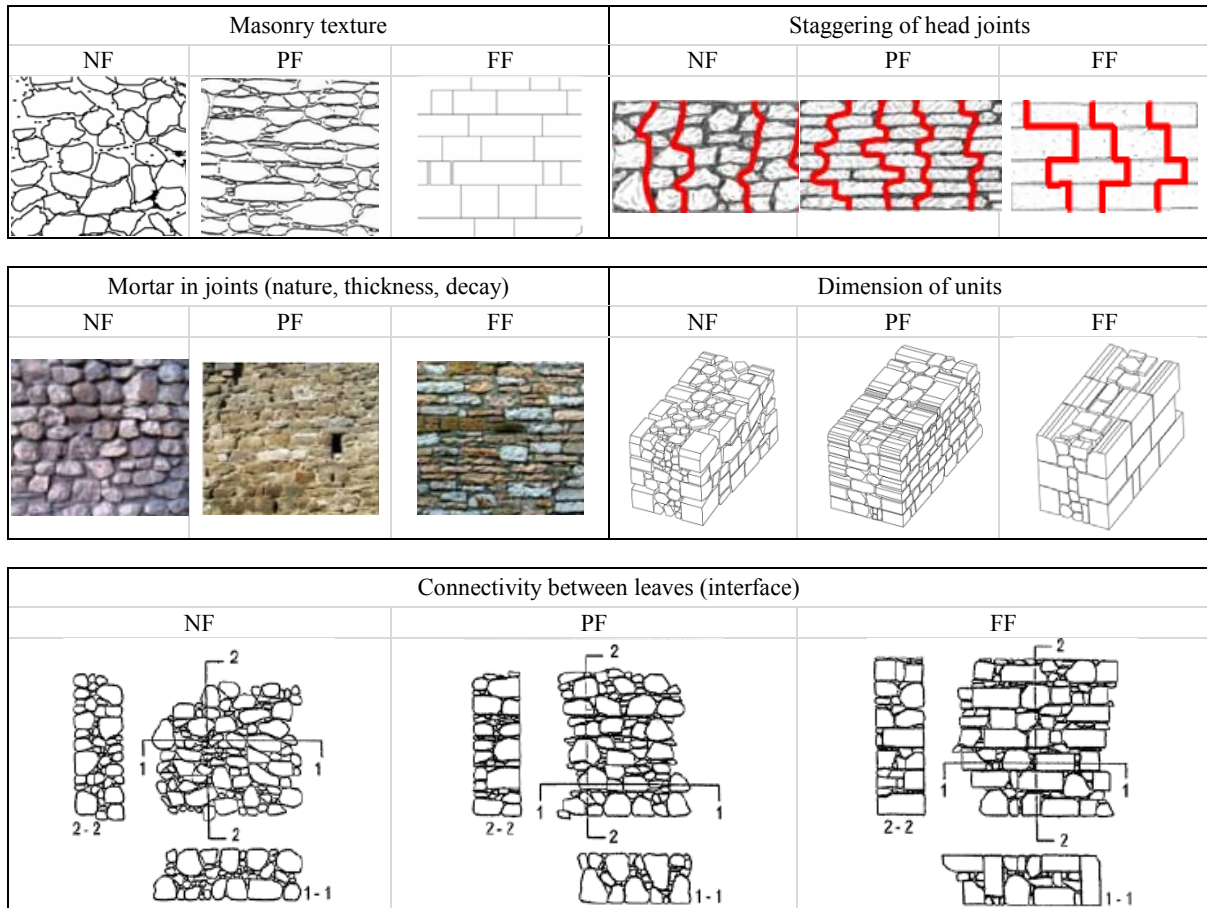
Figure 2.2. Classification of the masonry following visual inspection according to the RELUIS methodology for the assessment of the quality of built masonry (adapted from [16,18-21])

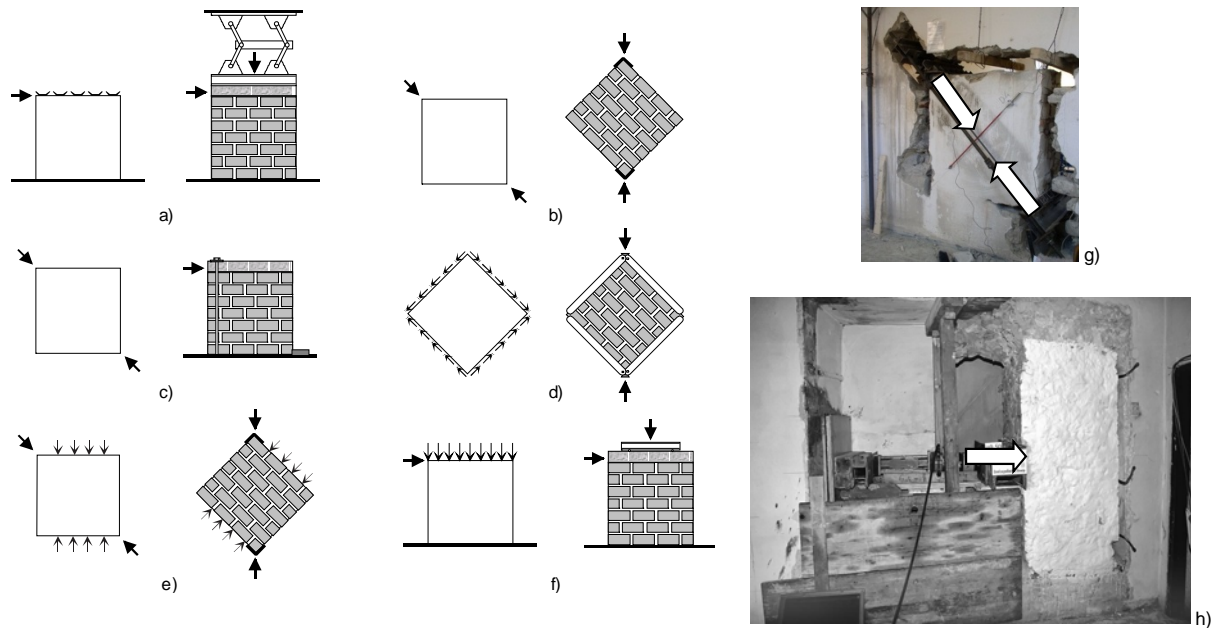
Figure 2.7. Different test methods for the determination of shear/tensile strength of masonry, where methods a) – f) refer to laboratory tests, while g) and h) refer to in-situ test conditions [51,55-57].

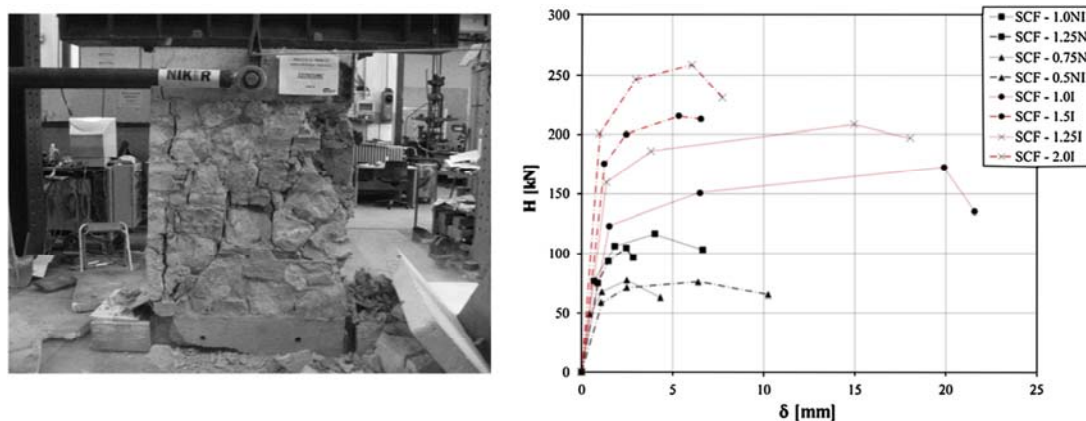
Figure 2.22: Silva et al [6]: crack pattern of the full scale un-grouted wall after shear test (left), comparison of the obtained results for full scale walls (right)

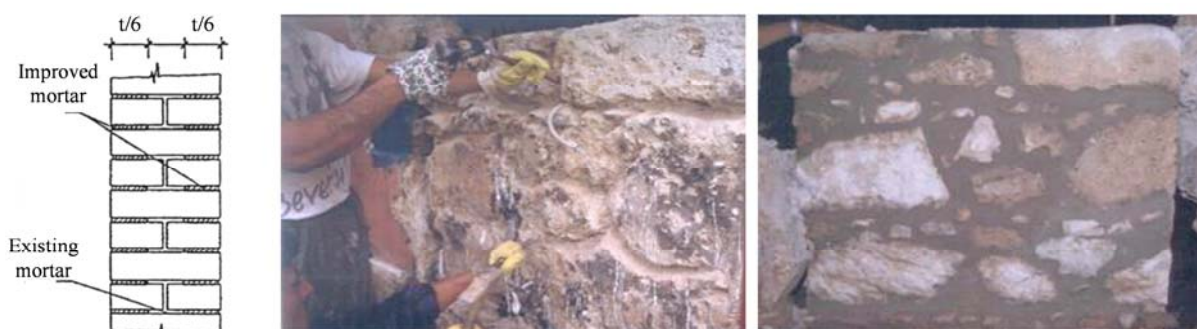
Figure 2.25: Deep repointing of brick (left, adapted from [168]) and of stone masonry (middle and right) [170]  
Slika 2.25: Prefugiranje opečne (levo, prilagojena [168]) in kamnite zidovine (na sredini in desno) [170]

Firstly, a significant increase of the mechanical characteristics can be obtained, if the repointing is conducted in a rather large masonry surface area. This is usually the case in slender masonry elements. The efficiency is again dependent on multiple aspects; appropriate masonry (poor mortar and relatively good units), proper mortar choice (compatible materials, stronger than original, but not too stiff), careful execution (adequate depth of stripping, wetting the surface, not making many voids when re-filling, possible repositioning of wedges, if removed during preparation, etc.). Vintzileou and Miltiadou-Fezans [168] have established that masonry compressive strength can be decreased if masonry joints are not fully filled. The authors applied deep repointing to brick masonry wall (Figure 2.25 left).

Secondly, application of repointing is actually a part of the preparation process before grouting; it is applied in order to prevent leakage of the grout and to additionally confine the injected material (Figure 2.25 middle and right). Corradi et al [169] have provided detailed information on deep repointing of multi-leaf stone masonry. Compression, diagonal compression and shear tests on repointed specimens confirmed not only the increase of shear strength, but also significant increase of shear stiffness of multi-leaf masonry.

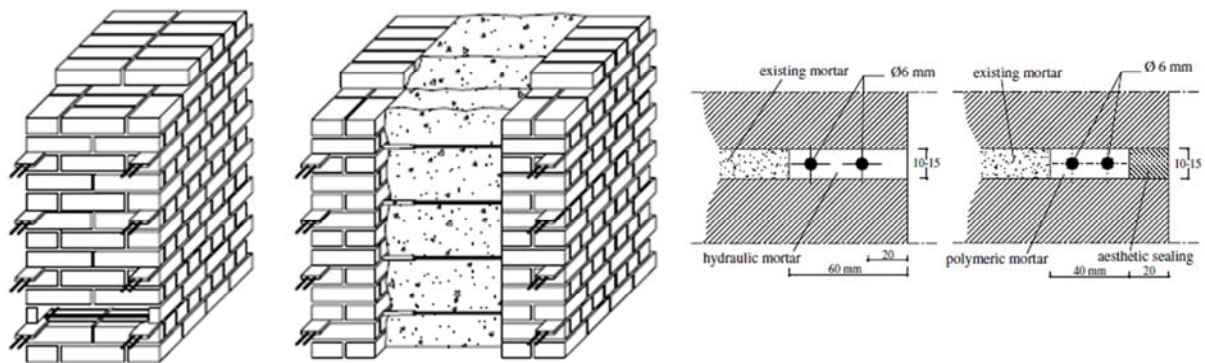
**Figure 2.26: NSM of single-leaf, three-leaf masonry, details of reinforced mortar joint after repointing by mortar and resin (from left to right, from [171])**

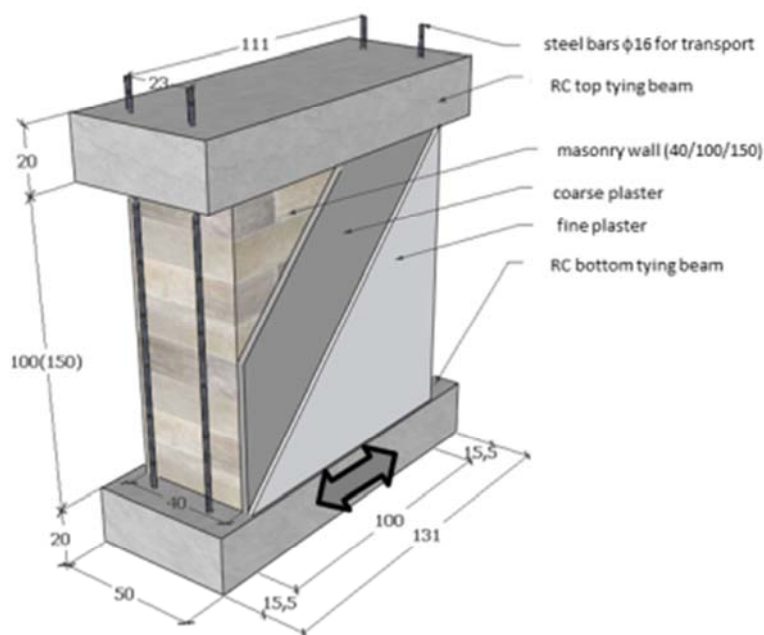
**Figure 3.1: Wall specimen with concrete foundation blocks and steel bars for transport [43]**  
**Slika 3.1: Kamniti zid z betonskima temeljema in jeklenimi palicami za transport [43]**

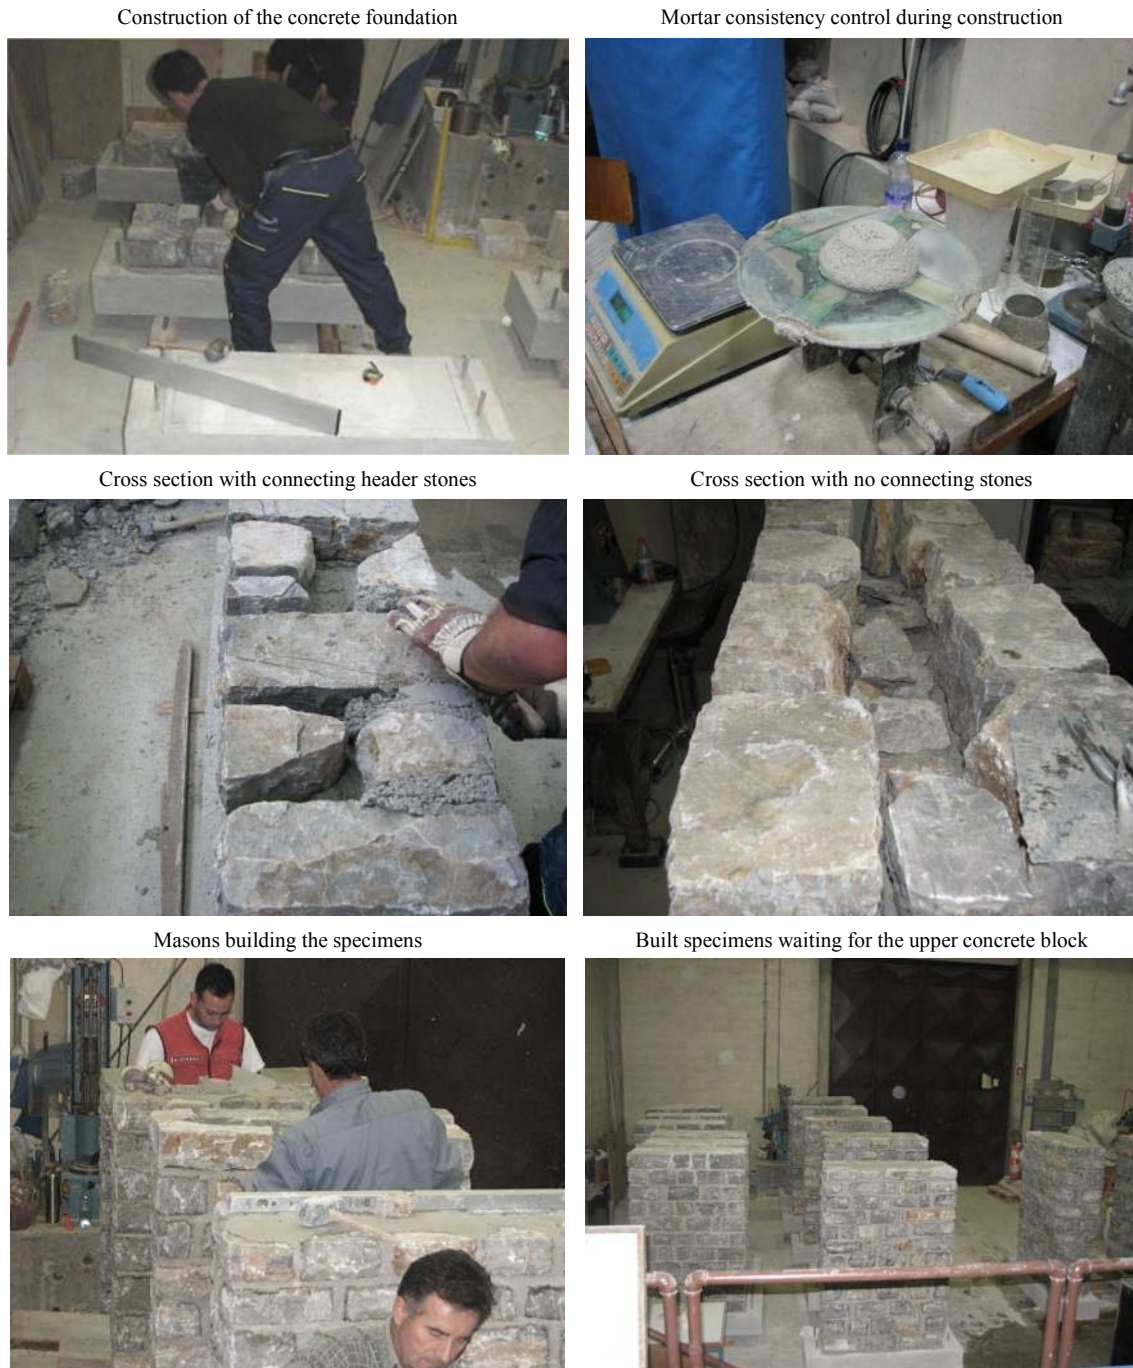
**Figure 3.2: Construction of the specimens**

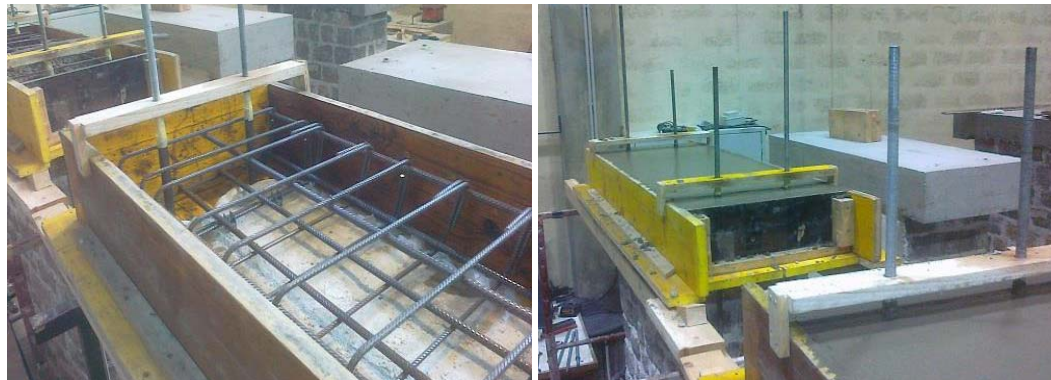
**Figure 3.3: Cast with steel reinforcement for the upper concrete block [43]**

When coarse plaster was dry enough, reinforced concrete tie beams were constructed. Their purpose was to provide uniform distribution of the vertical load applied and to fix the wall specimen into the testing setup. It also served for transporting the specimen; the wall had been connected (pre-stressed) from foundation block to the upper one by 4 steel bars. The casting (Figure 3.3) had to be done with extra care, otherwise the holes for fixing the specimen to the test setup would not be positioned properly and fixing would not be possible. For the same reason also the lower and top plane of concrete foundation block and upper lintel had to be parallel.

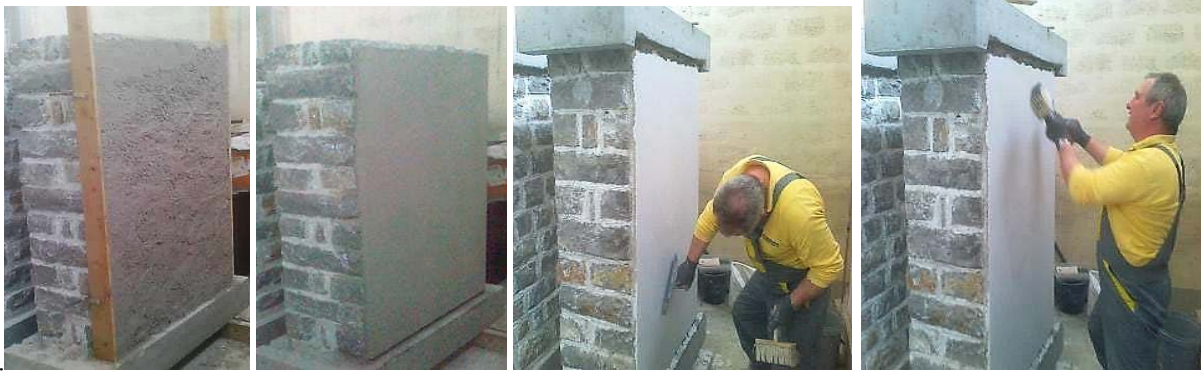
**Figure 3.4: Application of the coarse (left two photos) and fine (right two photos) plaster [43]****Slika 3.4: Nanos grobega (levi dve sliki) in finega (desni dve) ometa [43]**

After the masonry has dried for one month, coarse plaster was applied (Figure 3.4 left). Composition of mortar is presented in the Table 3.2; gravel aggregate of size 0-4 mm was used in volume ratio 3:1

Finally, 42 days after the application of coarse plaster, a layer of fine plaster was applied over it. Again the plasters were applied by professionals from the specialised construction company in two stages; first the render was applied, then after partial drying it was finely scraped (Figure 3.4 right). Lime putty was mixed with sand in 1:2 volume ratio; composition is presented in Table 3.3.

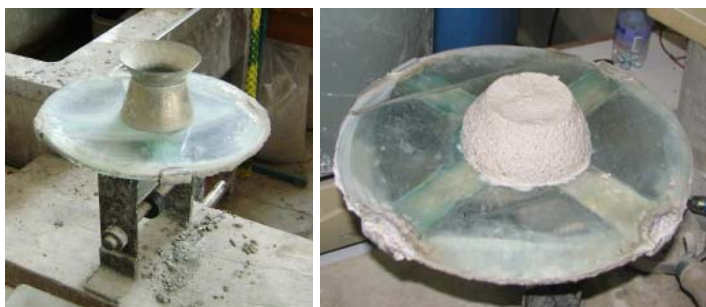
**Figure 3.6: Mortar consistency test by flow table**  
**Slika 3.6: Preskus maltne konsistence na udarni mizici**

Type of mortar	Time of construction	Diameter of spread mortar [mm]	Bulk density [kg/dm <sup>3</sup> ]
Construction of walls	14.-24.11.2011	116	2.16
Coarse plaster	11.-12.1.2012	145	2.08
Fine plaster	22.-23.2.2012	143	1.92

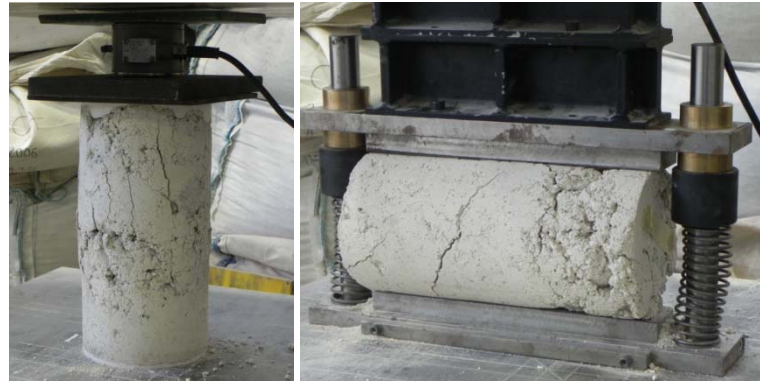
Figure 3.8: Compressive (left) and splitting tensile strength (right) test of the cylinder core sample  
Slika 3.8: Tlačni (levo) in cepilni (desno) preizkus valjastega vzorca jedra

Compressive and splitting tensile strengths  $f_{cc}$  and  $f_{cst}$  of the core were determined on cylinder specimens of 150 mm diameter and 300 mm length. Cylinders were filled with mortar used for construction and with stone rubble, similar to the core in the walls. They were prepared at the same time as the walls were built but the tests were performed approximately 1 year later, following the accomplishment of shear tests on the walls.

Prior strength tests (Figure 3.8), also density  $2.05 \text{ kg/dm}^3$  of the samples was determined. Average compressive strength of 0.90 MPa (c.o.v. 23.6%) was determined on 3 samples according to Eq. 3.2 with  $A$  in this case being the circular contact area. Splitting tensile strength was calculated according to Eq. 3.4 provided in SIST EN 12390-6:2001 [241], determined from maximum splitting force  $F$ . Average value 0.16 MPa with c.o.v. of 52.5% was determined on 3 test results.

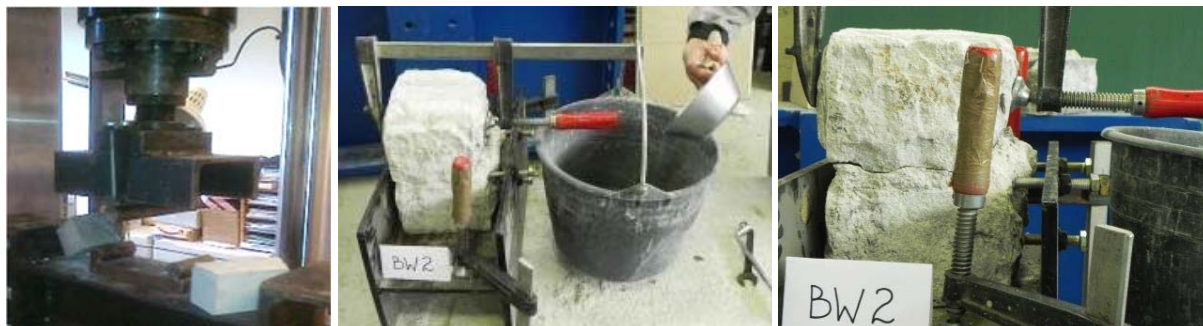
Figure 3.9: Three-point bending test of stone sample (left), “Bond wrench” test and mortar stone junction failure.  
Slika 3.9: Tri-točkovni upogibni test vzorca kamna (levo), “Bond wrench” test in porušitev stika malte in kamna

Flexural tests were performed on 3 prisms of 4/4/16 cm (Figure 3.9 left). The flexural strength  $f_{bf}$  ranged from 19.9 to 28.4 MPa, average  $f_{bf}$  being 24.2 MPa with c.o.v. of 17.4%.

Bond wrench tests on 3 samples were performed to determine bond strength  $f_{jx}$  of stone-mortar joints (Figure 3.9 middle). Samples to determine the strength were taken from the wall, after the wall has been tested in compression. Average flexural tensile strength was 0.03 MPa with c.o.v. of 26.6%. The failure occurred in the mortar stone junction. Such low strength could be the result of the fact that the samples were in partly damaged state.

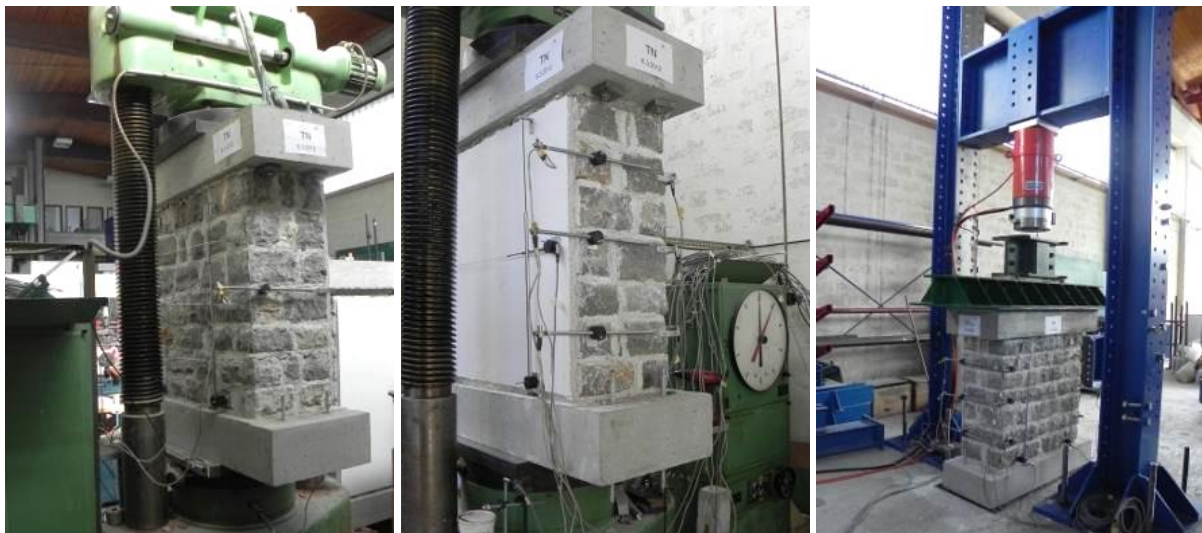
Figure 3.10: Test setup for the first test in the 5000 kN hydraulic jack (left two) and the following with 2500 kN capacity (right)

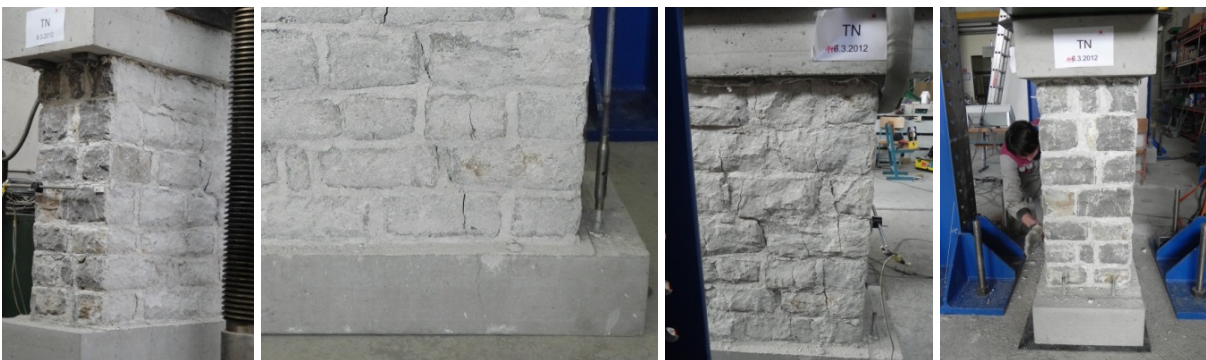
Figure 3.12: Damage on the walette without through stones due to non-uniform load distribution under hydraulic jack of 5000 kN capacity after the 1<sup>st</sup> test (TN-1, left two) and after the 2<sup>nd</sup> test under 2500 kN jack (TN-2, right two)  
Slika 3.12: Poškodbe na nepovezanem zidku zaradi neenakomerne porazdelitve sil pri 1. testu s 5000 kN batom (TN-1, levi dve sliki) ter po 2. testu z 2500 kN batom (TN-2, desni dve)

For the first test set-up, the damage pattern obtained after the test is presented in Figure 3.12 (left two), whereas in Figure 3.13 the crack pattern evolution on the wall and on the plaster in dependence from the actuator force is presented.

For the test under a different test setup (2500 kN jack), the load was applied with constant force increase of 0.83 kN/s. Maximum compressive stress 7.34 MPa was obtained for the wall. The damage of the wallette after the test is presented in Figure 3.12 (right two) and crack pattern evolution in Figure 3.14. Stress-strain relations for LVDTs are presented in Figure 3.15. Since the test was repeated and the wallette already damaged, some of the LVDTs were removed for the second test.

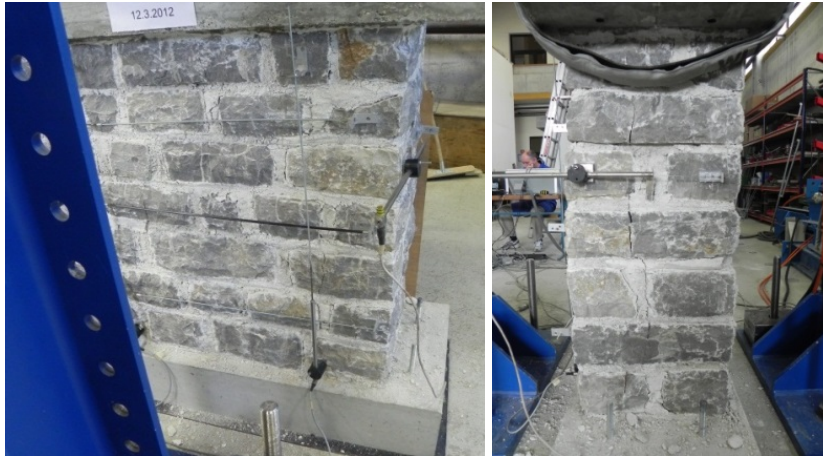
Figure 3.16: Damage of the wallette with header stones after test TP-1  
 Slika 3.16: Poškodbe na povezanem zidku po testu TP-1

For the test of the wallette with header stones, again the failure was not attained at test with the 2<sup>nd</sup> test setup (2500 kN jack). Maximum stress attained was 7.28 MPa. During the test the loading rate was in average 0.44 kN/s. Damage pattern after and during the test are presented in Figures 3.16 and 3.17, while the stress - strain relations for LVDTs in Figure 3.18.

Comparing the results, for wallette with header stones (TP-1), the leaves began to separate a bit earlier than at test TN-2 (wallette without header stones), which was not expected. Comparing strains at stresses approaching to  $\sigma_{max}$ , one can assume that the wallette with header stones was closer to failure than the wallette without header stones.

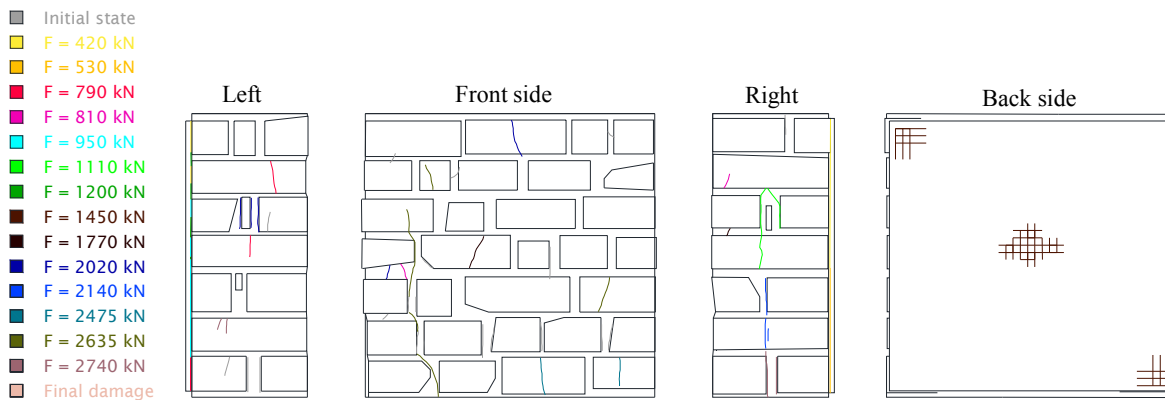
Figure 3.17: Crack pattern development on the wallette with header stones and on the plaster at test TP-1  
 Slika 3.17: Razvoj poškodb na povezanem zidku in ometu pri testu TP-1

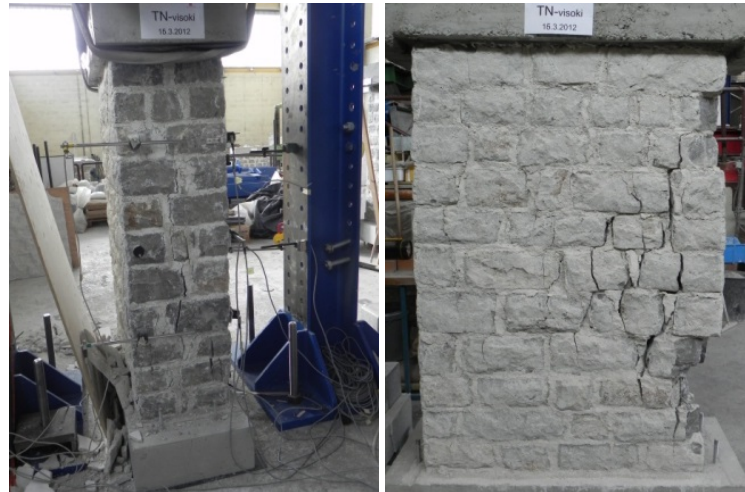
Figure 3.19: Damage of the wall without through stones after test TN-visoki  
Slika 3.19: Poškodbe na nepovezanem zidu po testu TN-visoki

In compression tests of both connected and unconnected walls compressive strength of masonry  $f_{Mc}$  and the softening were obtained. For the test of wall without through stones  $f_{Mc}$  of 6.10 MPa was obtained. Average velocity of loading during the test was 0.91 kN/s. Crack pattern after and during the test can be seen in Figure 3.19 and Figure 3.20, respectively. The leaves separated and a crack thicker than 1 mm evolved between them. One side of the wall was obviously more damaged. The stress-strain diagrams are presented in Figure 3.21.

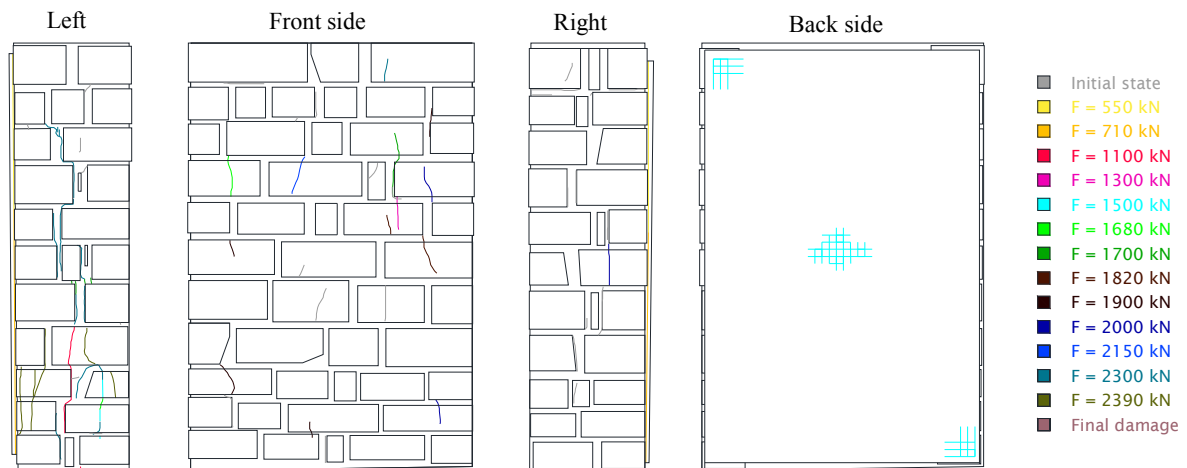
Figure 3.20: Crack pattern development on the wall without through stones and on the plaster at test TN-visoki  
Slika 3.20: Razvoj poškodb na nepovezanem zidu in ometu pri testu TN-visoki

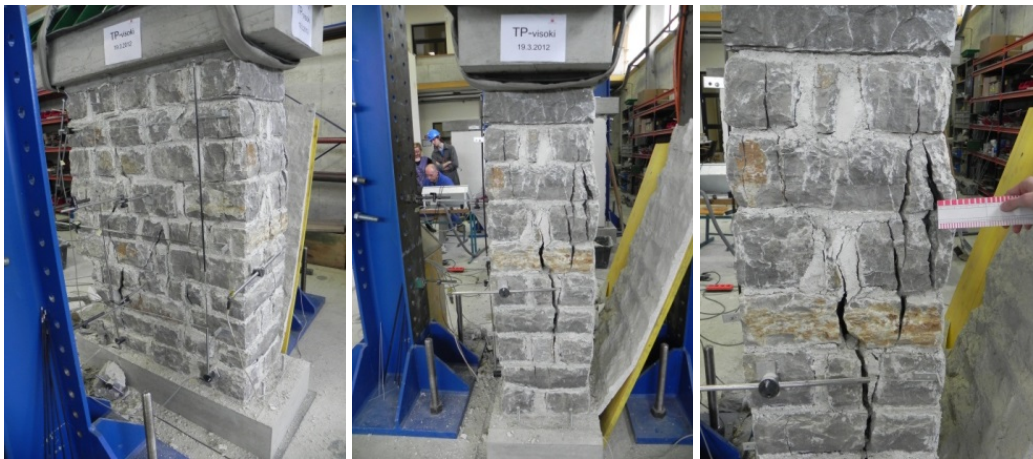
Figure 3.22: Damage of the wall with through stones after test TP-visoki  
Slika 3.22: Poškodbe na povezanem zidu po testu TP-visoki

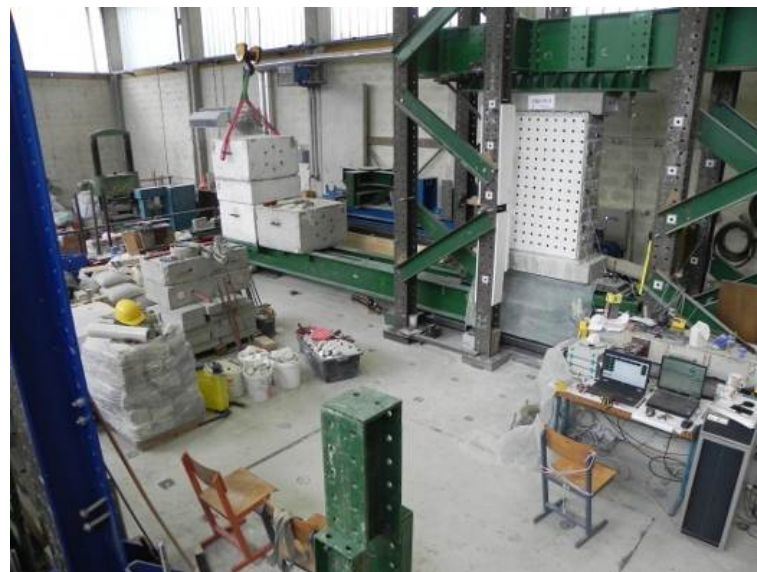
Figure 3.30: Wall specimen in position for testing  
Slika 3.30: Zid v poziciji za testiranje

Cyclic in-plane shear tests of walls under compression were performed on the testing machine presented in Figure 3.29 and Figure 3.30. The vertical load was applied with concrete weights which acted through a lever on the bottom of the wall. At the top, the wall specimen's RC tie beam was placed under a steel beam, designed especially for this experiment allowing the vertical load to distribute uniformly over the whole cross section.

The test setup allows the maximum vertical load up to 500 kN on the specimens and the servo-hydraulic actuator is capable of inducing horizontal displacements in both directions with the capacity of 250 kN. On the lower edge of the specimen, two types of the boundary conditions were used; in one case the rotation and the horizontal displacement were released, which made the wall a cantilever turned upside down, in the other case the rotation at the bottom was restrained, which made the wall a system with fixed rotations at both ends.

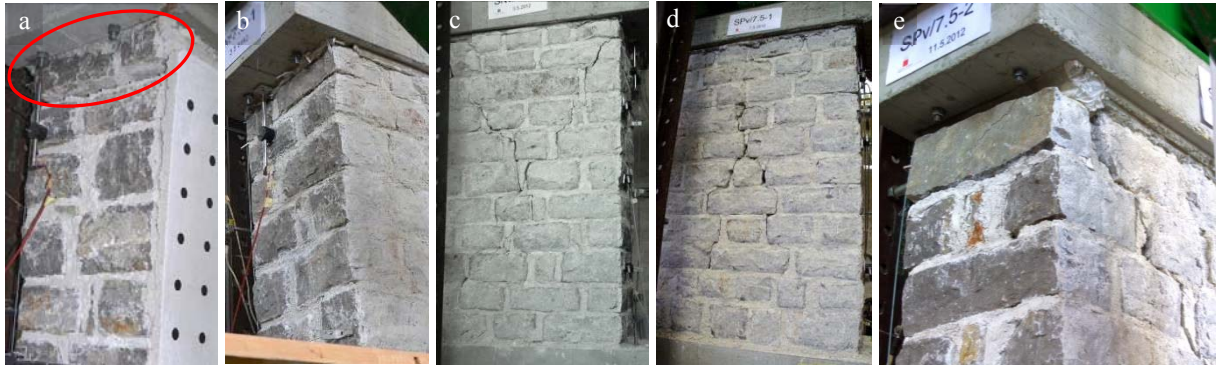
**Figure 3.34: a) rocking of the wall with opening of the mortar joint between the first two rows of stone during test 2 - SNk-7.5-1, b) rocking damage during test 3 - SNv-7.5-1, c) diagonal shear damage after test 3 - SNv-7.5-1, crack pattern on the wall d) after test 4 - SPv-7.5-1 and e) after test 6 - SPv-7.5-2**

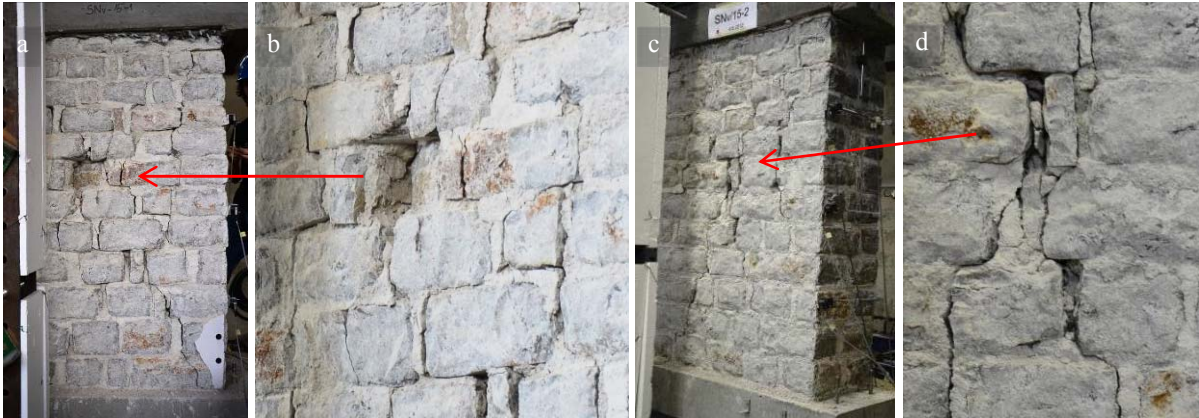
**Figure 3.35: Crack pattern on the walls after test 8 - SNv-15-1 (a, b) and test 10 - SNv-15-2 (c, d)**  
**Slika 3.35: Poškodovanost zidov po testu 8 - SNv-15-1 (a, b) in testu 10 - SNv-15-2 (c, d)**

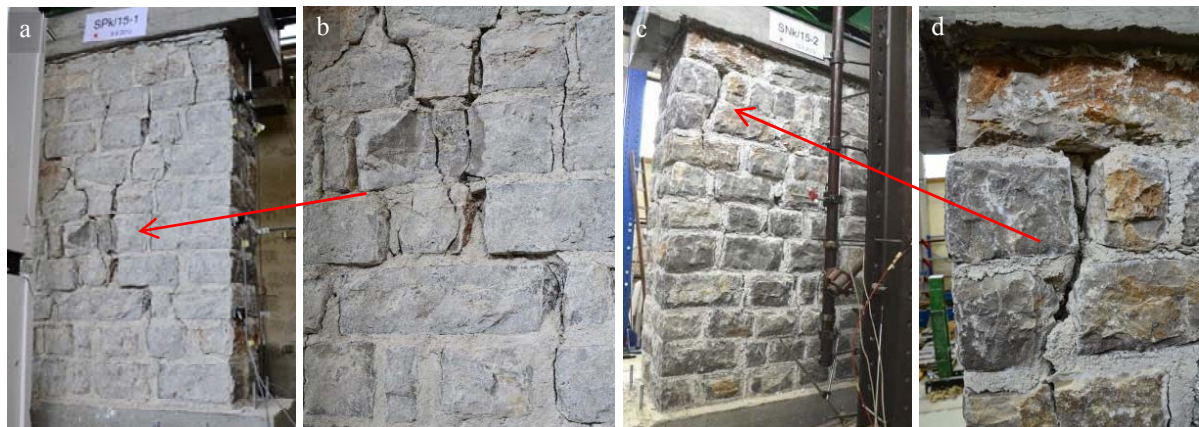
**Figure 3.36: Crack pattern on the walls after test 12 - SPk-15-1 (a, b) and test 14 - SNk-15-2 (c, d)**  
**Slika 3.36: Poškodovanost zidov po testu 12 - SPk-15-1 (a, b) in testu 14 - SNk-15-2 (c, d)**

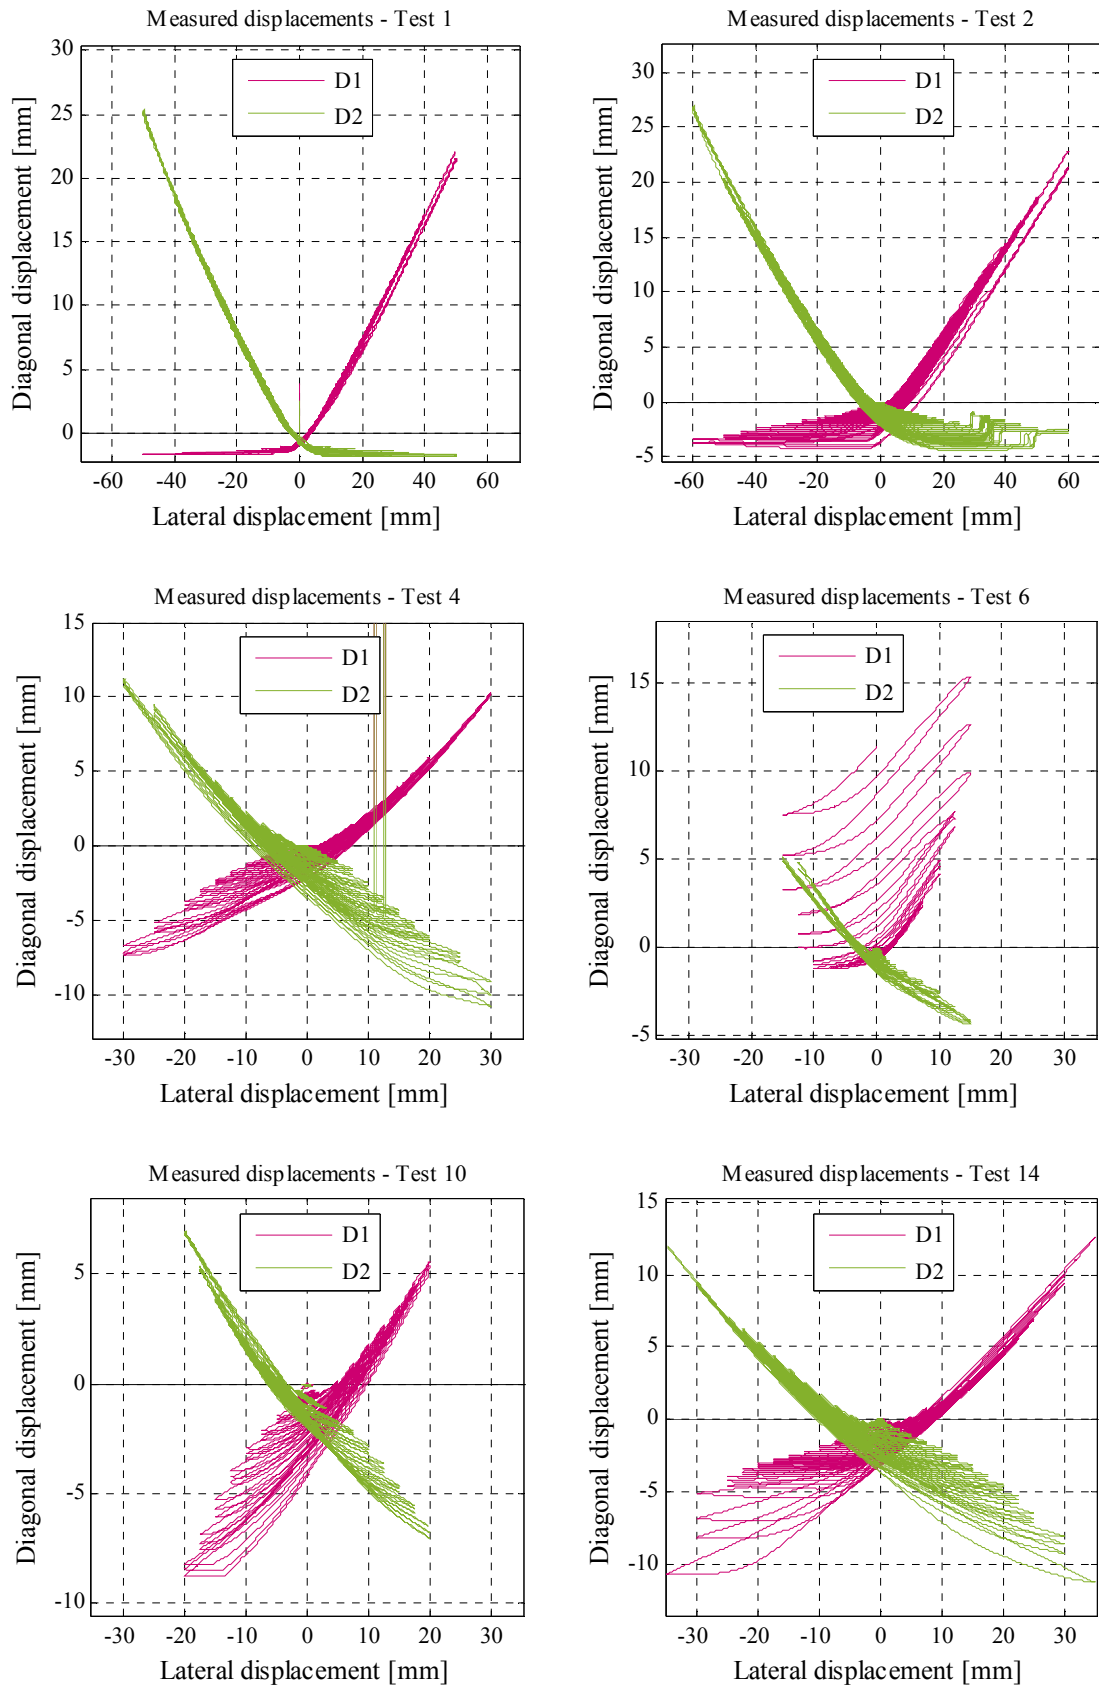
Figure 3.37: Measurements of LVDTs D1, D2 in dependence of walls' lateral displacement for tests 1, 2, 4, 6, 10, 14  
Slika 3.37: Meritve LVDT-jev D1, D2 v odvisnosti od horizontalnega pomika zidu za teste 1, 2, 4, 6, 10 in 14

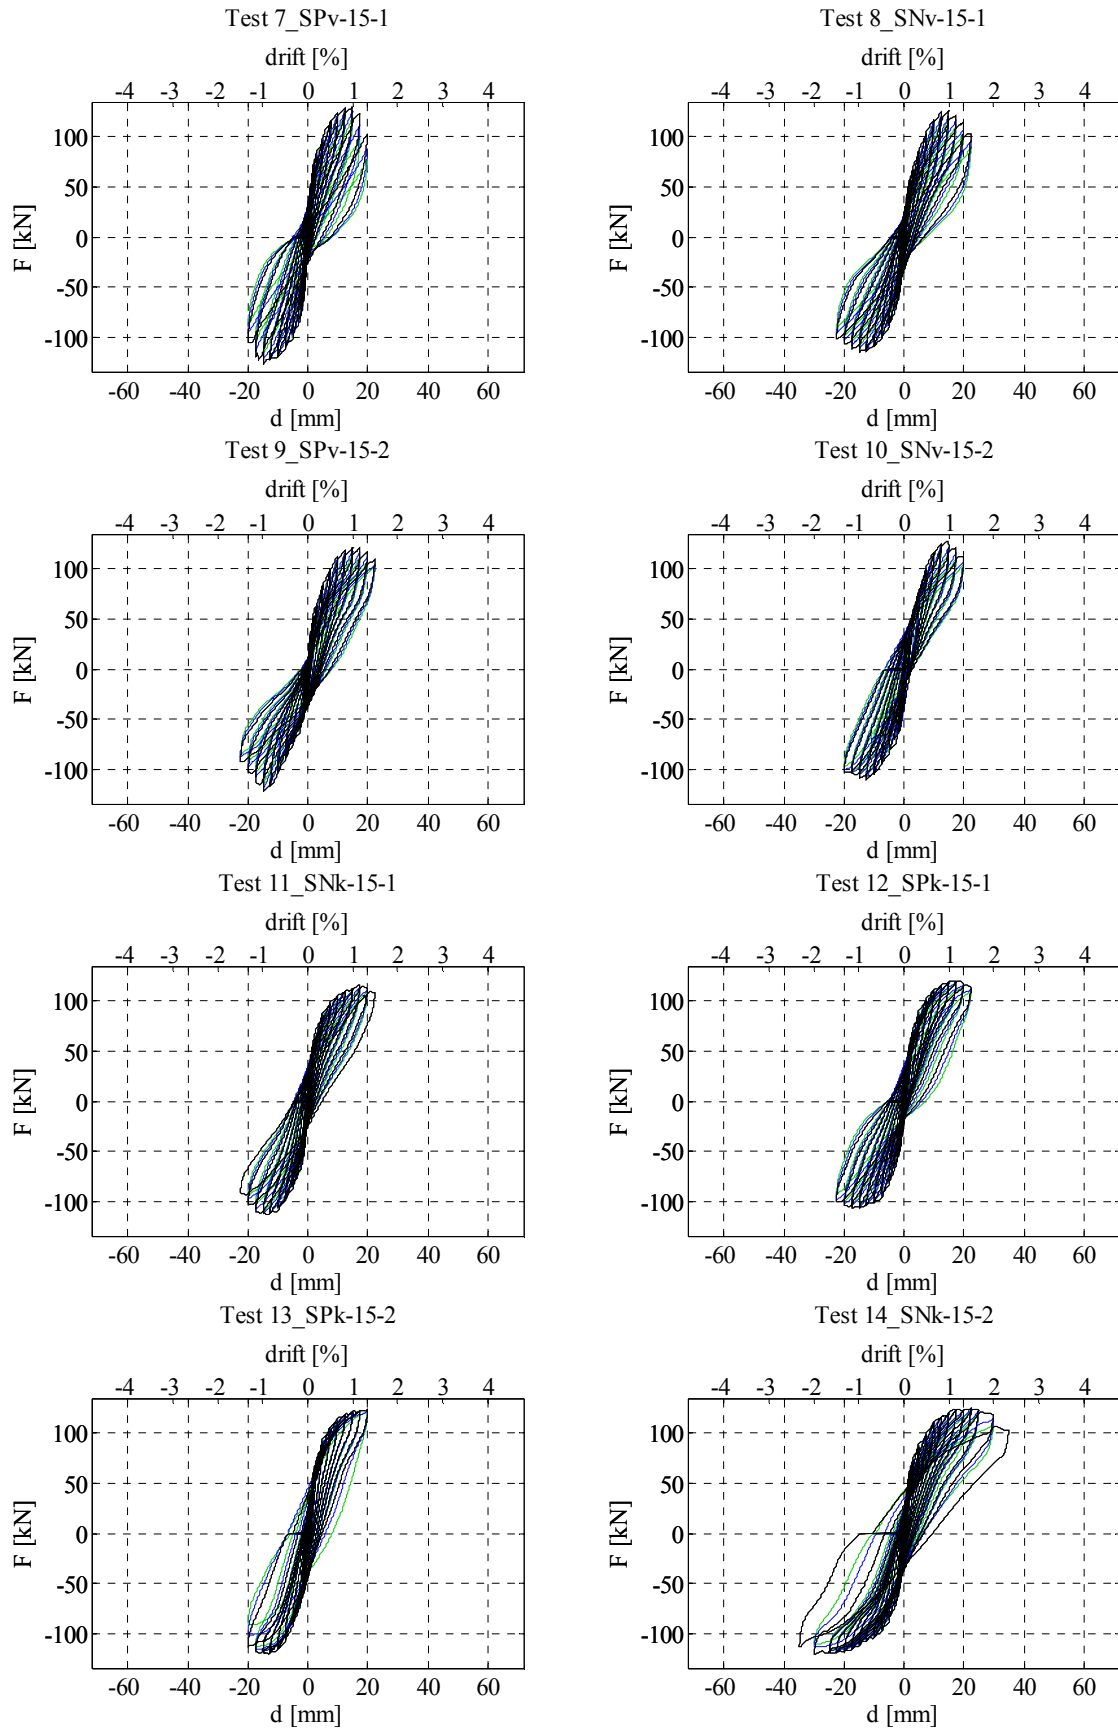
**Figure 3.42: Hysteretic lateral load - lateral displacement diagrams obtained for tests with higher pre-compression level; tests 7-10 fixed-fixed and tests 11-14 cantilever boundary conditions**  
**Slika 3.42: Diagrami histereznega odziva horizontalna sila - horizontalni pomik za teste z višjim nivojem vertikalnih obremenitev; testi 7-10 obojestransko in testi 11-14 konzolno vpeti robni pogoji**
