**META KRŽAN, univ. dipl. inž. grad.**

**EKSPERIMENTALNE IN NUMERIČNE PREISKAVE ZA  
DOLOČITEV KONTROLIRANEGA ODZIVA  
VEČSLOJNE KAMNITE ZIDOVINE**

**PERFORMANCE BASED EXPERIMENTAL AND  
NUMERICAL ASSESSMENT OF MULTI-LEAF STONE  
MASONRY WALLS**

Doctoral thesis No.: 247

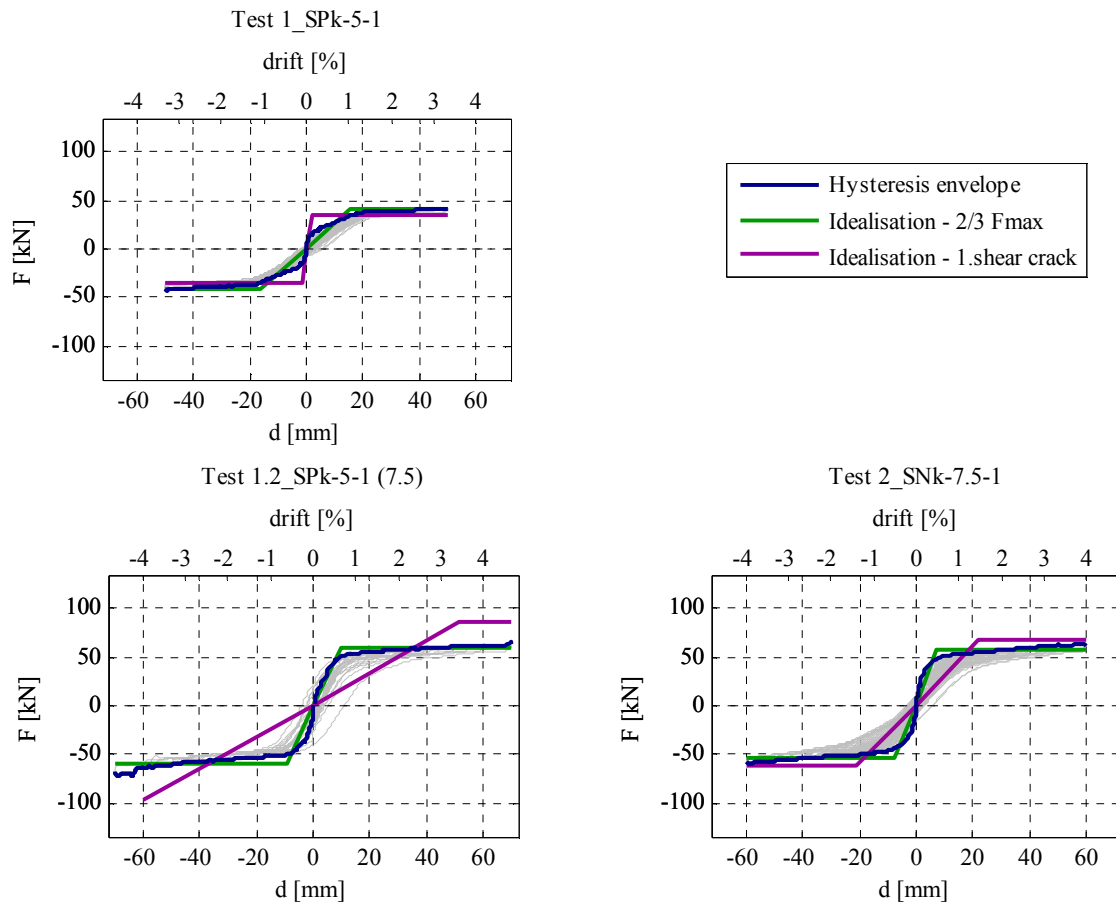
**Figure 3.46: Hysteresis envelopes and bi-linear curves obtained according to two criteria for tests 1-2**  
**Slika 3.46: Histerezne ovojnice in bi-linearna idealizacija po dveh kriterijih za teste 1-2**

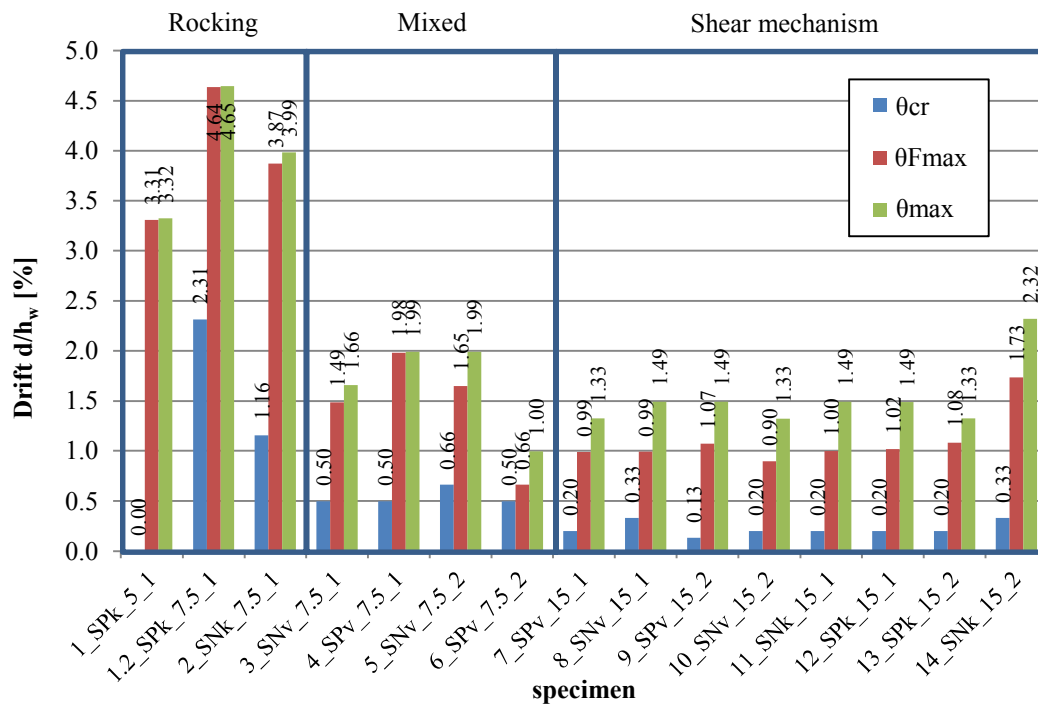
Figure 3.49: Average drifts  $d/h_w$  for both directions in characteristic performance limit states for each test  
Slika 3.49: Povprečni zasuki  $d/h_w$  obeh smeri obremenjevanja v karakterističnih točkah odziva za posamezne teste

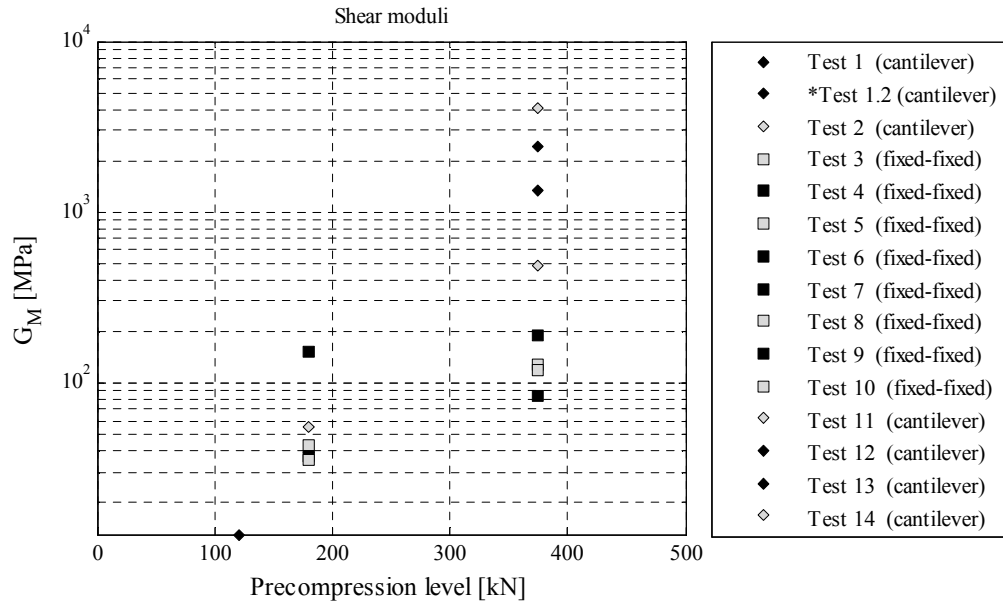
Figure 3.52: Shear moduli, calculated from effective stiffness in dependence of pre-compression load  
 Slika 3.52: Strižni moduli, izračunani iz efektivne togosti, v odvisnosti od nivoja predkompresije

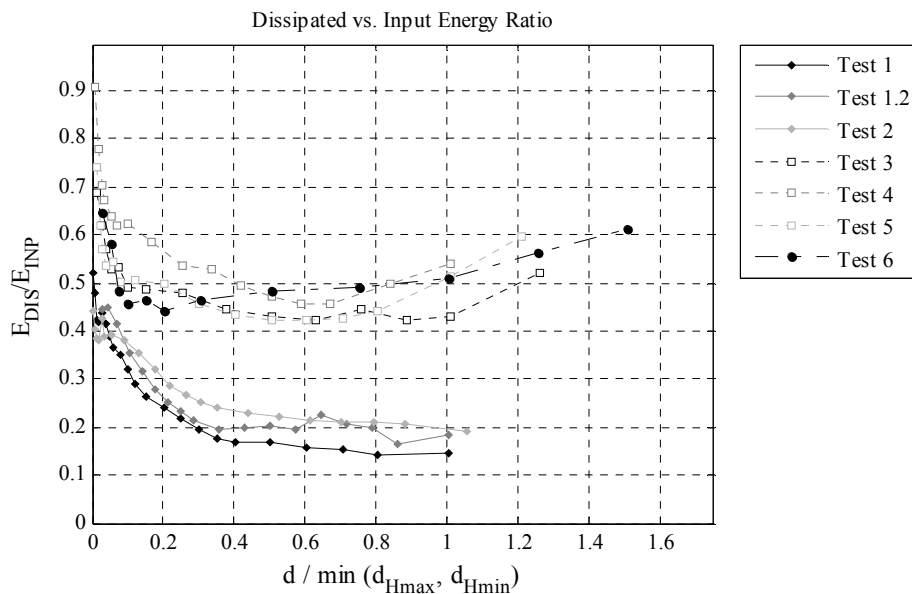
**Figure 3.56: Dissipated and input energy ratio at 1<sup>st</sup> cycles of each amplitude displacement in dependence of amplitude displacements normalized to displacement  $d_{Fmax}$  for tests 1-6**  
**Slika 3.56: Razmerje disipirane in vnesene energije v 1. ciklih posameznih amplitudnih pomikov v odvisnosti od pomikov, normaliziranih na  $d_{Fmax}$ , za teste 1-6**

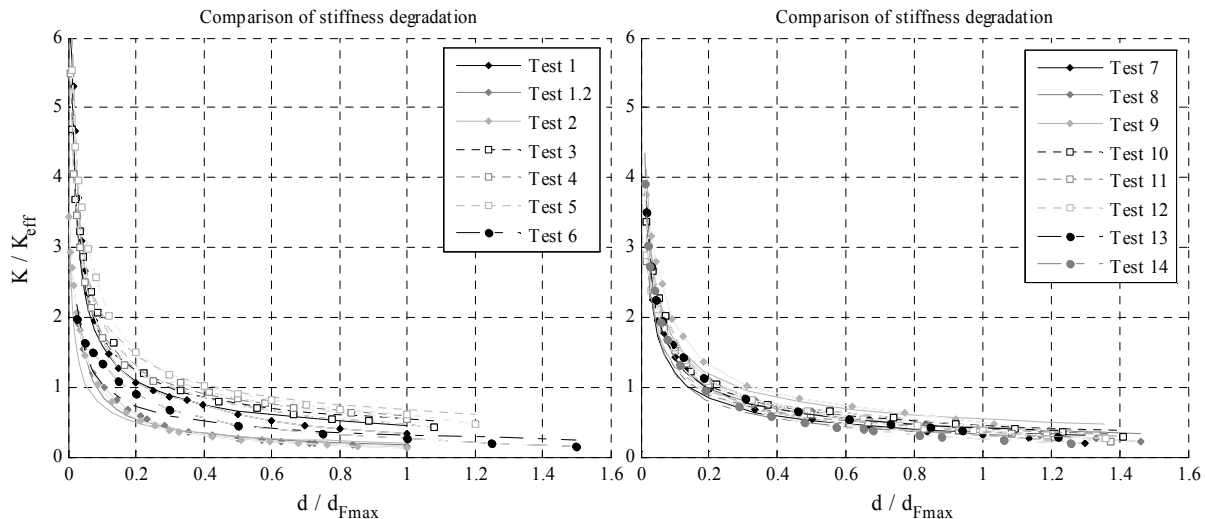
Figure 3.68: Stiffness degradation at 1<sup>st</sup> cycles of amplitude displacements for tests 1-6 and tests 7-14  
Slika 3.68: Padanje togosti za 1. cikle amplitudnih pomikov za teste 1-6 in teste 7-14

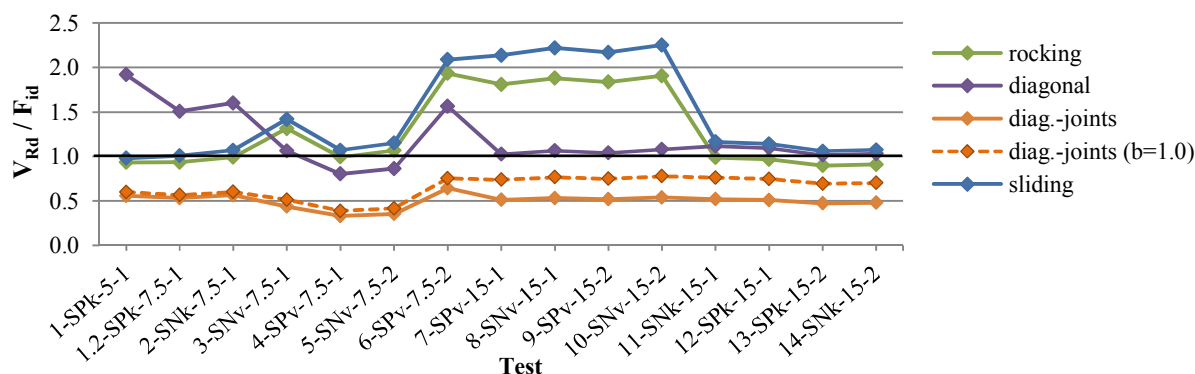
Figure 3.69: Ratio between analytically calculated shear resistances for various failure mechanisms and from tests idealized shear resistance for each test

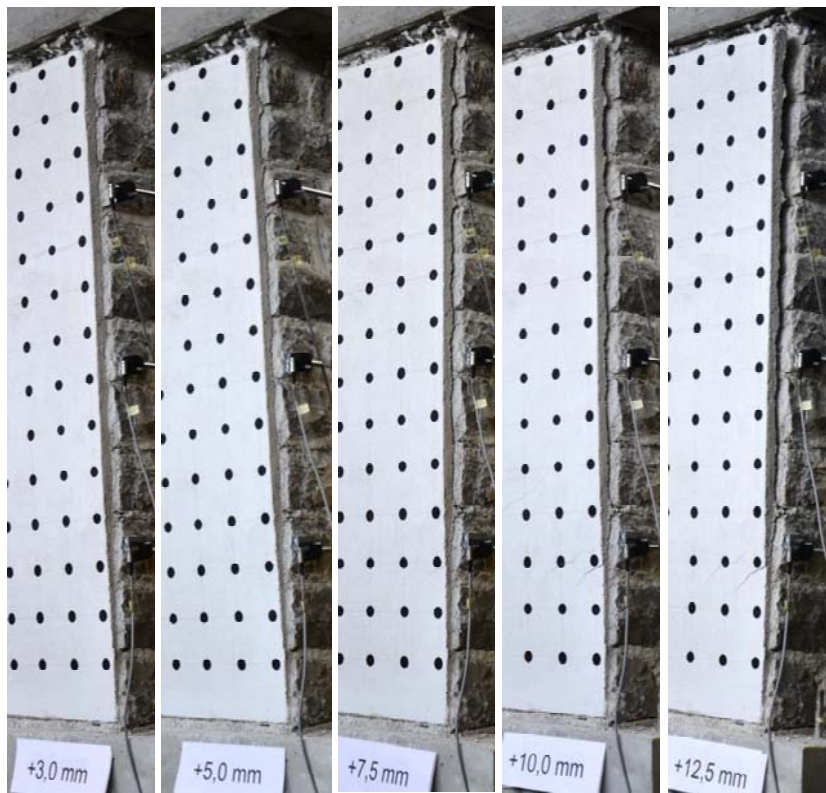
Figure 3.72: Increasing of the plaster's detachment with increasing amplitude displacements at test 8 - SNv-15-1  
 Slika 3.72: Povečevanje odstopanja ometa s povečevanjem amplitud pomikov pri testu 8 - SNv-15-1

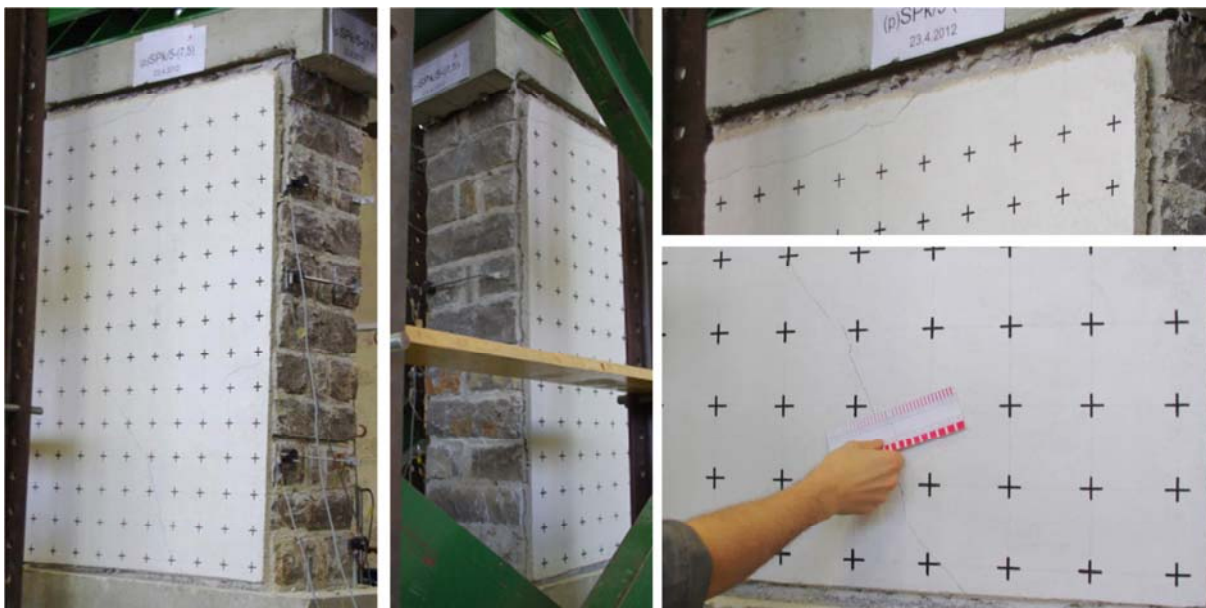
Figure 3.73: Detachment of the plaster and horizontal and diagonal crack on the plaster at test 1.2 - SPk-5-1 (7.5)  
Slika 3.73: Odstopanje ometa in horizontalna ter diagonalna razpoka na ometu pri testu 1.2 - SPk-5-1 (7.5)

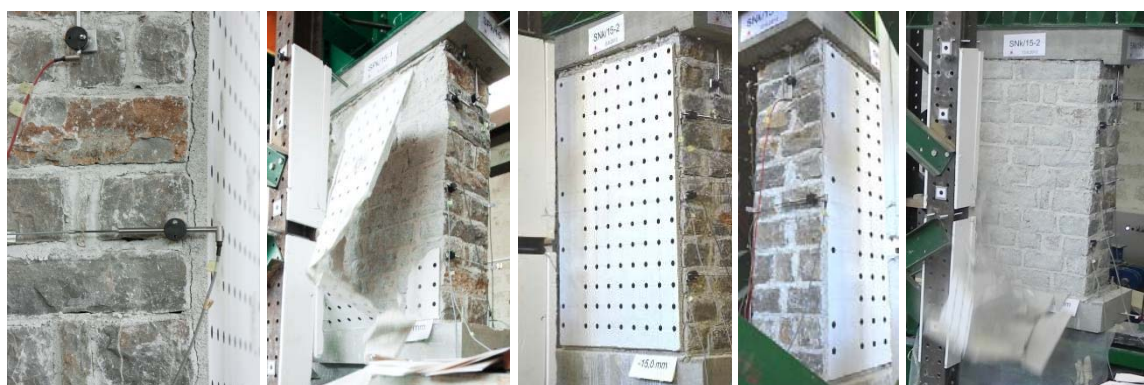
Figure 3.74: Detachment and collapse of the plaster at test 12 - SPk-15-1 (left two) and 14 - SNk-15-2 (right three)  
Slika 3.74: Odstopanje in porušitev ometa pri testu 12 - SPk-15-1 (levi dve sliki) in testu 14 - SNk-15-2 (desne tri)

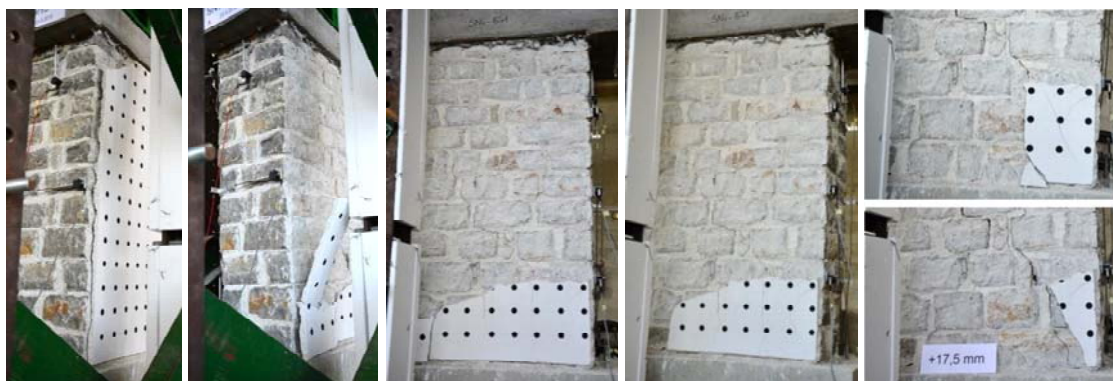
Figure 3.75: Detachment of the plaster prior its collapse and its subsequent collapse at test 8 - SNv-15-1  
Slika 3.75: Odstopanje ometa pred porušitvijo in postopna porušitev pri testu 8 - SNv-15-1

For walls with shear mechanism, shear cracks formed at lower displacements (damage "b" and "c" in Figure 3.71) and sometimes prevented either the plaster detachment over entire height or the widening of the crack between the wall and the plaster at side (Figure 3.74). In some tests, the plaster collapsed subsequently with increasing displacements (Figure 3.75), whereas in most cases the collapse of the entire plaster was immediate (Figure 3.76).

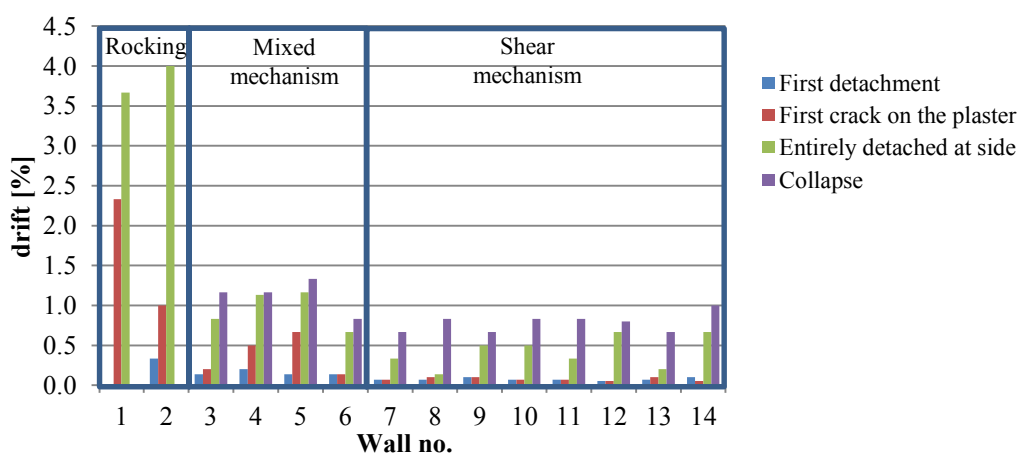
**Figure 3.78: Drift values of walls for characteristic plaster performance points**  
**Slika 3.78: Zasuki zidov pri karakterističnih točkah obnašanja ometa**

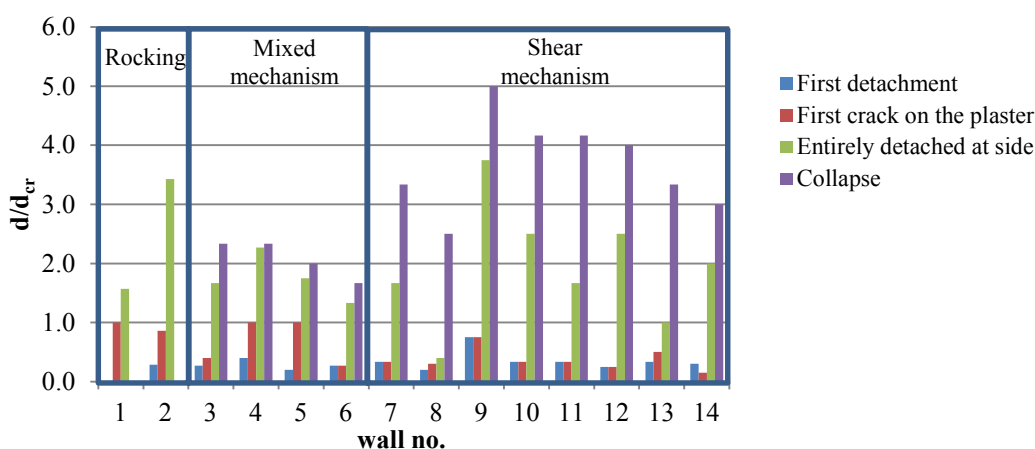
**Figure 3.79: Displacements of the wall at plaster performance limits relative to amplitude displacement of the first shear crack on the wall ( $d_{cr}$ )**

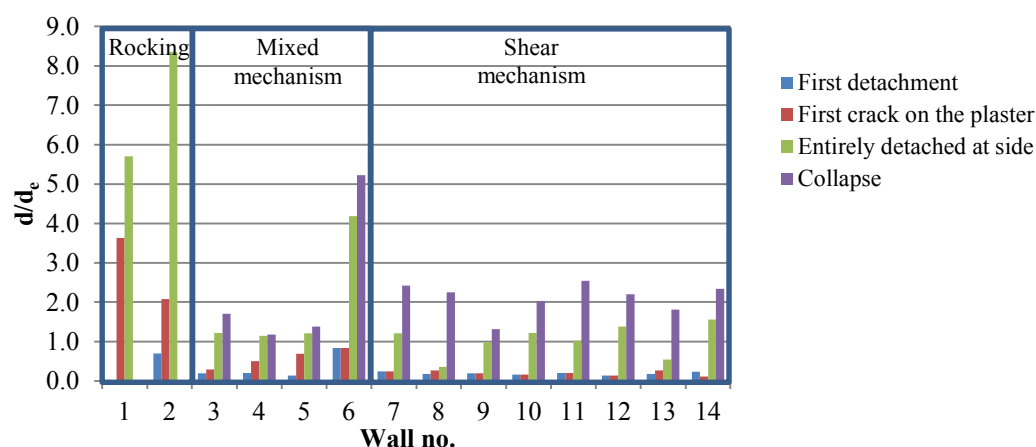
Figure 3.80: Displacements of the wall at plaster performance points relative to elastic displacements of the walls  $d_e$   
Slika 3.80: Pomiki zidov pri mejnih stanjih ometa relativno na elastične pomike zidov  $d_e$

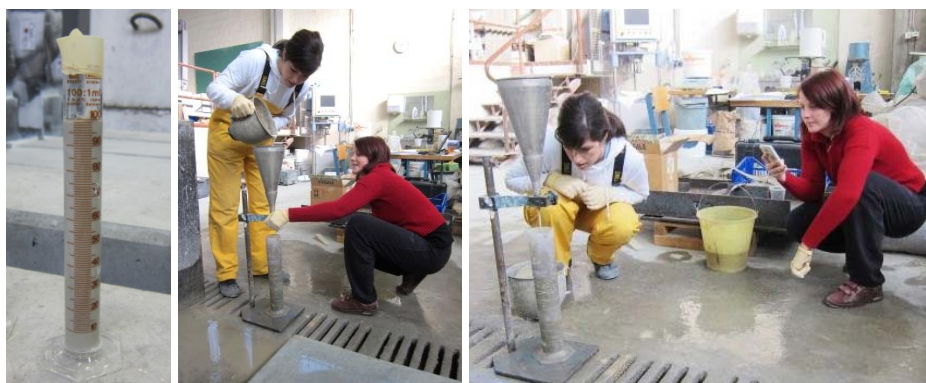
Figure 4.2: Bleeding test (left) and fluidity test (middle and right)  
 Slika 4.2: Preizkus izločanja vode (levo) in pretočnosti (na sredini in desno)

Density of mixture, fluidity and bleeding of grout in fluid state were determined (Table 4.2). Density test, performed according to provision EN 1015-6 [238], provided density of 1626 kg/m<sup>3</sup>. Fluidity was assessed with cone method described in SIST EN 445:2008 [258], which is actually a standard for testing grouts for pre-stressed tendons, as there are no standards for testing grouts for masonry grouting (Figure 4.2 right two). According to the standard, measurements should be conducted twice: right after mixing ( $t = 0$ ) and after 30 minutes ( $t = 30$  min). Mixture meets the demands if 1 l of mixture flows through the cone of the prescribed geometry characteristics in less than 25 s and if time results of both tests do not vary by more than 10%. Fluidity results were not in accordance with requirements of SIST EN 445, as recommended values are 20 ( $\pm 5$ ) s while our grout flowed through 10 s. Water content was however not changed as already said, this was a commercial grout mixture and it was prepared following instructions from the producer. Regardless the obtained test results, the grout was used for grouting of the walls and it has proved not problematic.

Bleeding was tested with wick-induced test prescribed by the same standard [258]. Grout of 100 ml volume was poured in the tube of prescribed dimensions, water evaporation was minimised and after 3h the amount of segregated water was registered (Figure 4.2 left). Bleeding is expressed as the ratio of after 3 hours segregated water's volume and the volume of mixture poured in the tube. Acceptable bleeding is limited to 2%. Tested lime-cement grout mixture exhibited no water bleeding.

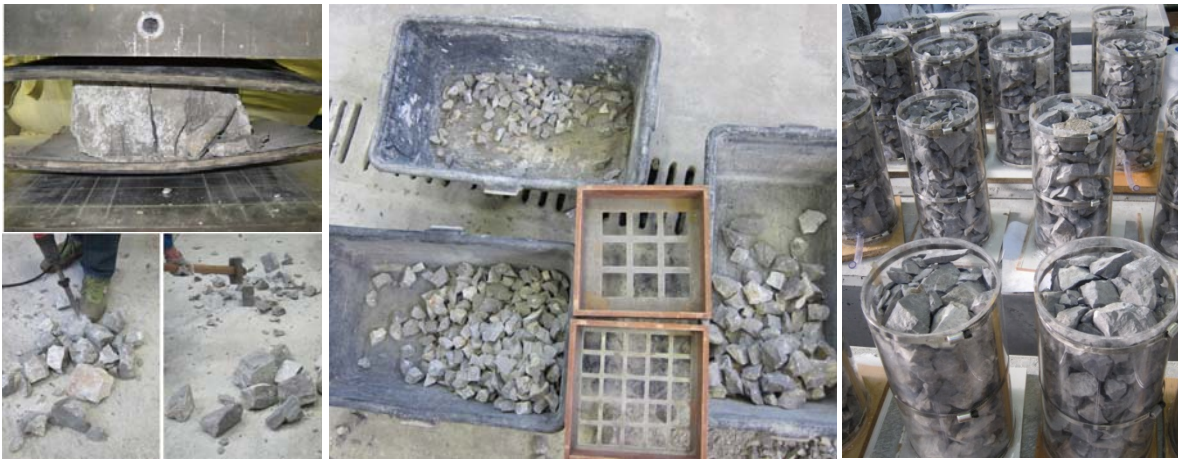
**Figure 4.3: Crushing of stone blocks first by hydraulic jack, then by drilling and finally with hammer, sieved stone rubble and cylinders before grout injecting**

Cylinders for grout injecting were prepared (Figure 4.3) to simulate the core of the three-leaf walls, which was filled with stone rubble and at which a higher amount of voids was present (than the amount of voids in our walls). In order to simulate such samples, stone rubble of specific grain size distribution was used (according to Uranjek [252]). It was prepared by crushing the same lime stone blocks, which were used for construction of the walls, and sieving them. For the composition, 37% of entire rubble mass consisted of aggregate of the largest fraction used; fraction 45/63 mm; further on 37% of mass presented aggregate of fraction 32/45 mm, 25% aggregate of fraction 16/32 mm and 1% aggregate of fraction 8/16 mm.

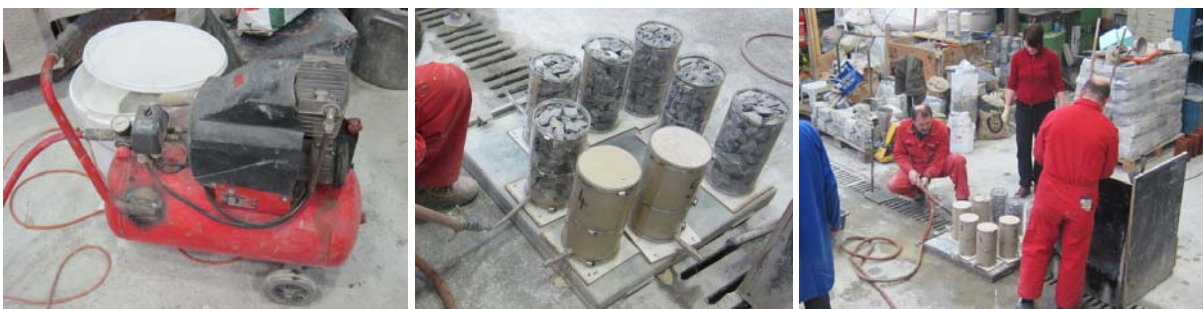
**Figure 4.4: Grout injecting of cylinder specimens**

The actual volume ratio of injected grout was determined by weighing the injected samples and samples prior grouting. Determined average grout volume ratio was 50.0%.

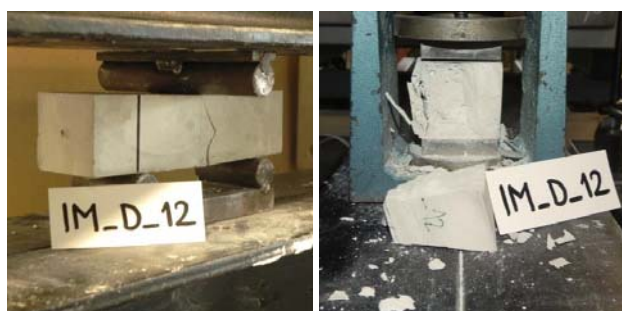
Figure 4.5: Flexural (left) and compressive (right) test on the mortar prisms [251]  
 Slika 4.5: Upogibni (levo) in tlačni (desno) preizkus maltne prizme [251]

Compressive strength of prisms  $f_{mc}$  was determined according to EN 1015-11 [239] by mono-axial compressive test performed on samples left from flexural tensile strength tests (both presented in Figure 4.5). Average compressive stress of grout prisms determined was 14.7 MPa (c.o.v. 6.27%, Table 4.4). Average dynamic modulus of elasticity determined with GrindoSonic was 5.86 GPa with c.o.v. equal to 2.6%.

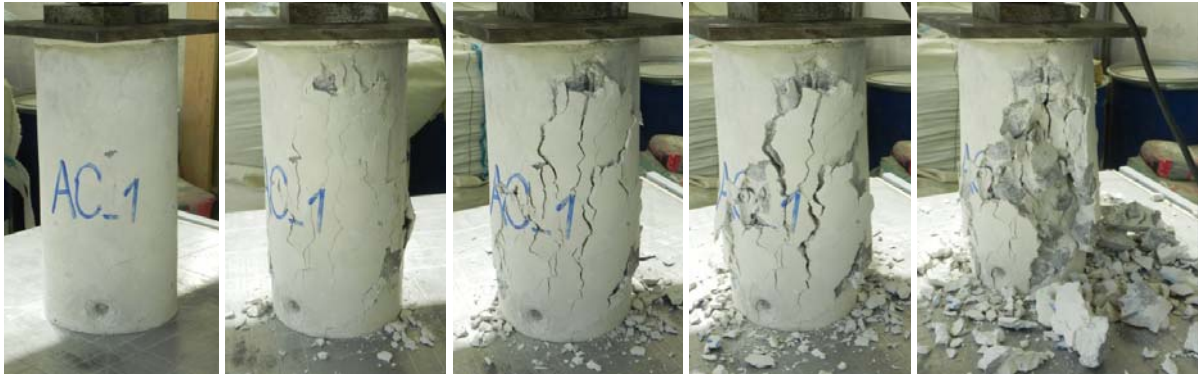
Figure 4.7: Failure mechanism of the cylinder during compressive test [251]

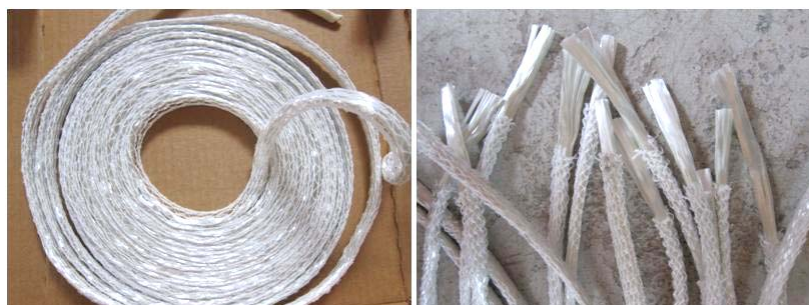
Figure 4.8: Dry glass fibre cords [251]

A dry cord made from high-strength, mono-directional glass fibres wrapped in a protective gauze sheet (Figure 4.8) was used for strengthening; for NSM as well as for transversal connecting of walls' leaves. It is a commercially available product which is mostly used for structural connecting of elements and anchoring. The supplier offers a complete system consisting of a range of products for structural strengthening, which was not used in our campaign, though.

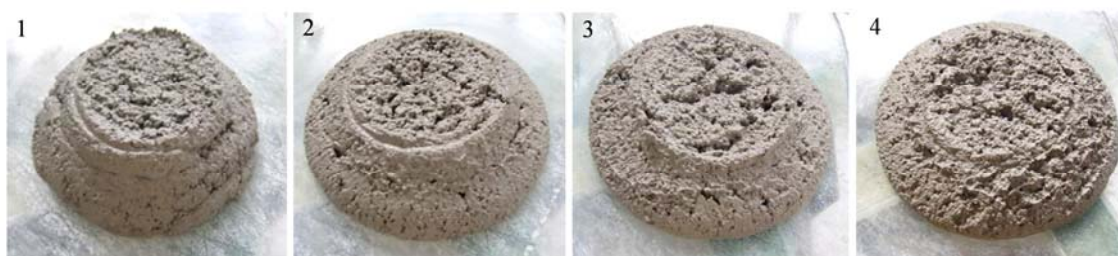
**Figure 4.9: Spread tests of mortar with various water/binder ratios [251]**  
**Slika 4.9: Razlez vzorcev malte z različnimi vodovezivnimi razmerji [251]**

(0.63); however when the cords were already inserted, it was easier to close the joints with more fluid mortar, so finally 0.77 water/binder ratio was used. Results of spread test are presented in Table 4.10 and Figure 4.9.

Test	1	2	3	4	5
Water/binder ratio	0.63	0.67	0.71	0.72	0.77
Spread [mm]	120	135	145	155	180

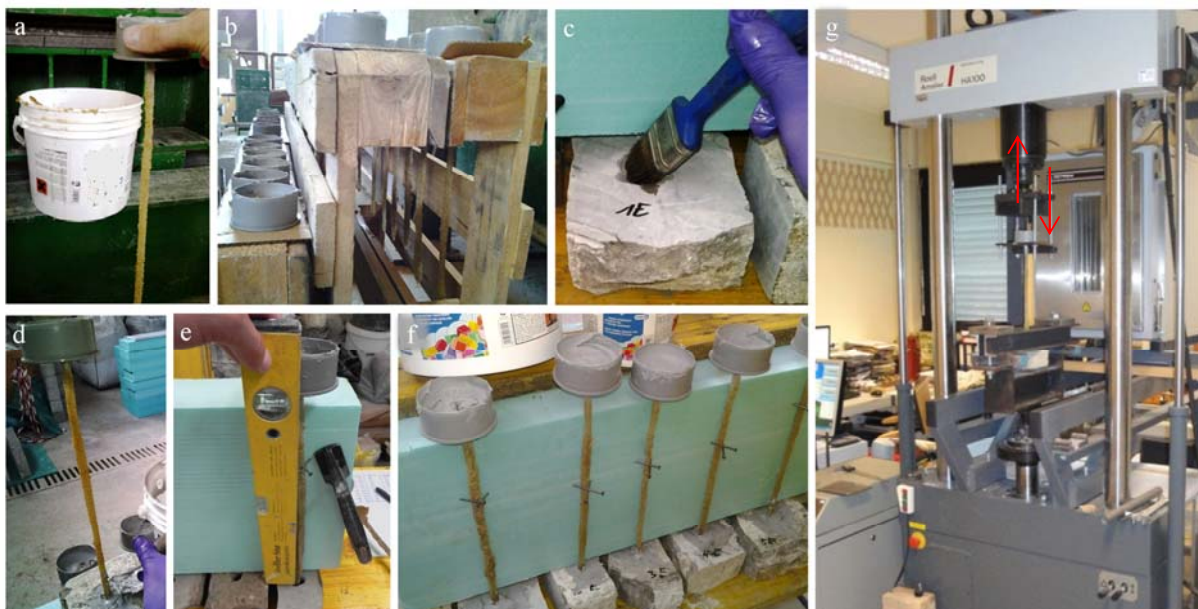
Figure 4.10: Preparation of the samples for the stone-mortar-cord junction tests: a) with epoxy resin impregnated cord coated with quartz sand and mounted with epoxy mortar in a PVC cap, b) hardening of the cords, c) application of the primer (in case of epoxy mortar), d) installing the cord with selected mortar, e) vertical positioning of the cord, f) hardening of the samples and g) test setup (adopted from [255] )

In order to obtain data for calculation of the FRP contribution to strength of the masonry specimen, tests of stone-mortar-cord junction were performed, since in some design models, bond shear strength is a necessary input parameter. Because of the specific type of strengthening by means of NSM of cord, a special test setup had to be developed in accordance with the testing equipment available. These studies were performed within graduation thesis of Luka Božič [255], where besides the test setup establishment, also a set of stone-mortar-cord junction tests varying mortar (three different types) and stone (limestone and sandstone) was performed. The preparation of the samples and the test setup, which is a sort of a pull-out test, is presented in Figure 4.10. For the test, the glass cord was pulled out from a stone cube, in which a hole was drilled and into this hole the cord was installed by the selected mortar. The cord was mounted with epoxy mortar in a PVC cap and this cap was fixed on the actuator, which pulled the cord from the fixed stone cube.

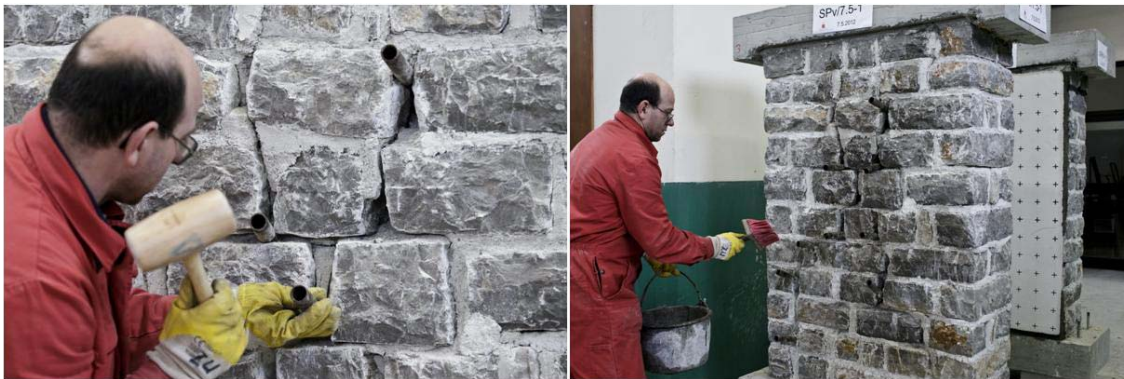
Figure 4.12: Inserting tubes (left) and pre-wetting the wall (right) (photos Željko Stevanić for UL FGG)  
Slika 4.12: Umeščanje cevk v zidove (levo) in vlaženje zidu (desno) (foto Željko Stevanić for UL FGG)

Grouting was executed by an experienced team of professionals. Holes were drilled into the walls and metal tubes inserted at an approximate distance of 50 cm; somewhere tubes were just inserted into existing cracks (Figure 4.12 left). Cracks were closed up by a cement-based binder in order the grout not to leak out during grouting, the wall was pre-wetted prior grouting (Figure 4.12 right) and the grout was injected through the tubes under approximately 2 bars of pressure (manual adjustment).

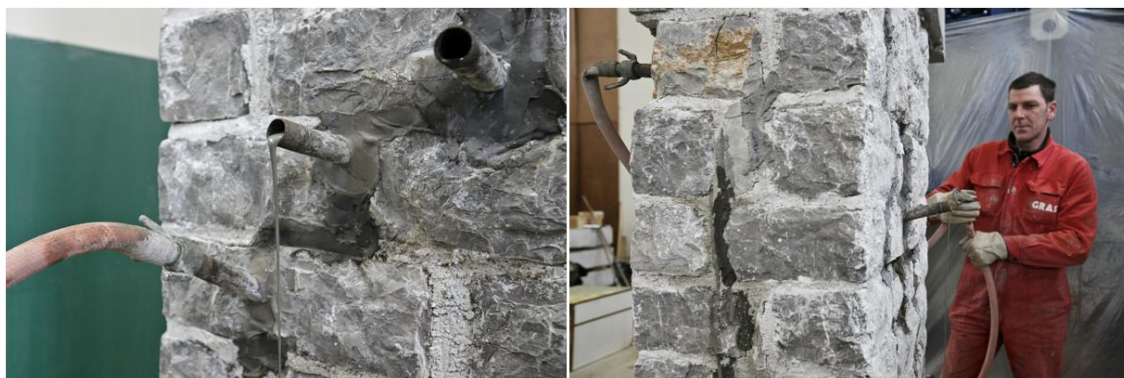
Figure 4.13: Leakage of the grout from a higher tube (left) and from a tube on the other side of the wall (right) (photos Željko Stevanić for UL FGG)

The grouting started from the bottom up. When the grout was injected and all the cracks and voids in the walls were filled with grout, the grout leaked out either from a higher positioned tube (Figure 4.13 left) or from tube on the other side of the wall (Figure 4.13 right).

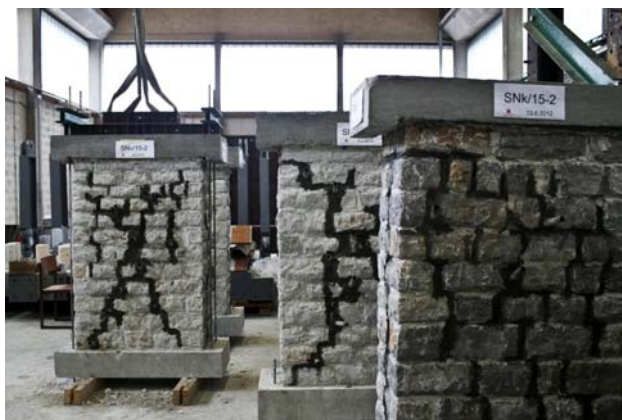
Figure 4.14: Grouted wall specimens (photo Željko Stevanić for UL FGG)  
Slika 4.14: Preizkušanci po linijskem injektiranju (foto Željko Stevanić for UL FGG)

After the grouting was finished, the tubes were removed. In average approximately 30 l of grout was injected into each wall, which is an acceptable value as the walls did not have many voids in the core and only line crack grouting was executed. If more voids were present in the walls, up to 80 kg of

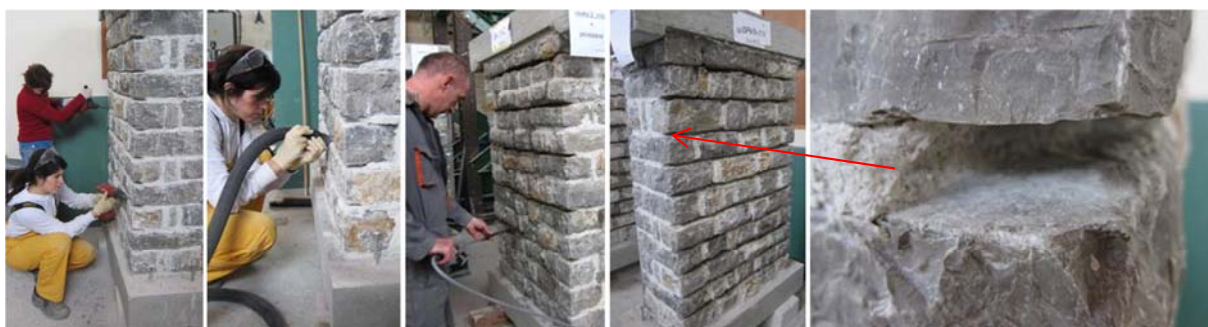
Figure 4.15: Process of emptying horizontal mortar joints: removal of mortar, vacuuming, water cleaning of emptied joints and wall with partially emptied joints

For inserting the cords, first the mortar was removed from the chosen horizontal joints up to 5-6 cm in depth (Figure 4.15 left). Various tools were used and it was a rather time-consuming procedure, especially as the work took place in a laboratory and grinders could not be used in order not to dust the laboratory equipment. After the joints had been emptied, they were cleaned with a vacuum cleaner and sprayed with water (Figure 4.15 middle), in order to assure better bond of the repointing mortar and the stones.

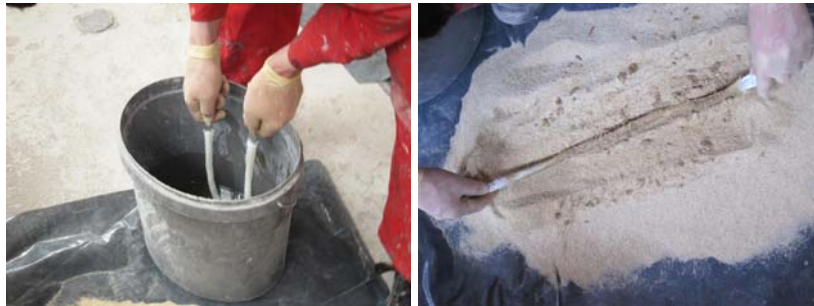
**Figure 4.16: Impregnating the cord with an epoxy resin (left) and coating the cords in quartz sand (right)**  
Slika 4.16: Namakanje vrvice v epoksi smolo (levo) in valjanje vrvice v kremenčevem pesku (desno)

After the joints had been emptied, approximately 1 cm of the repointing mortar (lower water/binder ratio 0.63) was inserted into the joint prior inserting the cords. Cords approximately 120 cm long were dipped into epoxy resin (Figure 4.16 left), impregnated and rolled into quartz sand (Figure 4.16 right), except in case of wall for test S8, where they were built-in by epoxy mortar. Coating the cords into sand proved to be a good decision not only for better cord-mortar junction characteristics but also due to prevention of the intensive dripping of the resin. The negative results of dripping of the

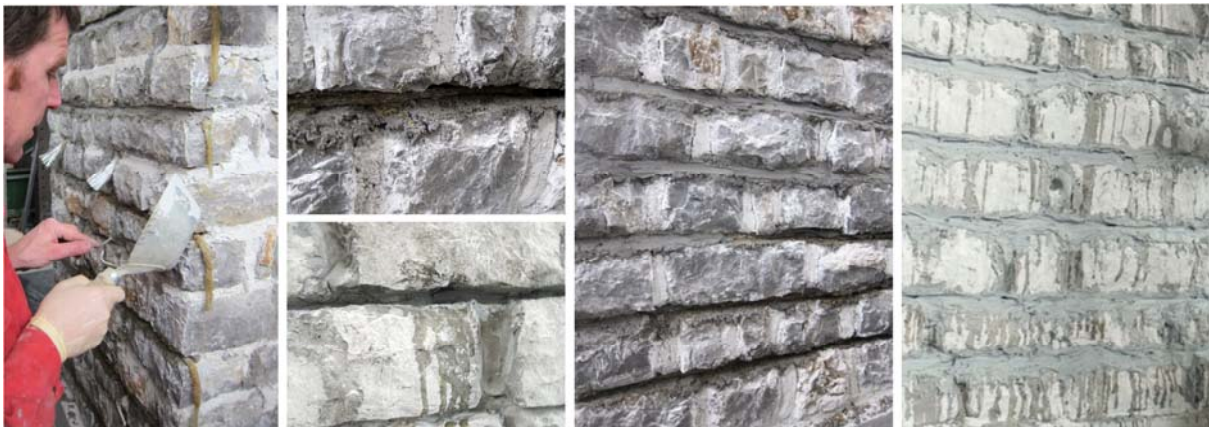
**Figure 4.17: Cords placed into the joints with cement-lime mortar, cord placed into the groove with cement-lime mortar (upper) and with epoxy mortar over epoxy primer (bottom), with cement-lime mortar repointed joints and with epoxy mortar repointed joints (from left to right)**

When the cords were inserted into the joints, they were manually stretched with approximately 10 cm hanging out on each side (see Figure 4.17). The remaining empty part of the joint was filled (repointed) with mortar with higher water/binder ratio of 0.75. This procedure had to be done fast, to avoid premature hardening of the mortar.

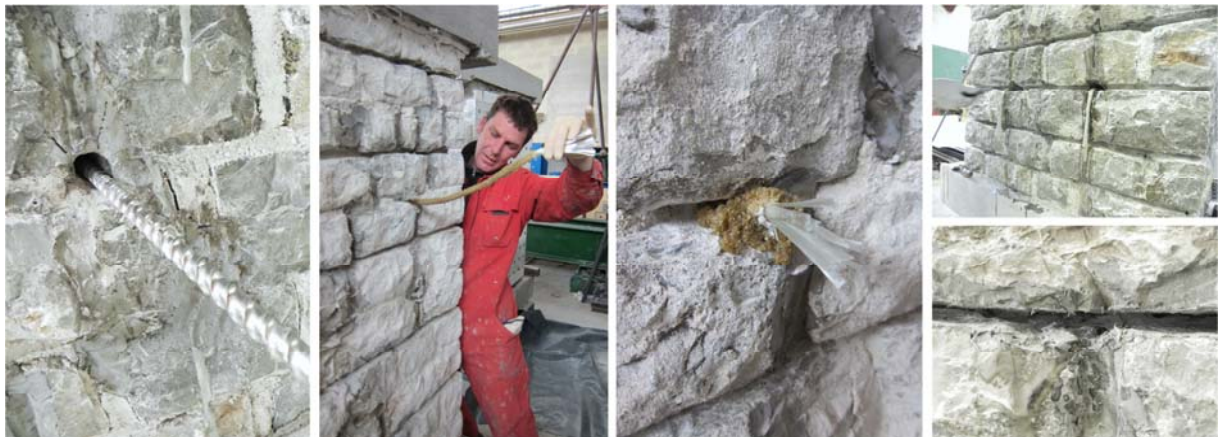
**Figure 4.18: Drilling of the hole, the insertion of the impregnated cord coated in sand and sand "plug", transversal connection with impregnated cord (upper right) and with spread and fixed fibres (test 8 only, bottom right)**  
**Slika 4.18: Vrtanje luknje, povezovanje slojev zidu z impregnirano in s peskom posuto vrstico, pečeni "čep", prečna povezava z impregnirano vrstico (zgoraj desno) in razprostrta in prilepljena vlakna (samo test 8, spodaj desno)**

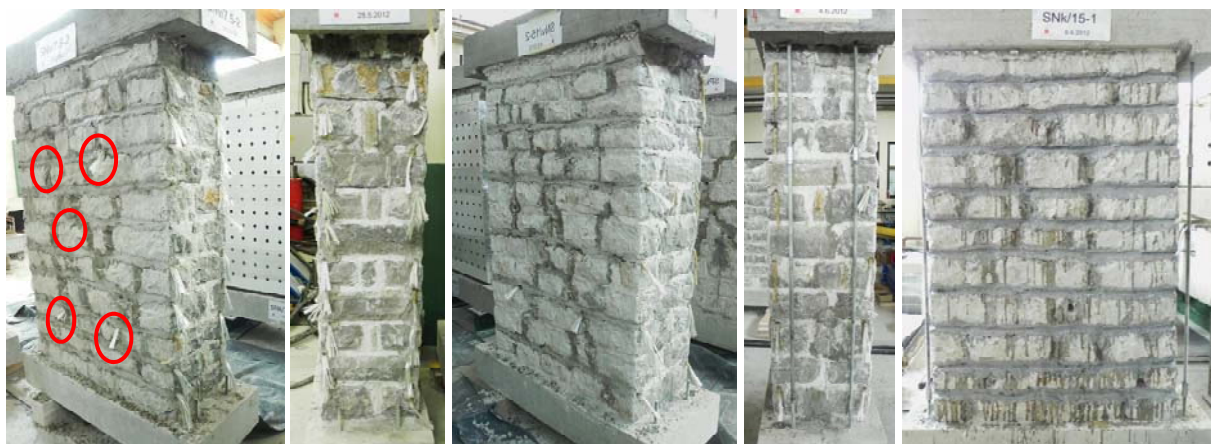
**Figure 4.19: Retrofitted and NSM strengthened walls**  
**Slika 4.19: Injektirani in z vrvicami v fugah utrjeni zidovi**

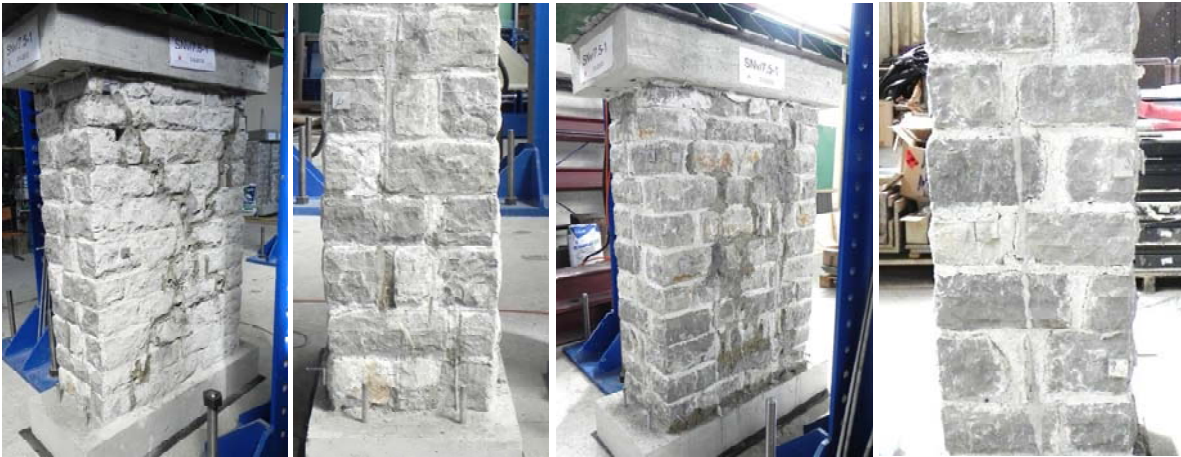
Figure 5.1: Grouted wall with existing damage pattern prior testing (test T1 - I(n))  
Slika 5.1: Injektirani zid z obstoječimi razpokami pred testiranjem (test T1 - I(n))

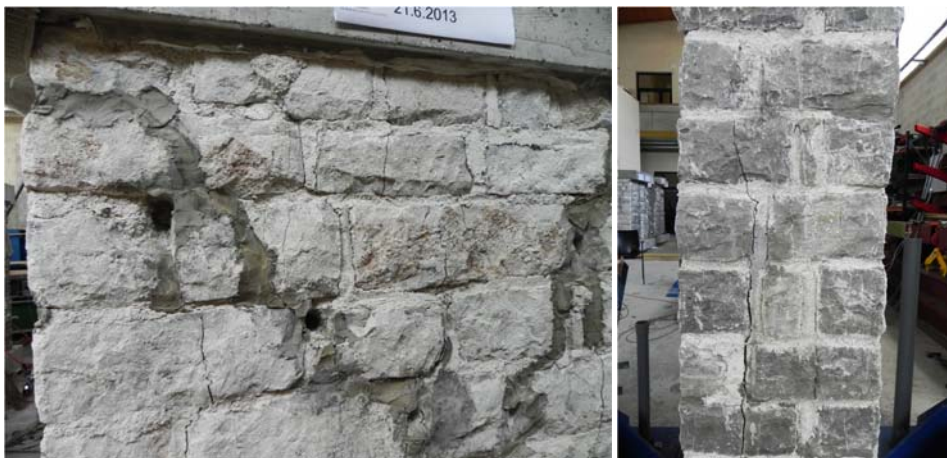
Figure 5.2: Damage pattern after failure attained at test T1 - I(n)  
Slika 5.2: Poškodovanost zidu po testu T1 - I(n)

The tested wall was retrofitted by grouting of cracks, caused by previous shear test (Test 3-SNv-7.5-1). Damage patterns after failure are presented in Figure 5.2.

Cracks occurred not only where they pre-existed, but also elsewhere on the wall. So it was established, that line crack grouting sufficiently connected the wall. Cracks through stones mainly progressed from pre-existing cracks in vertical mortar joints (grouted and others). They were observed over the entire specimen, many developed during the test, whereas some already existed from prior shear tests and widened. At corners vertical continuous cracks creating “columns” were evident. Vertical cracks observed at sides due to leaf separation, indicated eccentric out-of-plane behaviour (Figure 5.2 right).

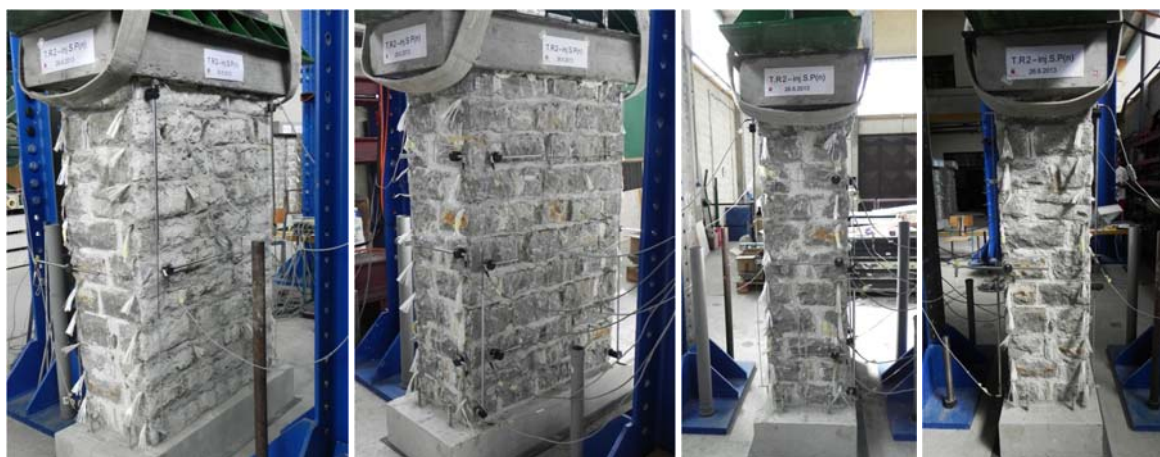
Figure 5.4: Grouted wall, additionally strengthened with NSM and transversally tied with glass cords (T2 – IS2.P (n)) prior testing (existing damage pattern)

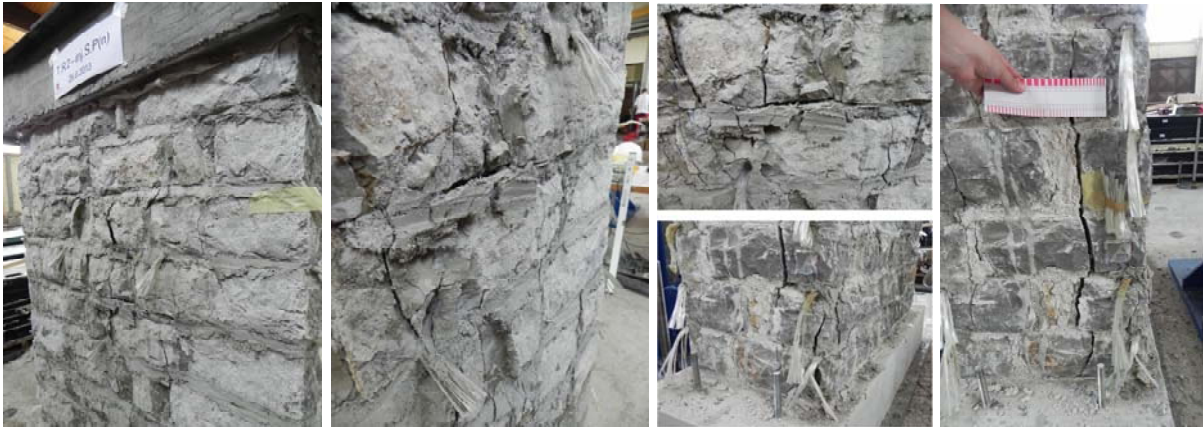
Figure 5.5: Damage pattern after failure attained at test T2 – I.S2.P (n)  
Slika 5.5: Poškodovanost zidu po testu T2 – I.S2.P (n)

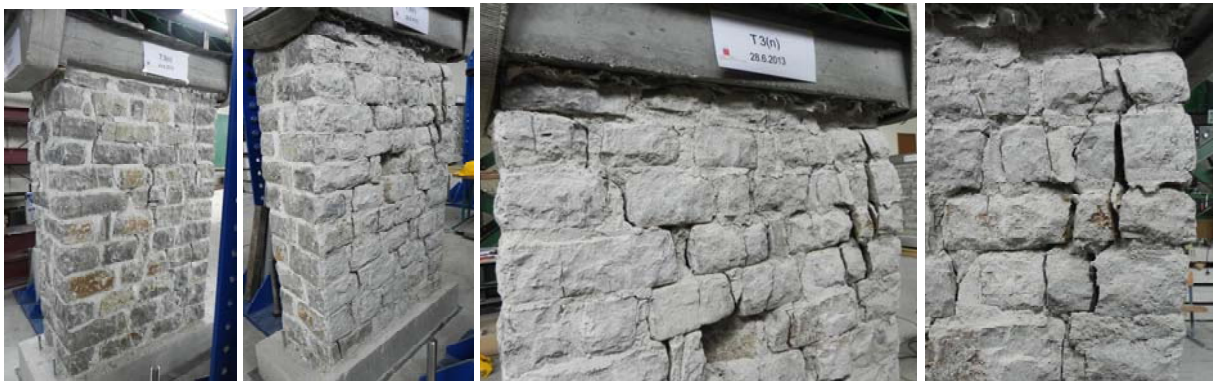
**Figure 5.7: Damage of the wall obtained after test T3-n**  
**Slika 5.7: Poškodovanost zidu po testu T3-n**

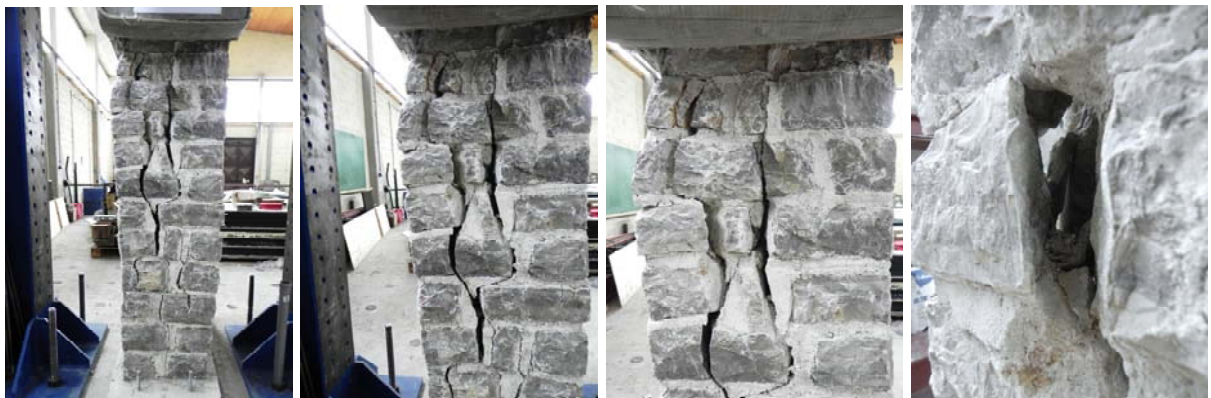
**Figure 5.8: Leaf separation obtained at test T3-n**  
**Slika 5.8: Razslojevanje slojev zidu pri testu T3-n**

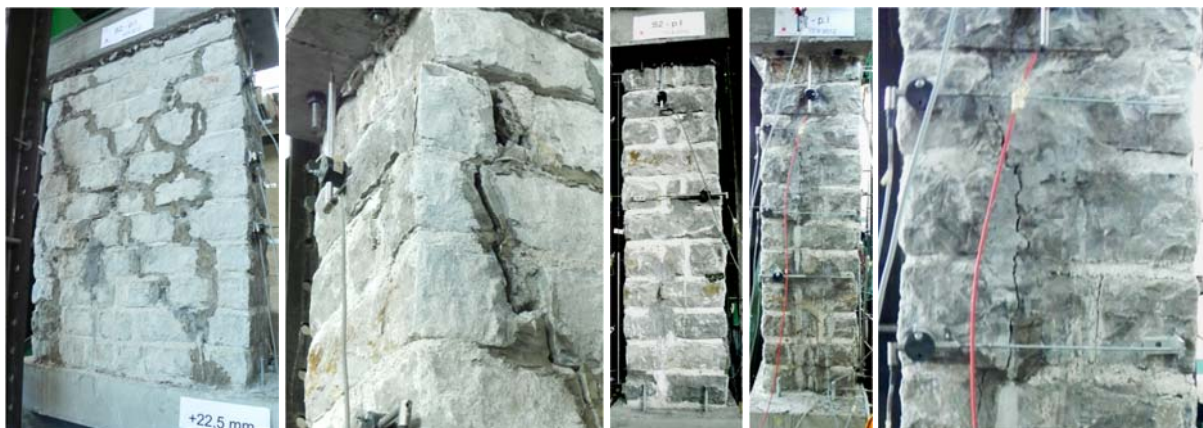
Figure 5.13: Damage after test S2 – I(p) on the front and transversal sides of the wall  
Slika 5.13: Razpokanost zidu na prednji in stranskih straneh zidu po testu S2 – I (p)

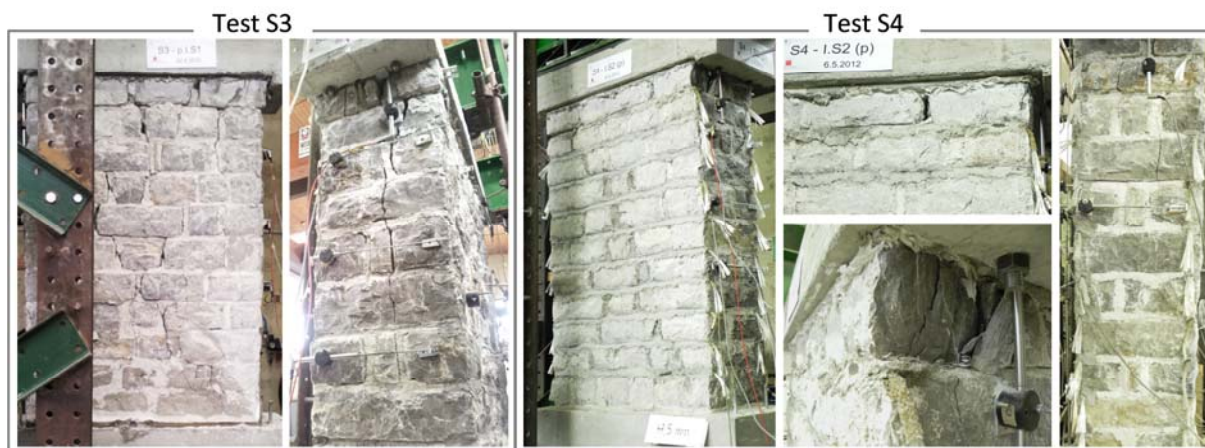
Figure 5.14: Rocking and minor shear damage on the wall after test S3 – I.S1(p) and rocking and toe crushing at test S4 - I.S2(p)
