**META KRŽAN, univ. dipl. inž. grad.**

**EKSPERIMENTALNE IN NUMERIČNE PREISKAVE ZA  
DOLOČITEV KONTROLIRANEGA ODZIVA  
VEČSLOJNE KAMNITE ZIDOVINE**

**PERFORMANCE BASED EXPERIMENTAL AND  
NUMERICAL ASSESSMENT OF MULTI-LEAF STONE  
MASONRY WALLS**

Doctoral thesis No.: 247

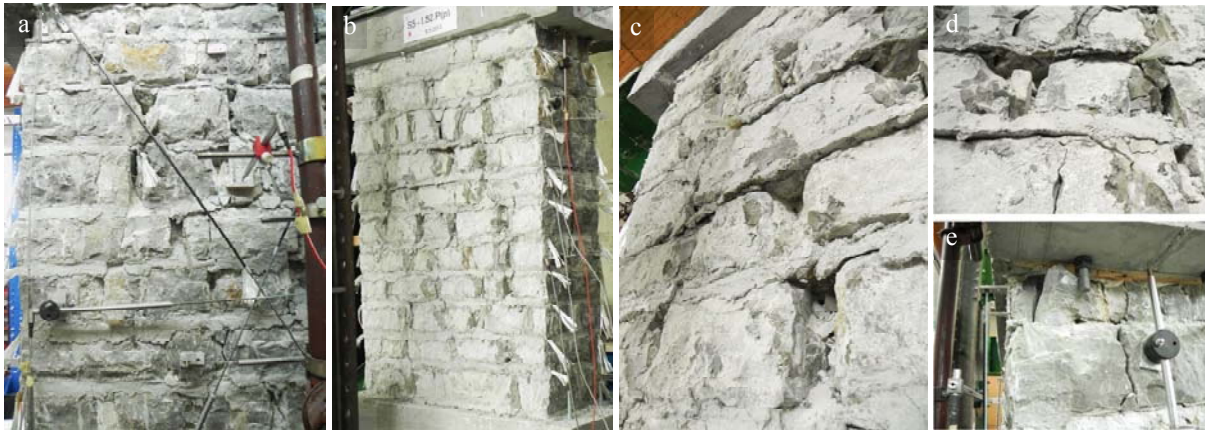
Figure 5.15: Crack pattern on the wall (a, b) with cord detachment (c, d) and toe crushing (e) after test S5 - I.S2.P(p)  
Slika 5.15: Razpokanost zidu (a, b) z odstopanjem vrvice (c, d) in zdrobljeno peto (e) po testu S5 - I.S2.P(p)

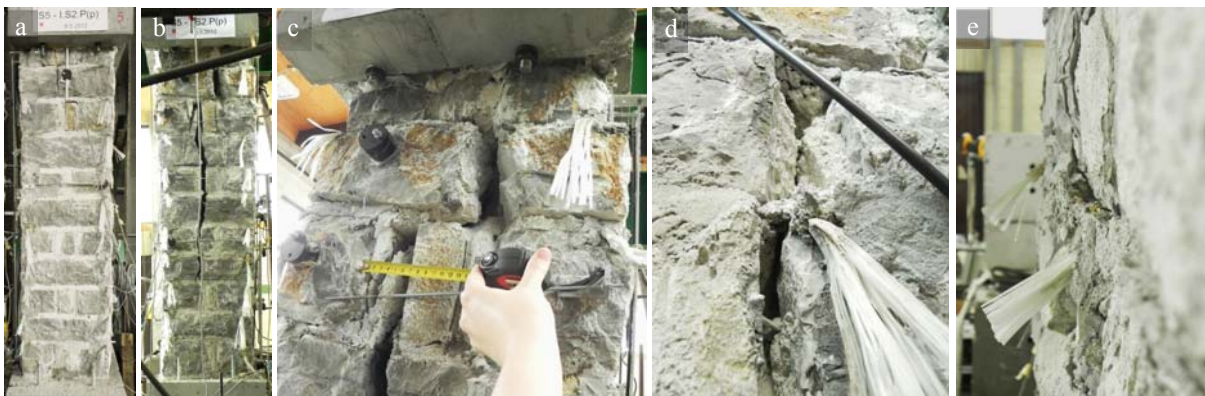
Figure 5.16: Leaf separation with toe-crushing (a-c), damage of the transversal connections (d, e) of the wall after test S5 - I.S2.P(p)  
Slika 5.16: Razpoka (vrzel) med slojema ter zdrobljena peta (a-c), poškodovanost prečnih povezav (d, e) zidu po testu S5 - I.S2.P(p)

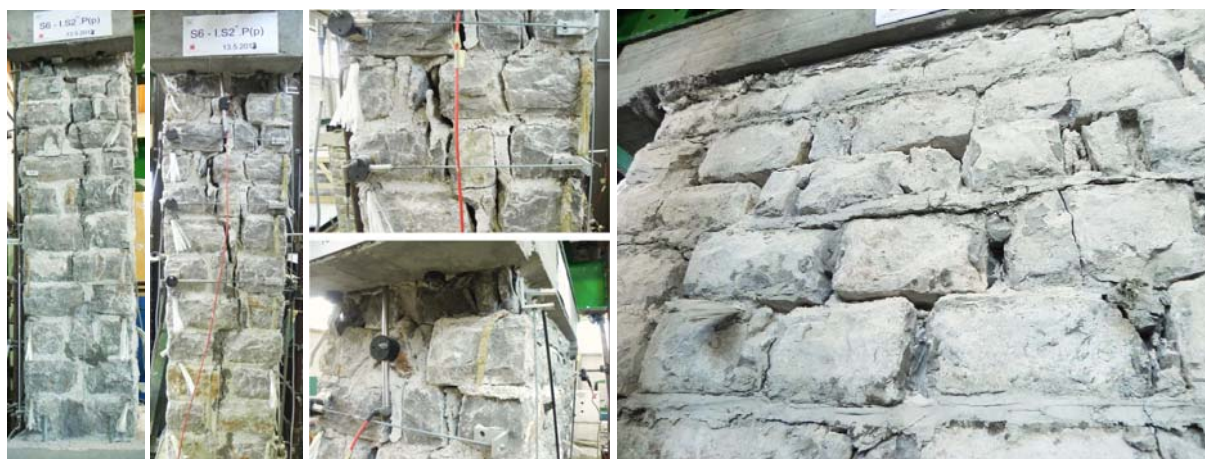
**Figure 5.17: Leaf separation, toe-crushing damage and cord detachment with partially emptied mortar joints after test S6 - I.S2-.P (n)**

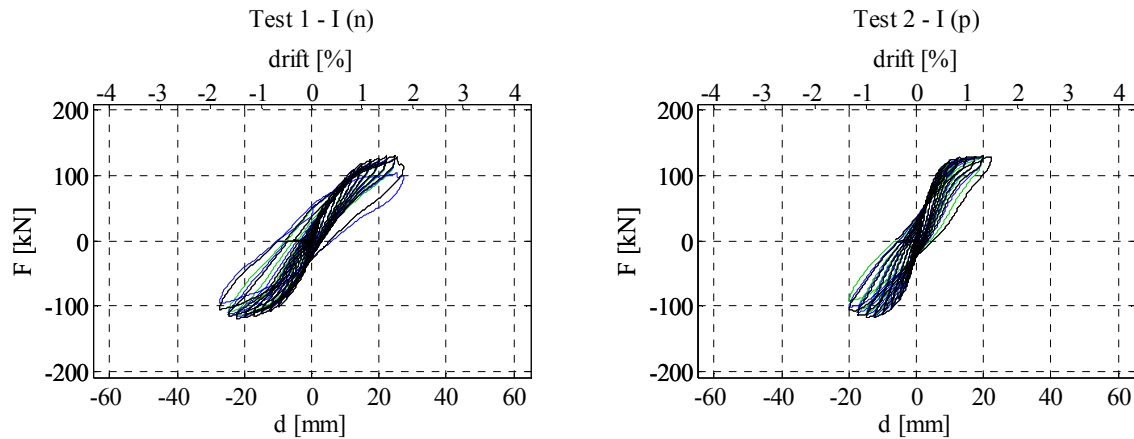
**Figure 5.18: Force - displacement diagrams for the tests of only grouted walls; less damaged wall – test S1 - I(n) and more damaged wall – test S2 – I(p)**

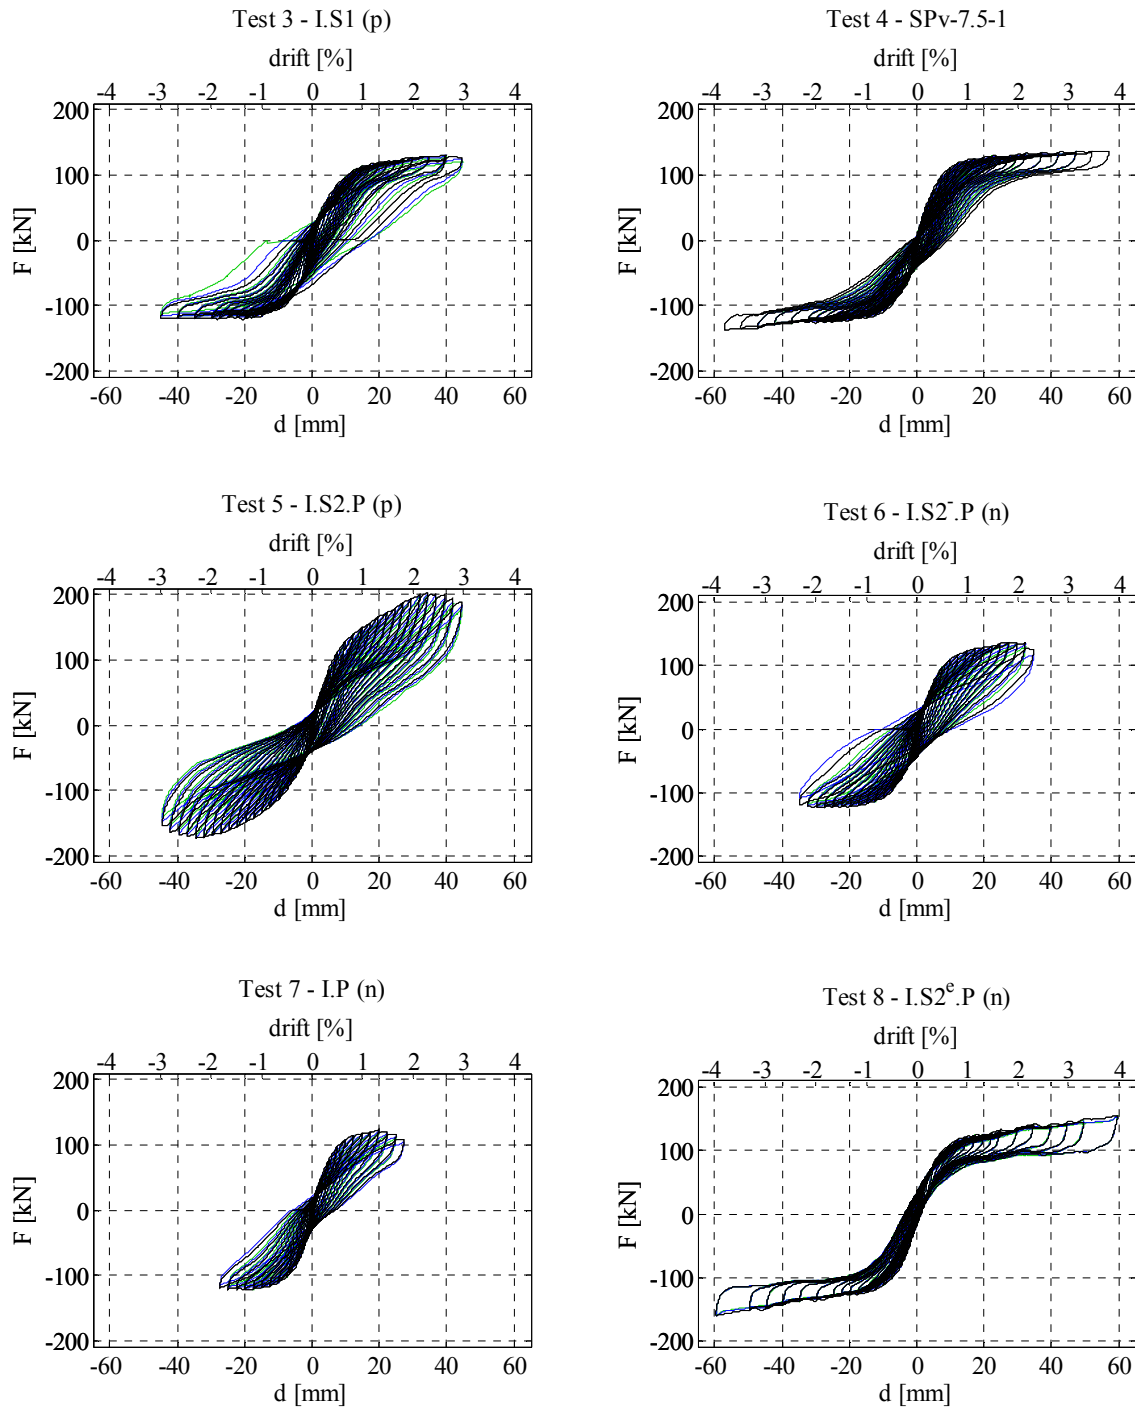
Figure 5.19: Force - displacement diagrams for tests S3 - S8  
Slika 5.19: Diagrami sile v odvisnosti od prečnega pomika za teste S3 - S8

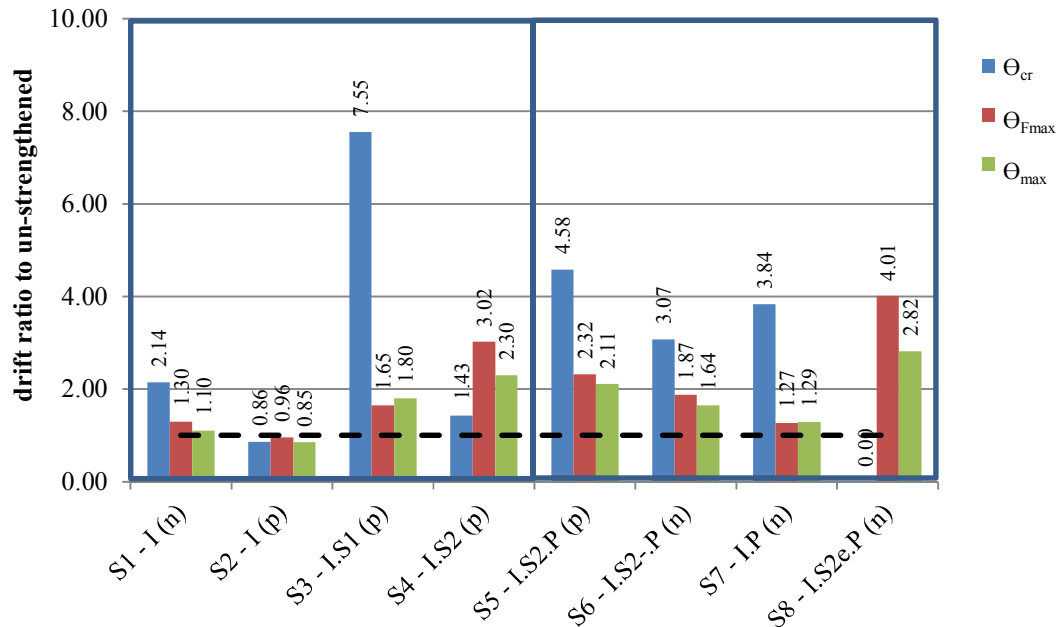
Figure 5.28: Comparison of drift limits of strengthened walls to average values of un-strengthened walls  
Slika 5.28: Primerjava mejnih rotacij utrjenih zidov s povprečnimi vrednostmi neutrjenih zidov

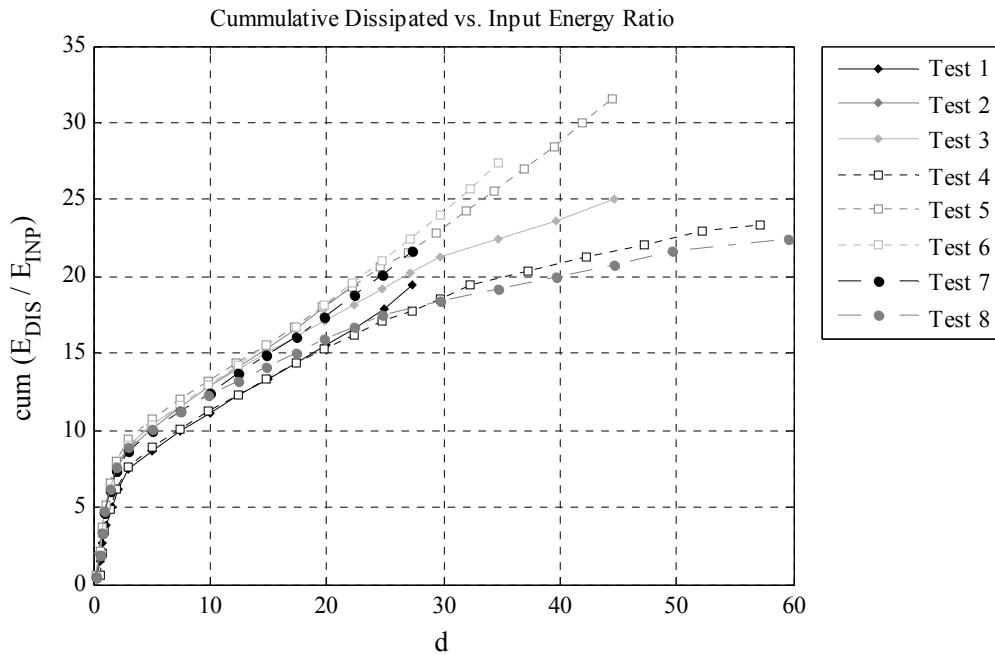
Figure 5.32: Ratio of cumulative dissipated and input energy  $cum(E_{DIS}/E_{INP})$  for tests of strengthened walls at 1<sup>st</sup> cycles of displacement amplitudes

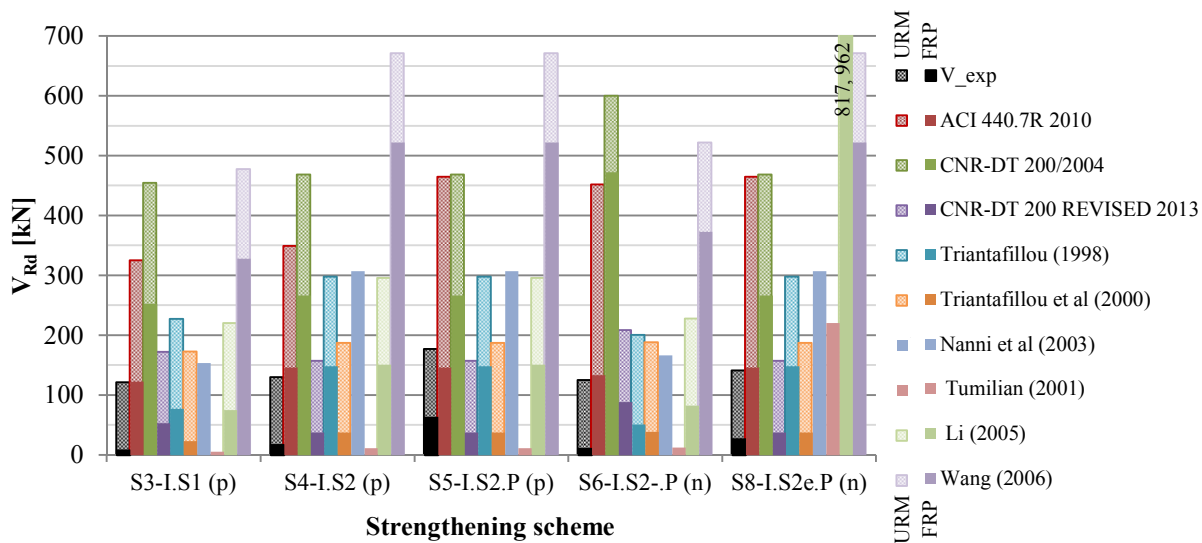
Figure 5.34: FRP and URM contributions to walls' total lateral resistance  $V_{Rd}$  obtained through tests and calculated according to various code provisions and models for various strengthening schemes

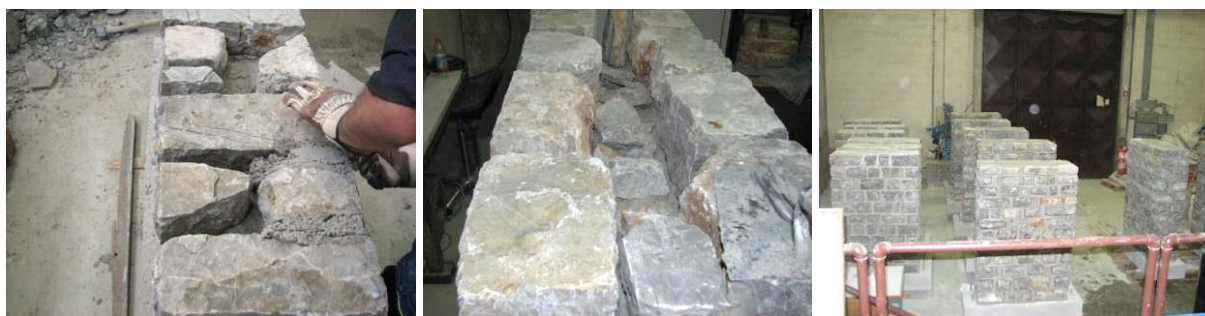
Slika 8.2: Gradnja zidov z vezniško zvezo (levo), s smerniško zvezo (na sredini) ter preizkušanci pred izdelavo zgornjih betonskih blokov (desno)

Figure 8.2: Construction of the wall with (left) and without (middle) header stones and the wall specimens prior construction of the upper concrete slab (right)

Preizkušanci so bili zgrajeni v laboratoriju za namene preiskav obnašanja starih kamnitih večslojnih zidov, zato so jih zgradili izučeni zidarski mojstri, ki so za gradnjo uporabili apneno malto. Zunanji sloji zidov so bili zgrajeni iz pol obdelanih kamnitih blokov iz apnenca, položenih v ravne pravilne vrste. Polovica zidov je bila zgrajena z vezniško zvezo, to je s povezovalnimi kamnitimi bloki, ki so po prerezu v vsaki drugi vrsti potekali čez vse tri sloje. Druga polovica zidov pa je bila zgrajena s smerniško zvezo, to je brez povezovalnih blokov. Debelina maltnih spojnic je bila v povprečju 1.5 cm. Notranji sloj je bil zapolnjen z ostanki kamna od zidave ter apneno malto, vseboval pa je tudi manjši delež votlin. Zaradi hitrejšega vezanja je bilo malto glede na volumen apna dodano 20% vulkanskega pepela, za reprezentativnost historičnih malt pa je bil cilj ne preseči 2 MPa tlačne trdnosti malte. Zidovi so bili z ene strani ometani; nanosena sta bila dva sloja ometa, in sicer grobi ter fini omet. Debelina ometa je glede na različne oblike kamna znašala med 1 in 3.5 cm. Tekom gradnje zidov se je merilo konsistenco malte ter pripravljalo standardne maltne vzorce za preiskave mehanskih karakteristik strjene malte ter valjaste vzorce malte in odpadnega kamenja za simulacijo in preiskave jedra zidu.

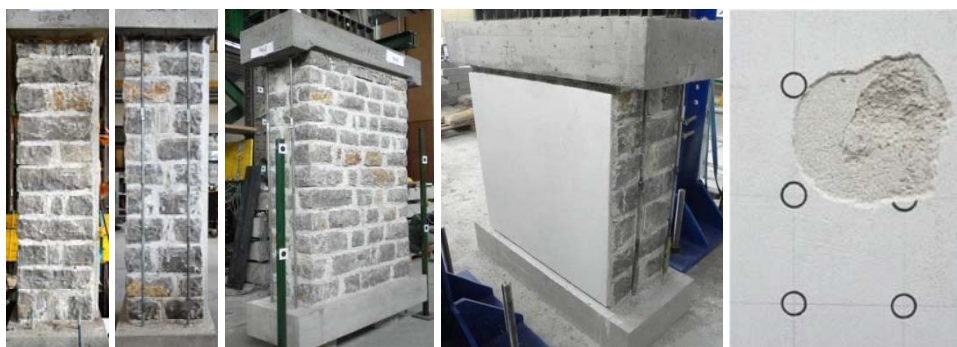
Slika 8.3: Morfologija povezanega zidu in nepovezanega zidu, zid za preizkušanje, zidek z ometom ter omet z vidnim grobim in finim slojem (od leve proti desni)

Figure 8.3: Morphology of the wall with and without through stones, the wall specimen, the plastered wall and lime plaster with coarse and fine layer (from left to right)

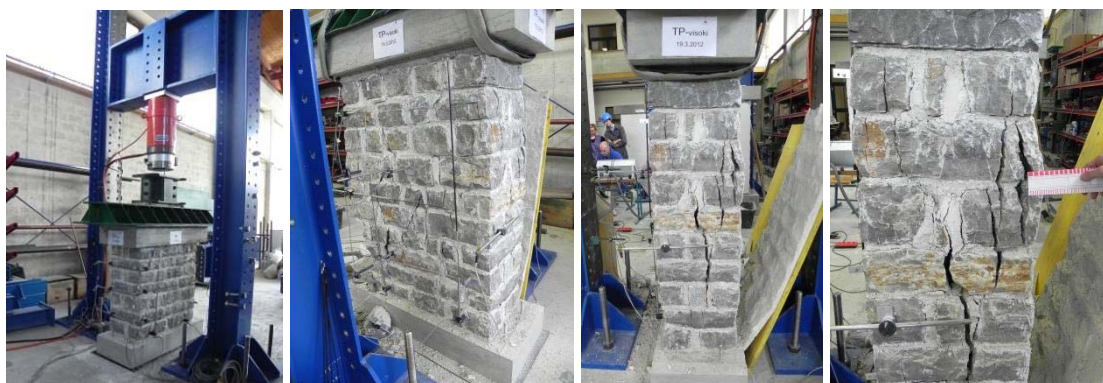
Slika 8.4: Postavitev tlačnega testa (levo) ter poškodovanost povezanega zidu po testu (ostale)  
Figure 8.4: Compression test setup (left) and damage of the wall with header stones after the test

Najprej sta bila preskušana zidka, eden nepovezan in drugi povezan, ter nato še zidova. Pri zidkih maksimalna nosilnost ni bila dosežena zaradi omejitve opreme (hidravlični bat kapacitete 2500 kN). Hitrost obremenjevanja je bila konstantna, in sicer med 0.25 kN/s in 1.0 kN/s za posamezne teste. Vertikalni in horizontalni pomiki zidov so bili spremljani z 11-imi induktivnimi merilci.

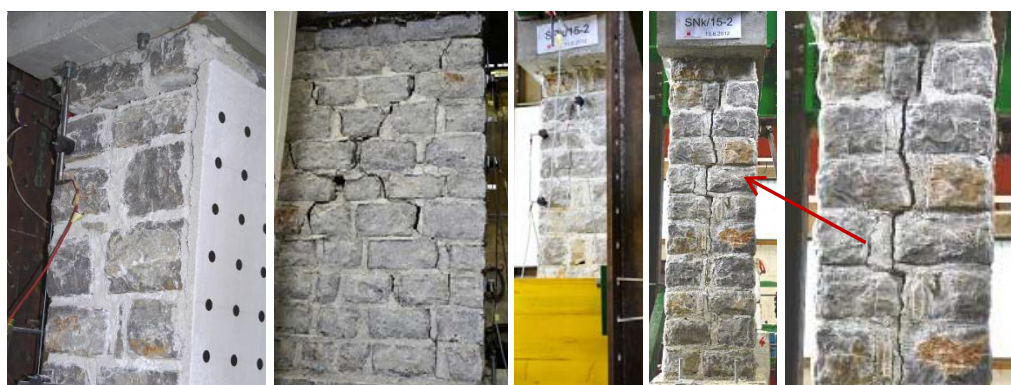
Slika 8.7: Upogibni mehanizem z odpiranjem maltne spojnice med prvima vrstama kamnitih blokov pri testu 2 - SNk-7.5-1, diagonalne strižne poškodbe zidu po testu 13 - SPk\_15\_2 ter razpoka med slojema po istem testu, razpoka med slojema zidu po testu 14 - SNk\_15\_2 (od leve proti desni)

Figure 8.7: Rocking of the wall with opening of the mortar joint between the first two rows of stone at test 2 - SNk-7.5-1, diagonal shear damage after test 13 - SPk\_15\_2 and crack between the leaves after the same test, leaf separation at test 14 - SNk\_15\_2 (from left to right)

Z izvedenimi kombinacijami robnih pogojev je prišlo do različnih mehanizmov obnašanja zidov (Slika 8.7). Pri nizkih tlačnih obremenitvah in konzolnem vpetju se je sprožil upogibni mehanizem, pri katerem se je »odpirala« spojnica med prvo in drugo vrsto kamnov. Pri vpetih zidovih se je pri nižji tlačni obremenitvi že delno aktiviral strižni mehanizem (dobljeni odziv je v nadaljevanju imenovan »mešan«), pri višjih vertikalnih obremenitvah se je tako pri konzolnih kot tudi vpetih robnih pogojih aktiviral strižni porušni mehanizem. Porušitev je večinoma potekala skozi maltne spojnice, razpokali pa so tudi kamni. Pri večjih pomikih je bilo prisotno drobljenje malte in praznjenje spojnic v sredinskem delu zidov, ponekod tudi v zgornjih vogalih. Vertikalne razpoke skozi spojnice in tudi čez kamne so tvorile (pri nekaterih testih bolj, pri drugih manj) izrazite vertikalne stebre na enem ali obeh robovih zidov.

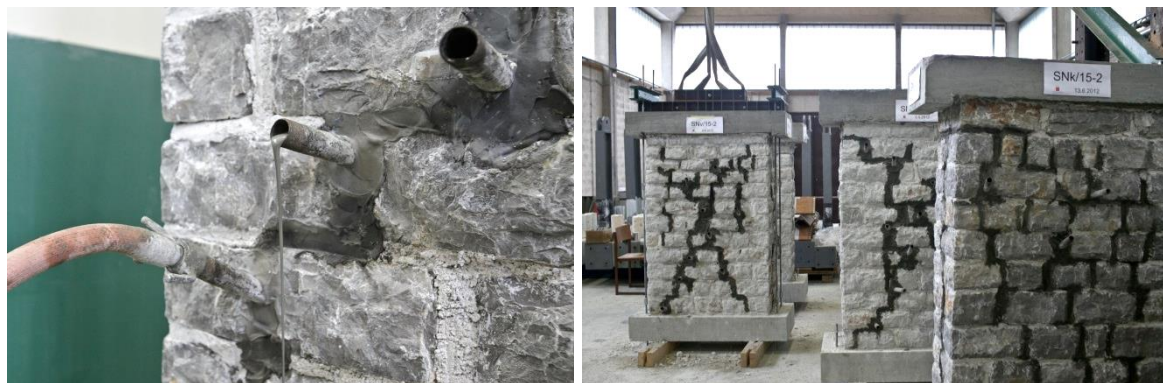
**Slika 8.13: Injektiranje zidov z iztekanjem injekcijske mase in zidovi po injektiranju**  
**Figure 8.13: Grouting of walls along the cracks with grout leakage and specimens after grouting**

Ker so bili vsi zidovi po strižnih testih poškodovani, so bili vzdolž razpok linijsko injektirani z apneno-cementno malto (Slika 8.13). Ker je bilo jedro med zunanjsima slojema kamnov precej zapolnjeno in ni imelo dovolj votlin, sistematično injektiranje niti ni bila ena od možnosti.

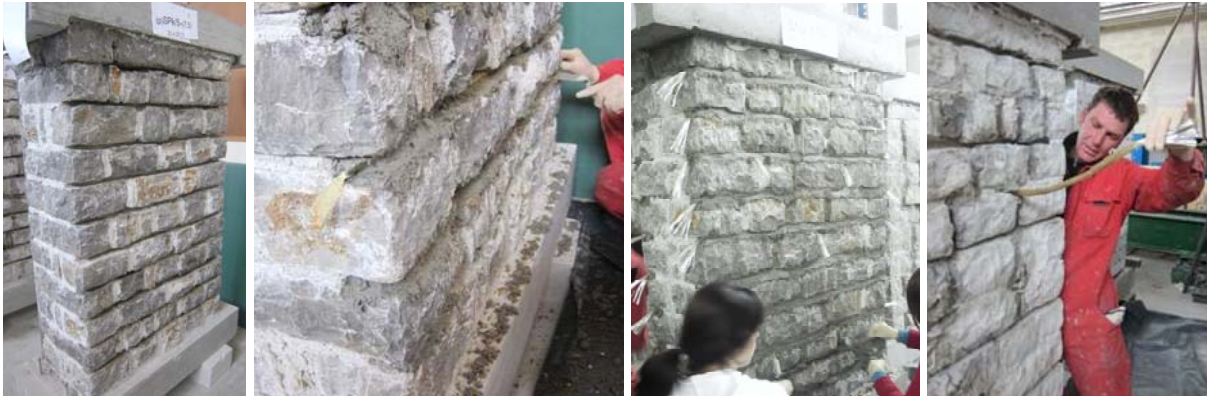
**Slika 8.14: Zid, pripravljen za NSM (delno izpraznjene in očiščene spojnice), vstavljanje vrvic v spojnice, zapolnitev spojnic z malto in prečno povezovanje zidov (od leve proti desni)**

**Figure 8.14: Wall prepared for NSM of cords (partially emptied and cleaned joints), inserting the cords into horizontal joints, repointed horizontal joints and transversal connecting of the wall with cords (from left to right)**

Da bi ohranili zunanjo teksturo zidov, je bila za utrjevanje izbrana namestitev steklenih vrvic v horizontalne maltne spojnice (Slika 8.14). Za namestitev utrditev pod površino zidov se uporablja akronim NSM (okrajšava za angleško poimenovanje utrjevanja “Near Surface Mounting”). Namestitev vrvic v horizontalni smeri je bila naravna glede na geometrijo zidov. Prednost uporabljenega sistema utrjevanja je uporaba upogljive vrvice namesto togih palic ali lamel, saj impregnacija na mestu utrjevanja omogoča njihovo oblikovanje v želeno obliko. Z njo bi torej bilo možno utrjevati tudi zidovino z manj pravilno teksturo. Steklena vlakna so bila uporabljena namesto karbonskih zato, ker so manj toga. V kolikor bi bila dobavljiva bazaltna vrvica dovolj majhnega premera, bi bila uporabljena le-ta. Z njo bi se izognili potencialni alkalno-silikatni reakciji pri uporabi steklenih vrvic. Steklena vlakna so bila impregnirana z epoksi smolo, za boljši oprijem namočena v kremenov presek in vgrajena v spojnice s podaljšano cementno malto, kljub običajni in s strani proizvajalcev priporočeni uporabi epoksidne malte. Vrvice niso bile sidrane, saj je bilo predpostavljeno, da naj bi bil stik vrvic z malto in zidom dovolj močan za prenos sil. Izpraznjene fuge so bile nato do konca zapolnjene z enako podaljšano cementno malto. Za primerjavo vpliva veziva za vgradnjo vrvic je bil NSM na enem zidu izveden po priporočilih podjetja, ki je proizvajalec vrvic ter ima na voljo tudi svoje komercialne sisteme utrjevanja zidov. Pri tem zidu je bila vrvica vgrajena z epoksidno malto, pri čemer vrvica ni bila namočena v pesek, ampak je bila spojnica predhodno premazana s temeljnim sprijemnim premazom (eng. “primer”). Fuge so bile zapolnjene z epoksidno malto. Pri tem zidu je bilo sidranje narejeno na način, da so se vrvic upognile v prečni del zidu v sami izpraznjeni fugi.

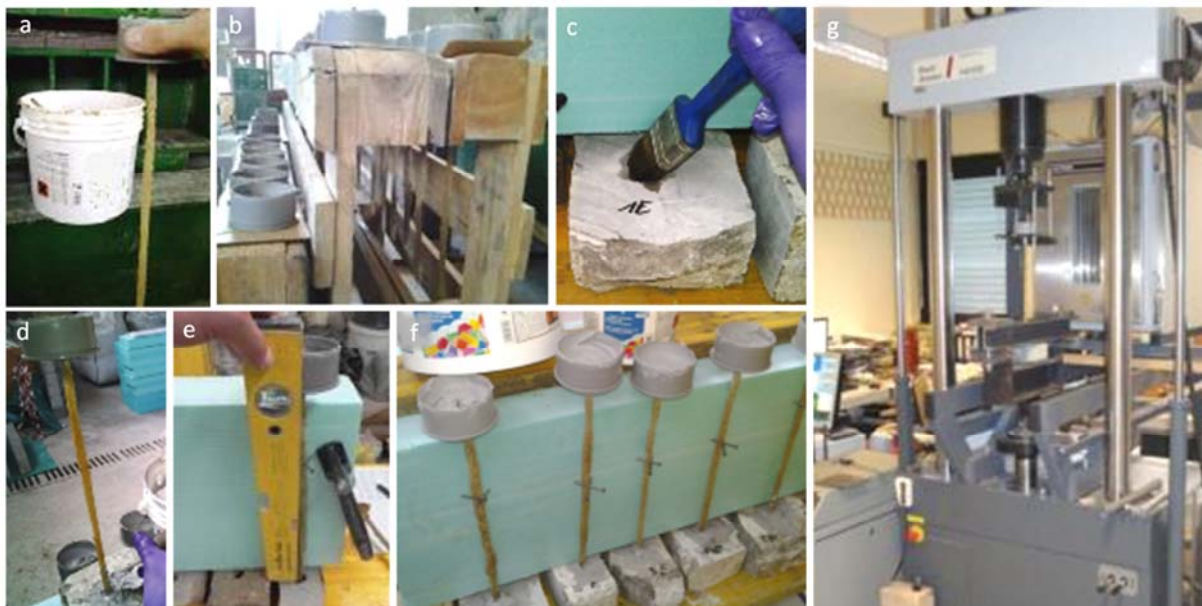
Slika 8.15: Priprava vzorcev za teste stika kamen-malta-vrvica: a) impregnirana in s kremenčevim peskom posuta steklena vrvica, vpeta v PVC čep, b) sušenje vrvic, c) nanos temeljno sprijemnega premaza (v primeru uporabe epoksi malte), d) vgradnja vrvic z izbrano malto, e) vertikalna namestitve vrvic v vzorcu, f) strjevanje vzorcev ter g) postavitve testa [255]

Figure 8.15: Preparation of samples for stone-mortar-cord junction tests: a) with epoxy resin impregnated cord coated with quartz sand and mounted with epoxy mortar in a PVC cap, b) hardening of the cords, c) application of the primer (in case of epoxy mortar), d) installing the cord with selected mortar, e) vertical positioning of the cord, f) hardening of the samples and g) test setup [255]

V sklopu diplomske naloge Luke Božiča [255] se je preučevalo trdnost stika vrvica-malta-kamen pri uporabi različnih veziv ter tudi kamnin. V skladu z razpoložljivo opremo se je pripravil primeren način testiranja, ki je bil neke vrste izvlečni test. Priprava vzorcev in postavitev testa so vidni na Sliki 8.15. Izvedeni testi so med drugim pokazali, da sta trdnosti stika v primeru uporabe obeh malt v različnih velikostnih razredih; povprečna vrednost trdnosti stika za apno-cementno malto 0.23 MPa in približno vsaj 10-krat višja za epoksidno malto, pri čemer pri testih s slednjo ni prišlo do porušitve stika, temveč do pretrga vrvice na mestu vpetja v PVC čep.

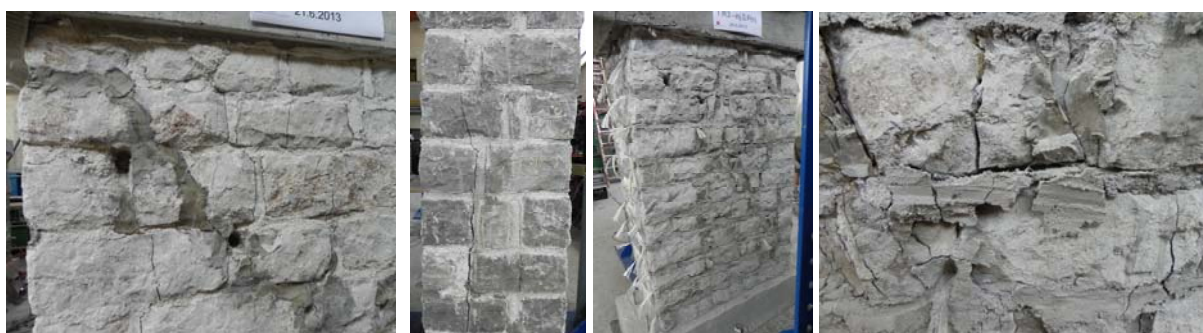
**Slika 8.16: Poškodba zidov pri tlačnih testih: poškodovanost na licu zidu in razpoka med slojema na strani pri injektiranem zidu (levi dve) ter poškodovanost injektiranega, z NSM utrjenega ter povezanega zidu ter porušitev stika med malto in vrstico na sredini zidu (desni dve)**

**Figure 8.16: Damage of walls in compression tests: crack pattern and leaf separation on grouted wall (left two), damage of the grouted wall additionally strengthened by NSM of glass cords and transversally connected, failure of mortar-cord connection (right two)**

Through the tests it was confirmed, that the anchorage of the cords at their ends is unnecessary, if their bond-strength is sufficient. In the tests the connection of the cord to the wall in the central part of the wall failed; mainly at mortar-cord junction. The cords did not break.

Dva, pravzaprav trije, zidovi so bili tlačno testirani, pri čemer tretji ni bil utrjen, temveč je služil za določitev tlačne trdnosti poškodovanega, neutrjenega zidu. Preizkusi so bili narejeni z enako postavitvijo testa ter protokolom obremenjevanja kot pri preizkušanju neutrjenih zidov. Prav tako so bile deformacije merjene z 12 uporovnimi merilniki, razen pri testu neutrjenega zidu, kjer je zaradi nepredvidljivega obnašanja bilo nameščenih manj merilcev, pa še ti so bili tekom testa preventivno odstranjeni.
