Determining compactness of the quality of natural stone blocks with ultrasonic technic

Andrej Kos¹, Jože Kortnik^{2,*}

¹Marmor Sežana d.d., Partizanska cesta 73a, 6210 Sežana

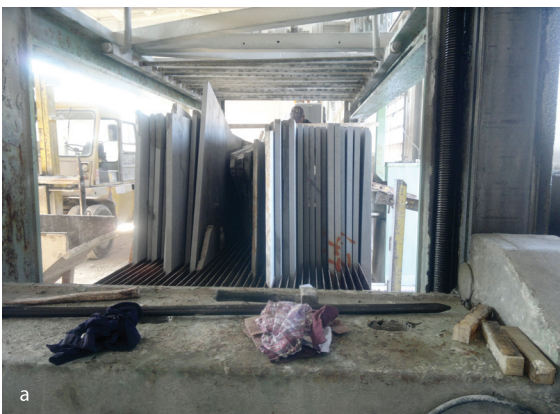
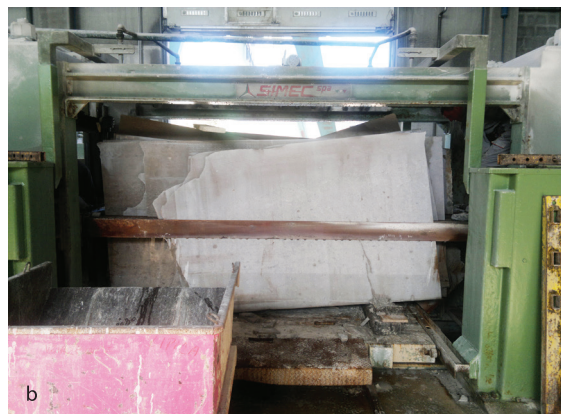
Figure 2: Opening of slabs on a gang saw.

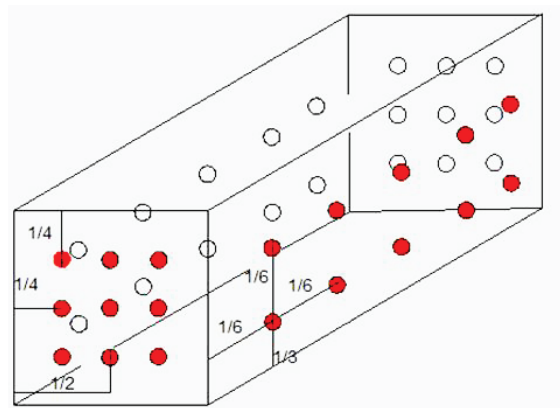
Figure 3: Setting up profiles of ultrasonic measurement on natural stone block.

Profiles for measuring the block were determined by width in three lines, namely at $1/6$ of the distance of width and height; lengthwise in two lines at an interval of $1/6$ of the length, and heightwise in two lines at an interval of $1/3$ of the height. Density of the profiles depends on the dimensions of the blocks and on the results of the measurements. In the event that there are significant deviations, the profiles must be condensed. On the basis of the profiles' density, it is possible to follow a crack, which is located in the block.

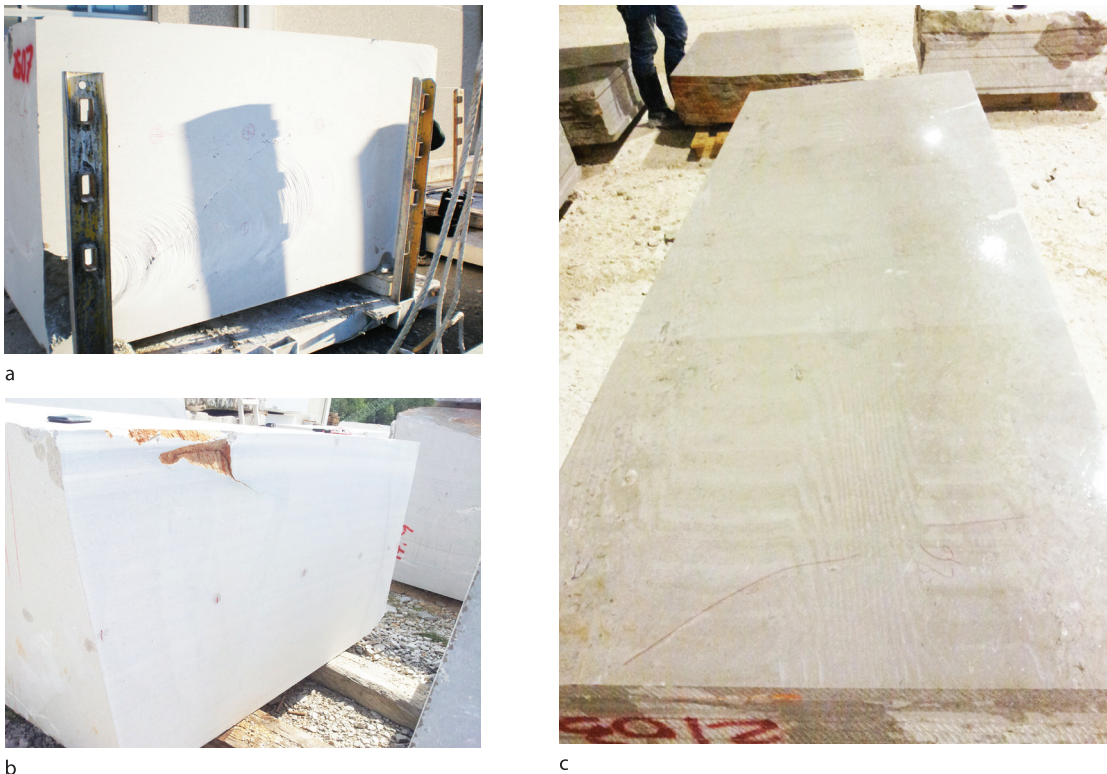
Block in Figure 5 was characterized by an average speed of sound pressure of 4.572 km/s. 24 profiles were measured. Measurements were carried out both with the probe and with a hammer. Both measurements gave similar results. The block is composed of three pieces that are 45 cm thick, meaning we are dealing with a composed block. The speed was very low for a limestone, but we cut the block in panels 4 cm thick. The surfaces between smaller blocks were filled with polyester resin. Therefore, the block did not open during multi-blade sawing.

Figure 5: Measurement of the composed block (a, b) and review of the panels after cutting the block (c).

The measurements were carried out on blocks of large dimensions. Thus, we tested the real possibility of using this method on blocks of natural stone - limestone. The figure below shows the placement of measuring profiles on a glued block and an overview of obtained panels, as well as a comparison with the results of measurements on the block from which the panels were cut.
