HIGH SAFETY PILLARS STABILITY CONTROL USING EL BEAM DISPLACEMENT SENSORS IN LIPICA II QUARRY

JOŽE KORTNIK, SUNNY O. NWAUBANI and ANDREJ KOS

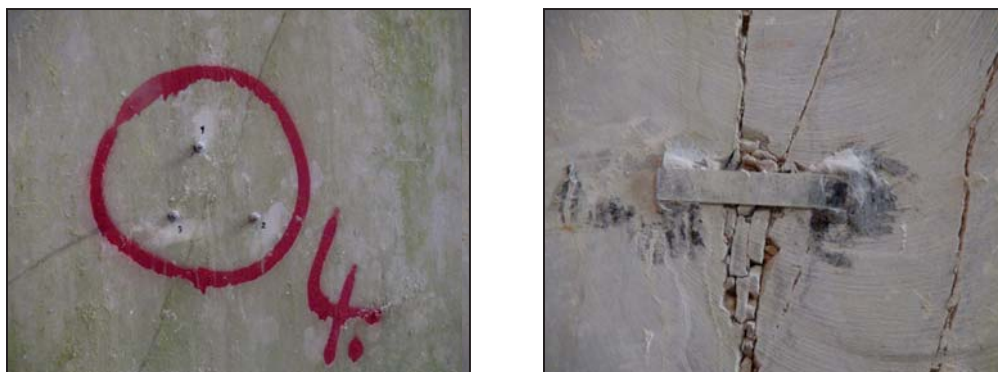
Figure 1. 3 screw open fissures displacement meter (left) and glass fissures displacement meter/seal (right) for visual monitoring of underground structures stability in Lipica II. quarry.

Purpose of the study presented in this article is to observe the movement of the rock wedges and the impact on the stability of high safety pillars. Additional several 3 screws open fissure displacement meters, cement and glass seals (Figure 1.) were used for visual monitoring the rock deformations in the Lipica II. quarry.

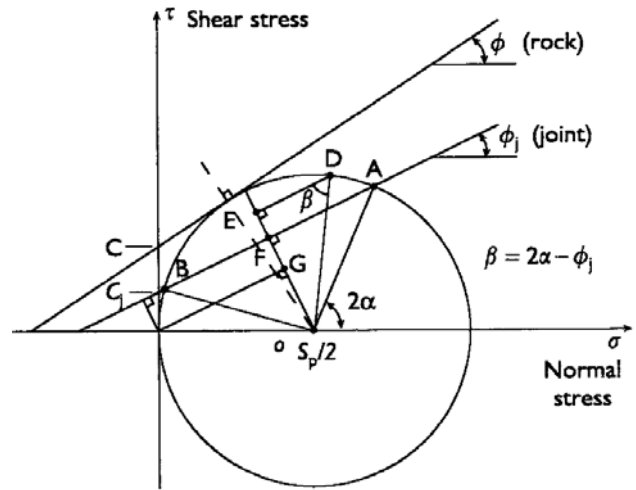
A graphical interpretation of this criterion is shown in Figure 3 that contains Mohr-Coulomb failure criteria for pillar and joint and the Mohr circle that represents the stress state in the pillar. Figure 3 shows that in the range \$(\alpha_A, \alpha_B)\$ joint slip is possible. This range increases with pillar stress and is maximum when the pillar stress equals pillar unconfined compressive strength, as shown in Figure 3 where the Mohr circle just touches the pillar strength line. Formal solution requires finding the inverse sine of the function containing \$\alpha\$ in the slip condition. There are actually four solutions because there is symmetry to the problem. This symmetry is graphically represented in the lower half of Mohr's circle where shear stresses and (strengths) are negative. Physi-

Figure 3. Pillar in a flat seam with a joint [11].

cally, there is symmetry of dangerous and safe dips about the vertical load axis. Near vertical and near horizontal joints will be safe as one would intuitively suppose [11].

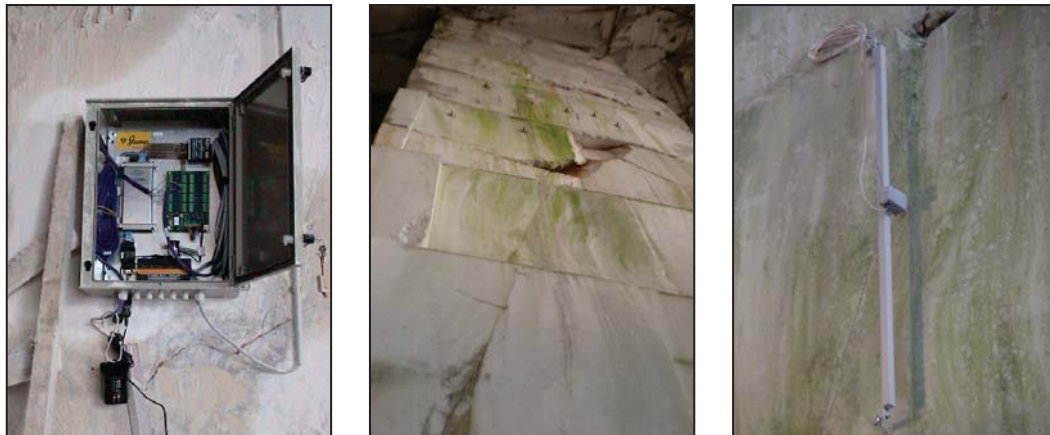
Figure 7. Datalogger (left) with vertical EL beam gauge (right) installation on the high safety pillar VS3 stabilized with anchors (middle) in Lipica II. quarry.

In Lipica II. quarry EL beam meter manufacturer Slope Indicator is used to measure supervisory convergences in one vertical plane in high safety pillar VS03 (Figure 7). A bar gauge is installed through the cracks, so that there is one screw on the part of the anchor windlass for anchor, such as flexible wedge screw for stable work. From practical experience, the best indicators of developments are movements in pillar corners. Consequently, it was decided to monitor the developments on the safety pillar corner, where the sliding surfaces of the main crack are driving out.

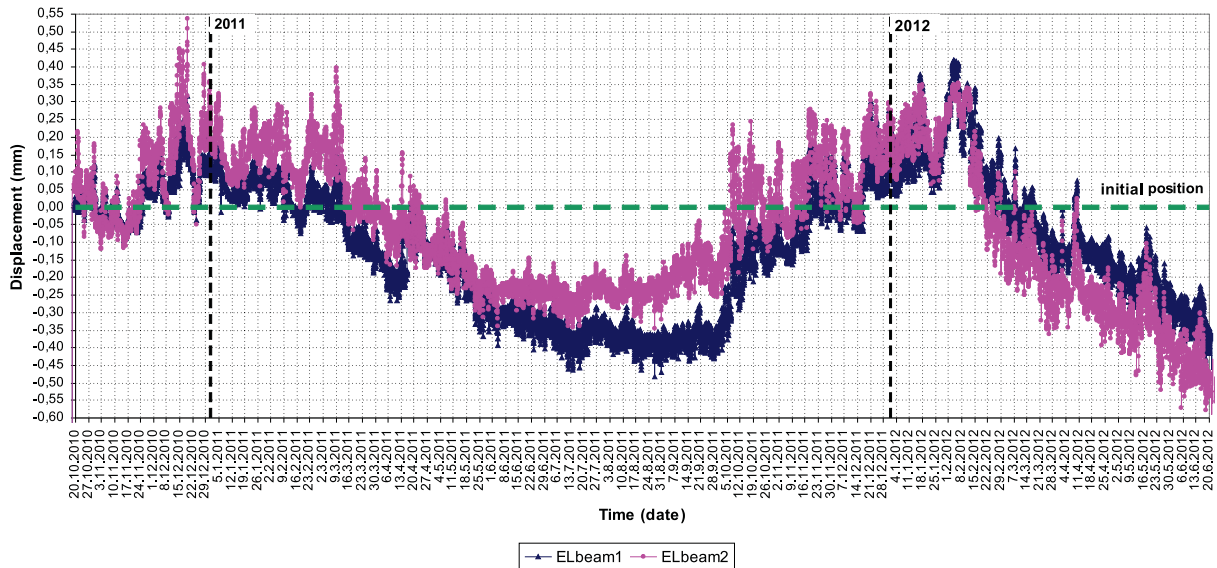
Figure 8. Diagram of the measured EL beam1 and EL beam 2 true deflections/movements in mm in the time period October 2010/June 2012.

In the time period October 2010/June 2012 absolute max. measured deviation was $D_1=0.9$ mm and $D_2=1.1$

mm (see Table 3. and Figure 8.), which does not threaten the stability of the heigh safety pillar VS3. EL beam gauges have so far proved to be a reliable tool for high safety pillar stability monitoring.

As already mentioned the heating and cooling of air in underground structures leads to expansion and contraction of metal rods. Therefore, the data processing involves use of correction factor for metal rods. From Figure 8, we can see that in the summer times, the EL beam rod stretches but in the winter time the EL beam rod shrinks. The metal rod, on which there is displacement meter was observed to be sensitive to changes in temperature, which occurs in the underground extraction during the winter/summer and may be relatively large (ΔT of air in period from 2010/2011 winter -6.4°C / summer 22.3°C).
