FLOODING IN THE AREA OF KNEŽAK, BAČ AND KORITNICE IN NOVEMBER 2000

Flooding in the area of Knežak, Bač and Koritnice in November 2000

ABSTRACT: In November 2000 a flood occurred in karst polje between the settlements Bač, Knežak and Koritnice in the municipality of Ilirska Bistrica. The continuous surface of the flood extended to 59 hectares. The flood mostly affected Bač, where 23 residential and some other buildings, an industrial facility and road infrastructure suffered damage.

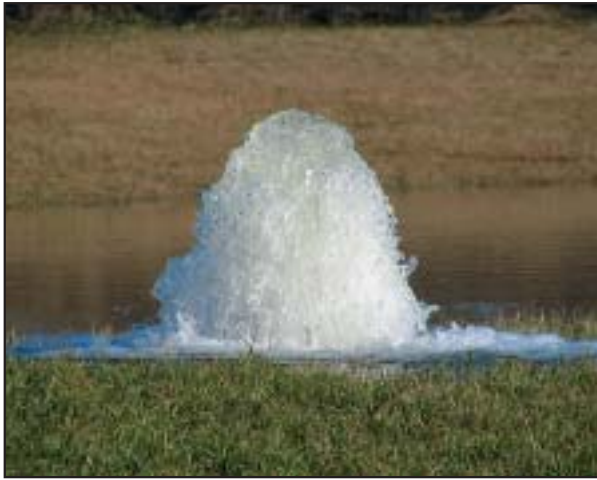
Karst groundwater erupting from a borehole in the vicinity of Bač indicates that the water table on Upper Pivka lies rather close to the surface, which causes flooding during extreme high waters (photography: Gregor Kovačič, 30. 12. 2004). Bruhanje kraške podtalnice iz vrtnice v bližini Bača kaže, da leži gladina podtalnice na Zgornji Pivki blizu površja, kar povzroča v času ekstremno visokih voda poplave (fotografija: Gregor Kovačič, 30. 12. 2004).

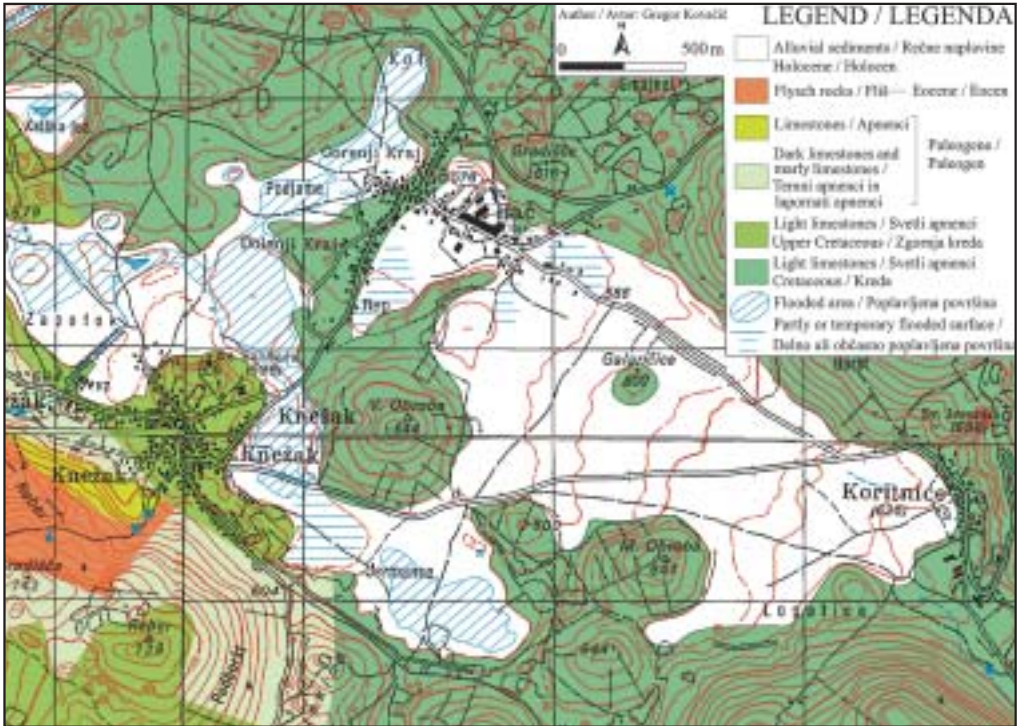
Geological structure of the discussed area is shown on figure 1. With the exception of a small area situated west from Knežak, where flysch rocks outcrop to the surface in a tectonic window (Pleničar 1959), the margins of the depression between the settlements Bač, Knežak and Koritnice and the hills within its flatted bottom are built mostly of medium to well permeable Cretaceous and Paleogene limestones, characterised by karstic and karst-fissured porosity (Šikić et al. 1972; Šikić and Pleničar 1975; Krivic et al. 1983).

Flooding area between the settlements Bač, Knežak and Koritnice is covered with unconsolidated rubble and gravel-like clastic sediments, which are the product of Pleistocene torrents processes, when a great

Figure 1: Geological map of the area around Bač, Knežak and Koritnice and the extent of the flood in November 2000.

In November 2000, in the discussed flooding area karst groundwater table rose for 20–35 m. First of all, waters appeared on the fields in the vicinity of Knežak, where they regularly occur during long-lasting raining periods, but in a much lesser extent. Later water began to stagnate also on other areas, where until the year 2000 floods had never been recorded before. Flooded surface was not concluded, therefore the water levels of the individual closed flooded parts reached different elevations (Figure 1 and 2). The water

It is necessary to construct a flood-prone area map of the karst depression between Koritnice, Bač and Knežak, where the mapped flooding areas marked on the figures 1 and 2 should be classified as potentially flood-threatened areas. In these areas the construction of new buildings should be restricted, although the return period of the extremely high waters is very long.

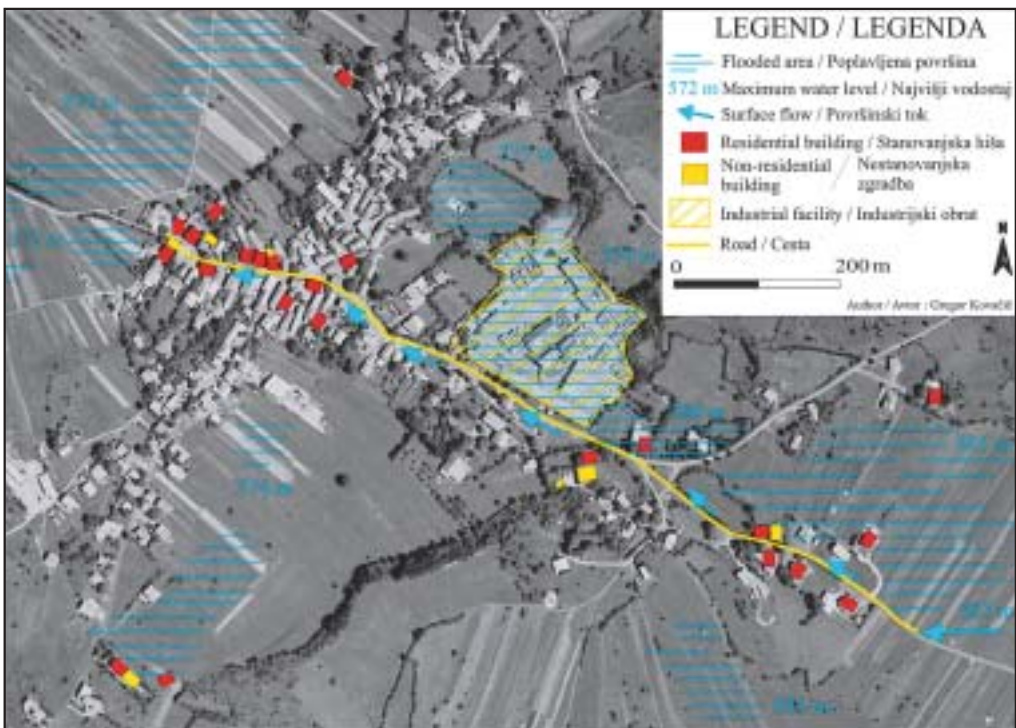
Figure 2: The level of flooding and the damage reported in the settlement Bač in November 2000 (Register of House Numbers 1999; Digital orthographic photographs 2000; Arhiv 2001).

reached its highest level in the area of Dolge njive (576.5 m asl), southeast from Knežak. At its maximum, a flooded surface extended to 13.2 hectares and did not exceed the depth of 3 m, the volume of the water amounted to 157,600 m³. North from the flooded area water inundated a small doline (0.1 hectares). The largest concluded flooded area with the surface of 46 hectares (Habič 2005) extended in three branches in the concave surface between Knežak and Bač, the water level of this inundated area reached the elevation of 571 m asl.

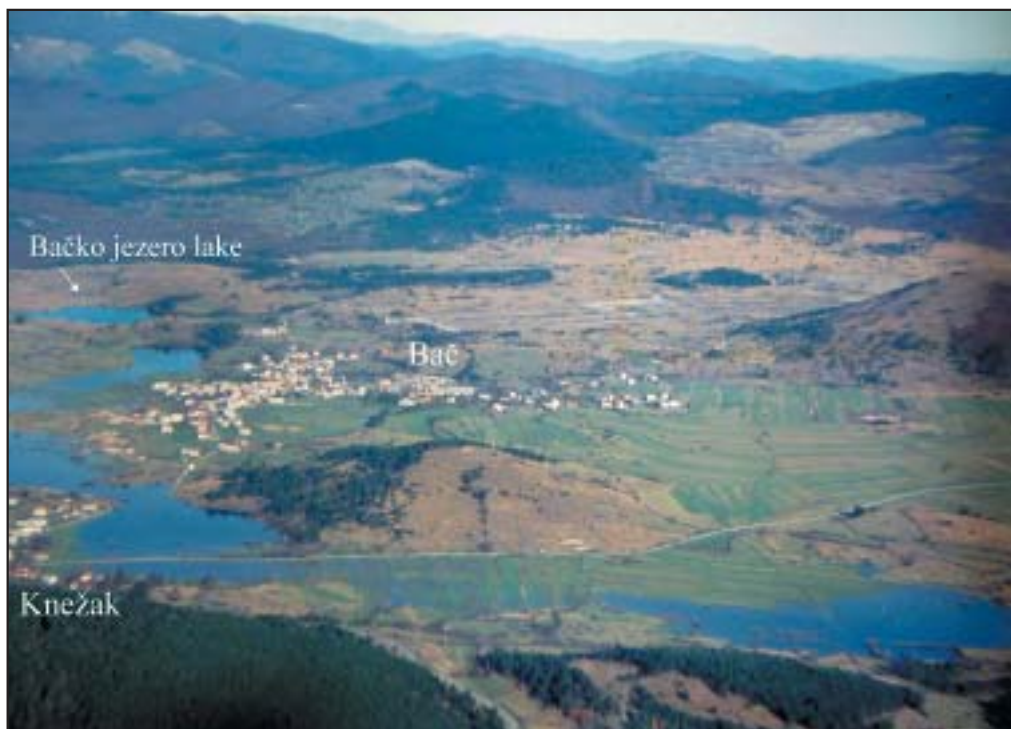
Figure 3: Floods around Knežak and Bač in November 2000 (photography Špela Habič, 29. 11. 2000).

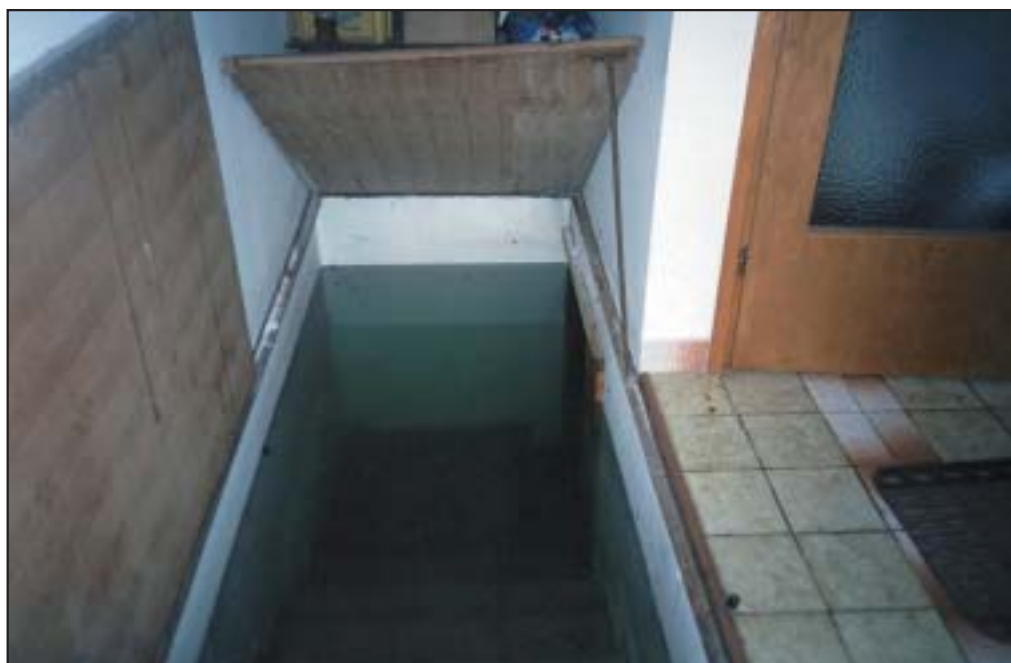
According to the data from the Local administration for civil protection of the Municipality Ilirska Bistrica (Arhiv 2001), the flood damage of high waters was reported only in the settlement Bač, which lies on the lowest elevation among the all three settlements of the discussed area. Regarding the data of reported damage, flood affected 23 residential buildings and 7 other buildings (stables, woodsheds, workshops). All together 15% of all residential buildings in the settlement suffered flood damage. First cellars in Bač were flooded by the rising groundwater already on November 9 2000, in a greater extent on November 14 2000, when the water entered the majority of the cellars in the village. The water table reached the highest elevation on the eastern part of Bač, where cellars were flooded up to the ceilings and so the damage occurred also in the ground floors of the residential buildings (Figure 4). Here the flood height reached an elevation of 580 m asl. In other parts of the settlement the water flooded cellars to various heights (30–100 cm). Local people managed to retain low water levels in their cellars with the usage of water pumps, which were operating uninterruptedly.

Figure 4: Flooded cellar in the residential house on the eastern part of Bač (Arhiv 2001).

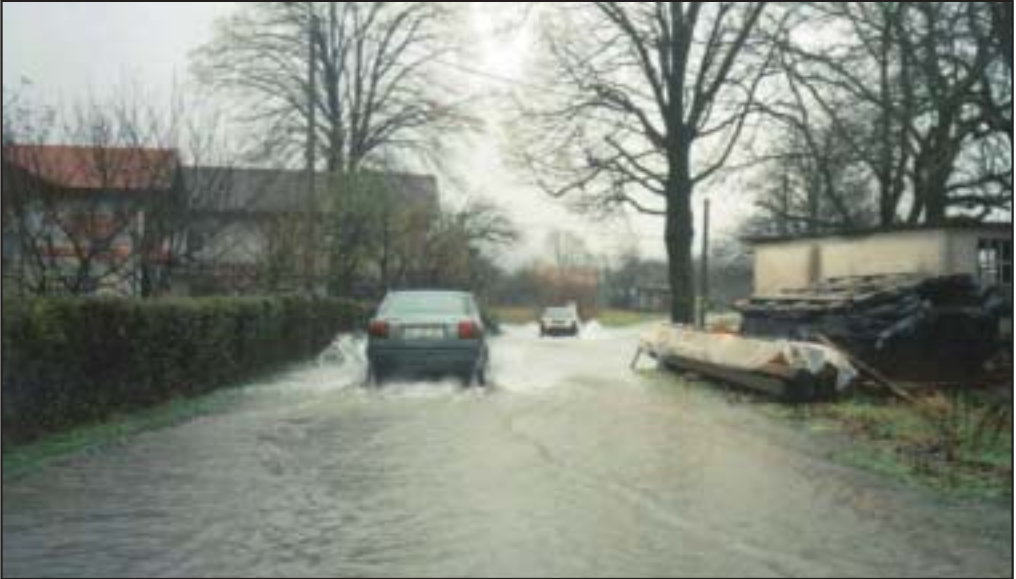
Beside the increased water table of groundwater, a surface stream, which had activated in the dry bed of the former Pivka river between Koritnice and Bač, additionally intensified the effect of the flood. At the eastern part of the settlement water was directly flowing to the village, and the road through the settle-

Figure 5: Surface flow through the settlement Bač in November 2000 (Arhiv 2001).

ment transformed into some kind of a riverbed in the length of a few 100 m (Figure 5). Underground sewers of meteor waters, built along the main road through the settlement, changed into the system of small ponors and boiling streams. In some of the sewers' shafts water was sinking, while in the others was again springing out to the surface. An industrial facility of *Javor stolarna* company also suffered flood damage.

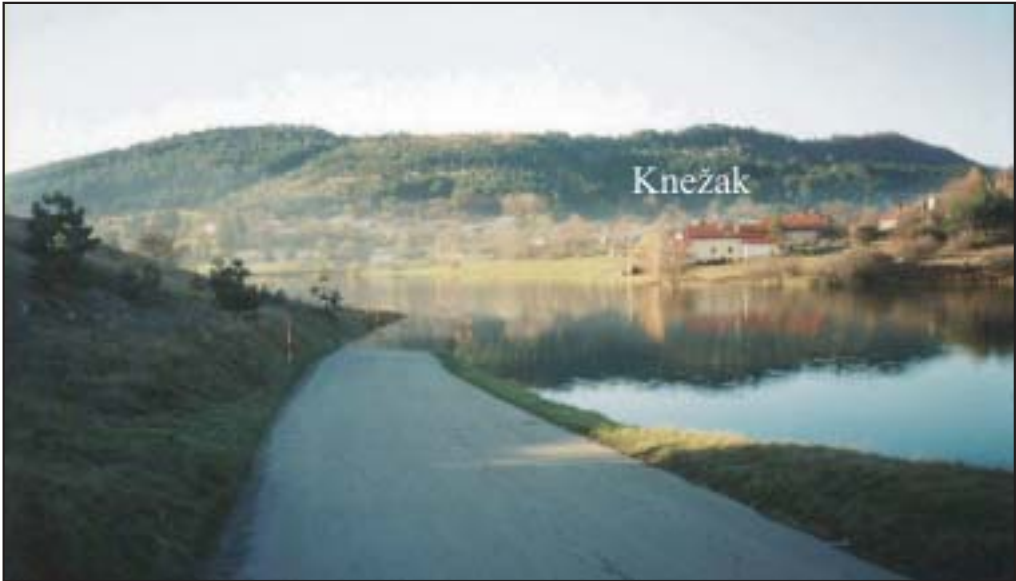
Heavy rains with the flood caused the biggest damage on road infrastructure. The main road through Bač suffered the most serious damage. Due to the continual inflowing of surface stream and clogged sewer of meteor waters in the settlement, the roadway was damaged. Flooded roadway hindered the traffic in the direction from Bač to Koritnice. A few days in November, when a part of Bač named Rep was flooded, a ditch was dug through the road connecting Knežak and Bač in order to faster drainage of the water towards the west. Due to the extensive flood the abovementioned road was impassable for several days in November (Figure 6). Several other cart tracks and field roads also suffered damage. The total estimated flood damage on the road infrastructure accounted to 30.748,000 SIT (Arhiv 2001).

Figure 6: Flooded road between Knežak and Bač (Arhiv 2001).
