Monitoring of high safety pillars stability in quarry Lipica II – EL beam displacement sensors

Merilni nadzor stabilnosti visokih varnostnih stebrov v kamnolomu Lipica II. – palični merilniki deformacij EL

Andrej Kos¹, Jože Kortnik^{2,*}

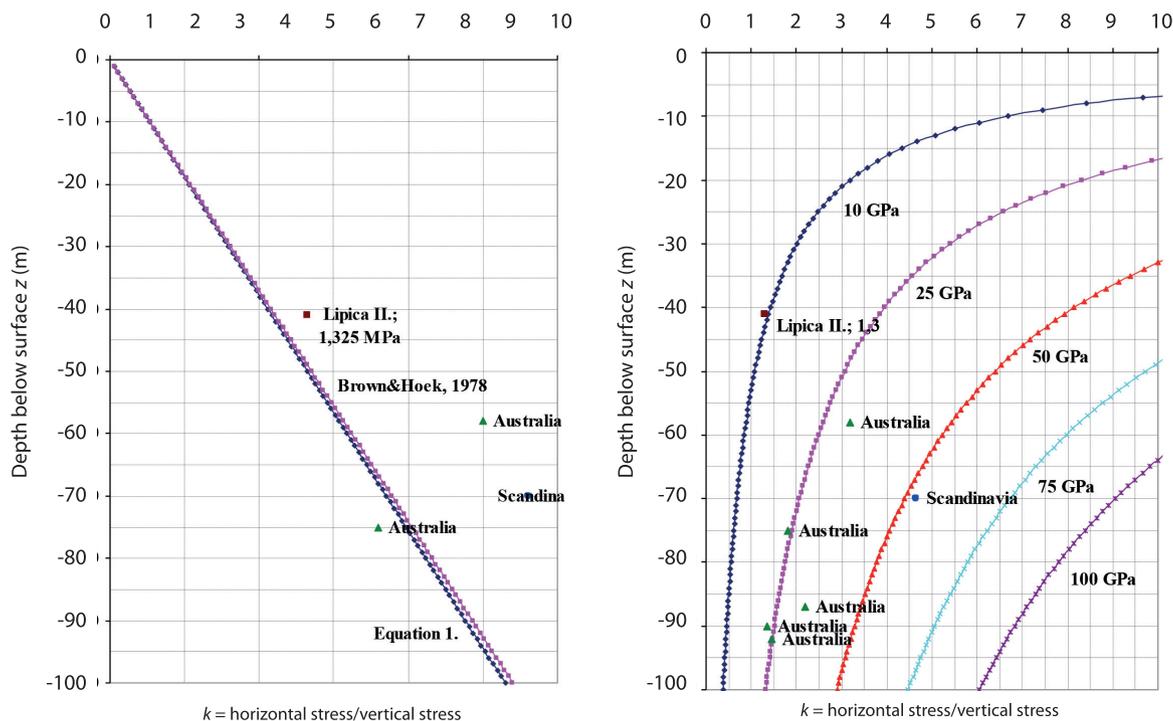
Figure 1: Ratio of horizontal to vertical stress for different deformation moduli base upon Sheorey's equation (Sheorey, 1994)^[12] (left) and calculated vertical stress (Brown and Hoek, 1978)^[1] (right) with measured parameters in the quarry Lipica II. and the world.

In-situ measurements of horizontal stresses at mining sites around the world show that the ratio k tends to be high at shallow depth and that it decreases at depth (Brown and Hoek, 1978, Herget, 1988)^[1,6]. Sheorey (1994)^[12] developed an elasto-static thermal stress model of the rock. This model considers curvature of the crust and variation of elastic constants, density and thermal expansion coefficients through the crust and mantle. A simplified equation which can be used for estimating the horizontal to vertical stress ratio k is (Figure 1, left):

Horizontal direction of the average deformation modulus measurement is important particularly in layered sedimentary rocks, in which the deformation modulus may be significantly different in different directions. A plot of this equation is given in Figure 1 for a range of deformation moduli. The curves relating k with depth below surface h are similar to those published by Brown and Hoek (1978)^[1], Herget (1988)^[6] and others for measured in situ stresses. Hence equation 3 is considered to provide a reasonable basis for estimating the value of k .

In Figure 1 (right), the vertical stress, σ_v is plotted against depth h , while Figure 1 (left) shows a plot of $k = \sigma_h / \sigma_v$ against depth h . Figure 1 (right) shows that measured vertical stresses generally follow the trend given by the simple relationship;

$$\sigma_v = 0,927 \cdot h \quad (4)$$

At shallow depths (0–100 m), there is considerable scatter in the observed values.

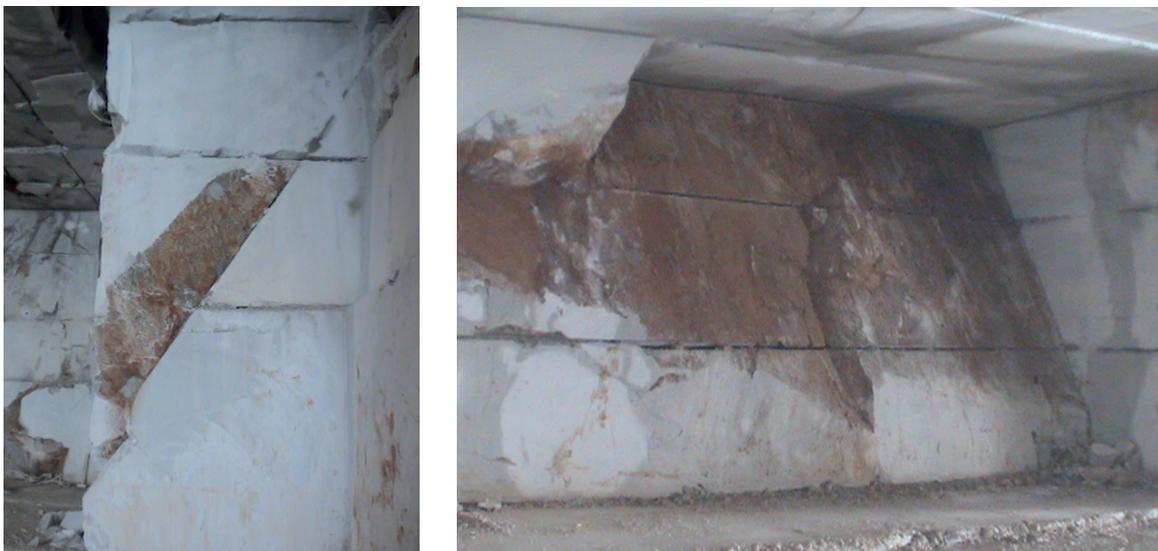
Figure 2: Open fissures in underground structures of quarry Lipica II.

Discontinuities (open cracks) appearing in the quarry Lipica II. have rough walls and in space variable dip, which is a favorable property regarding the stability of randomly generated wedges. Cracks are mostly empty or filled with heavy mouldable reddish-brown clay (Figure 2). The thickness of clay fillers varies from thin clay trash to few inches thick clay layer. Cracks walls are mostly lined with red calcite incrustation, which is also advantageous feature of the stability of cracks. In cases where cracks have no incrustation, they are wavy to the rough, which means that the unevenness of the cracks surface increases the shear strength of the cracks. Spacing between the cracks is 1–5 m.

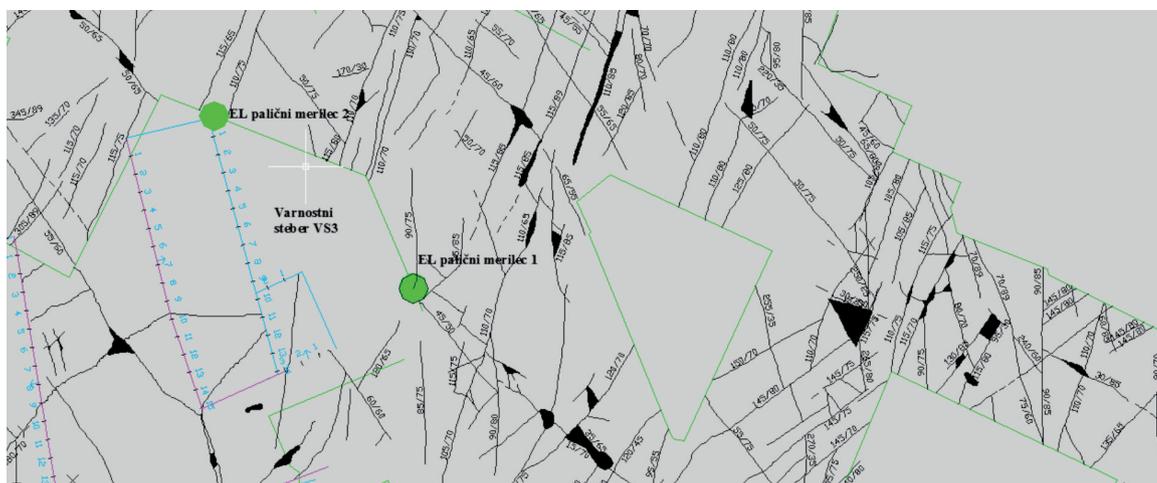
Figure 4: Map of the rock discontinuity orientations and locations (green circle) of EL beams gauges installations in quarry Lipica II^[11].

Two EL beams we have built in safety pillar (VS3) at level 359 on the open cracks, both located on the corners of the high safety pillar. Discontinuities with the direction 120°/60° and 110°/75° are open and filled with clay. Both discontinuities cross-cut the safety pillar. In the case of additional compressive load of safety pillar, there could appear a deformation and slip a stone wedge from safety pillar. For a Visual check on the safety pillar also installed a glass seals. Dangerous rock wedges on the security pillar are stabilized with anchors.

Figure 4. shows a map of the rock discontinuities apparing on sealing of underground structures and locations (green circle) of EL beams gauges instalations in quarry Lipica II.

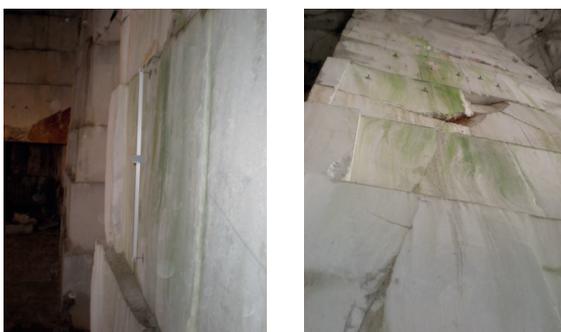
Figure 5: EL beam gauge on the high safety pillar VS3.

In quarry Lipica II. EL beam meter manufacturer Slope Indicator is used to measure supervisory convergences in one vertical plane in high safety pillar VS03 (Figure 5). A bar gauge is installed through the cracks, so that there is one screw on the part of the anchor windlass for anchor, such as flexible wedge screw for stable work.

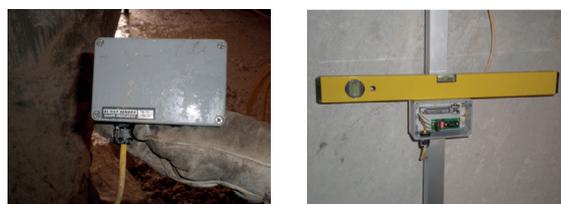
Figure 6: Vertical EL beam gauge installation on the high safety pillar VS3.

From Figure 6, we can see that in the summer time period El beam rod is stretching in the winter time period EL beam rod is shrinkage.

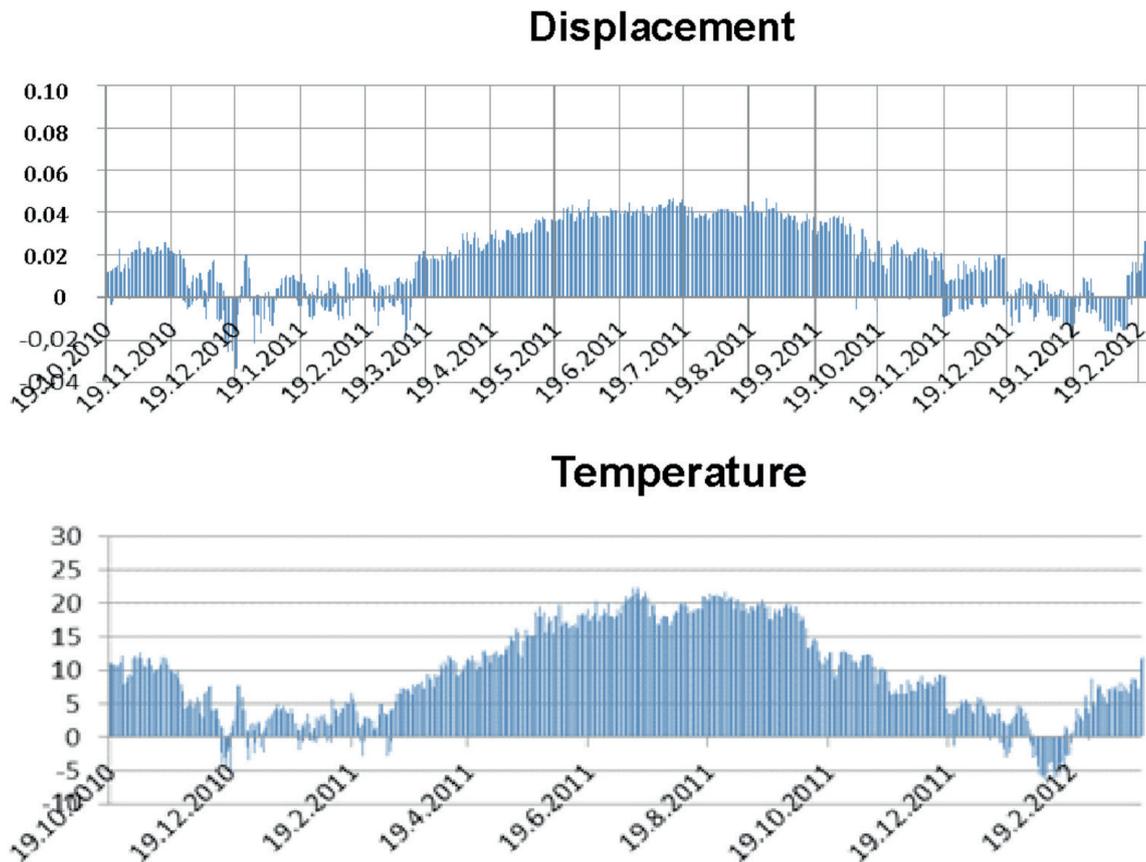
Figure 7: Diagram of the measured EL beam true deflections/movements in mm (above) and temperature in °C (below) in the time period October 2010/March 2012.

The metal rod, on which there is displacement meter is sensitive to changes in temperature, which may be in the underground extraction during the winter/summer relatively large ($\Delta T/^\circ\text{C}$ in period from 2004/2010 9.24 $^\circ\text{C}$ / 12.2 $^\circ\text{C}$ / 14.07 $^\circ\text{C}$ / 10.52 $^\circ\text{C}$ / 12.19 $^\circ\text{C}$ / 14.7 $^\circ\text{C}$ / 13.55 $^\circ\text{C}$). During heating and cooling of air in underground structures leads to expansion and contraction of metal rods. Therefore, the data processing necessary to consider correction factor of metal rods. In the time period October 2010/March 2012 absolute max. measured displacement was 0.08 mm, which does not threaten the stability of the high safety pillar VS3.
