SOIL LIQUEFACTION IN THE TONE RIVER BASIN DURING THE 2011 EARTHQUAKE OFF THE PACIFIC COAST OF TOHOKU

STANISLAV LENART, JUNICHI KOSEKI and YUKIKA MIYASHITA

A brief report about the liquefaction damage in the Tone river basin, caused by the 2011 earthquake off the Pacific coast of Tohoku, is presented. It includes sand boiling, damage to river dikes, the settlement and tilt of super-structures, the uplift of light underground structures and lateral spreading. A history of land reclamation along the Tone river is briefly presented to understand why extensive liquefaction took place predominantly in reclaimed land. The recorded ground motions near the river were analyzed

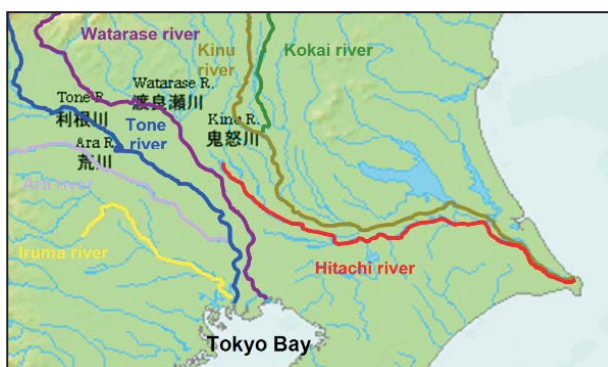
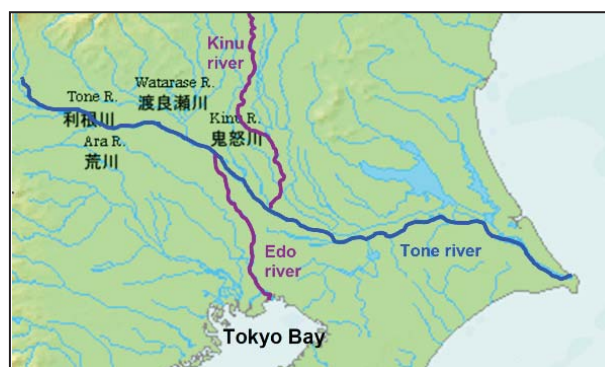
Figure 1. Eastward diversion of Tone river (modified from [2]): original course (left) and diverted course (right).

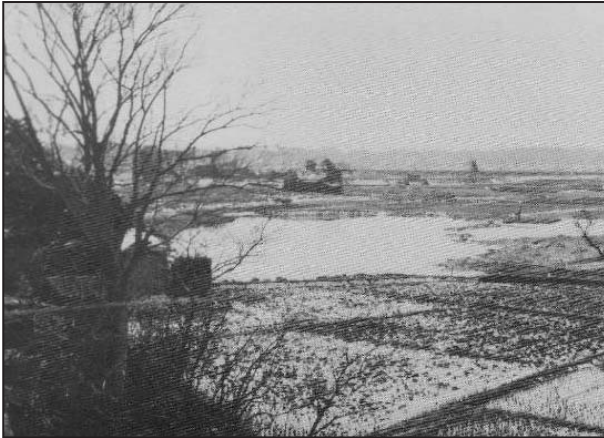
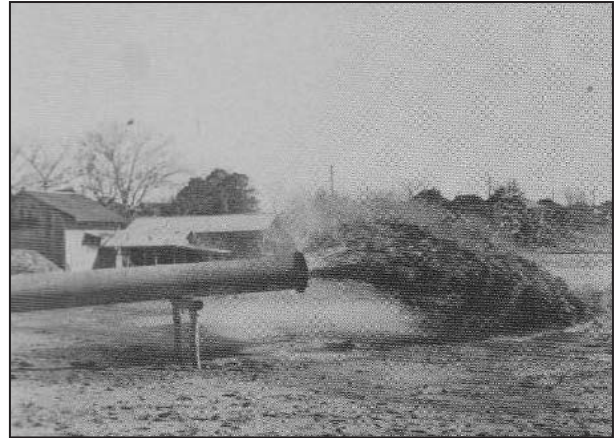
Figure 2. "Kirisho-numa" swamp (left) and its reclamation using dredged soils (right) [3].

One of the floods caused the breaching of the Tone river dike near Fusa, Abiko city in Chiba prefecture in 1870 [2]. The embankment for controlling the waters of the river collapsed over a length of more than 80 m and submerged the whole Fusa area. A large swamp called "Kirisho-numa" with an area of more than 5 ha was created. This area suffered from frequent flood disasters. Therefore, a project to improve the Tone river channel and the dike was initiated in 1952. The dredged soil was transported through pipes to reclaim the swamp. Finally, the reclaimed area was converted into a residential area. The "Kirisho-numa" swamp and the process of its reclamation using dredged soils are shown in Fig. 2.

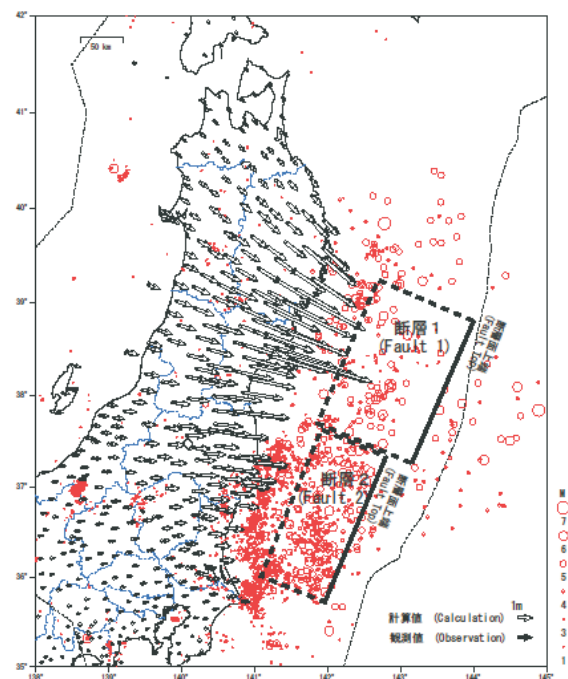
Fig. 3 shows the surface displacements caused by the main shock. A star indicates the epicenter of an earthquake. Two rectangular faults were assumed. The circles indicate the epicenters of the aftershocks determined until the 15th of March. There have been 408 aftershocks

Figure 3. Calculated and observed co-seismic horizontal surface displacements [4].

Miyagi prefecture. One should refer to Fig. 3, where the assumed faults are shown. A similar distance to rupture is evident for both locations.

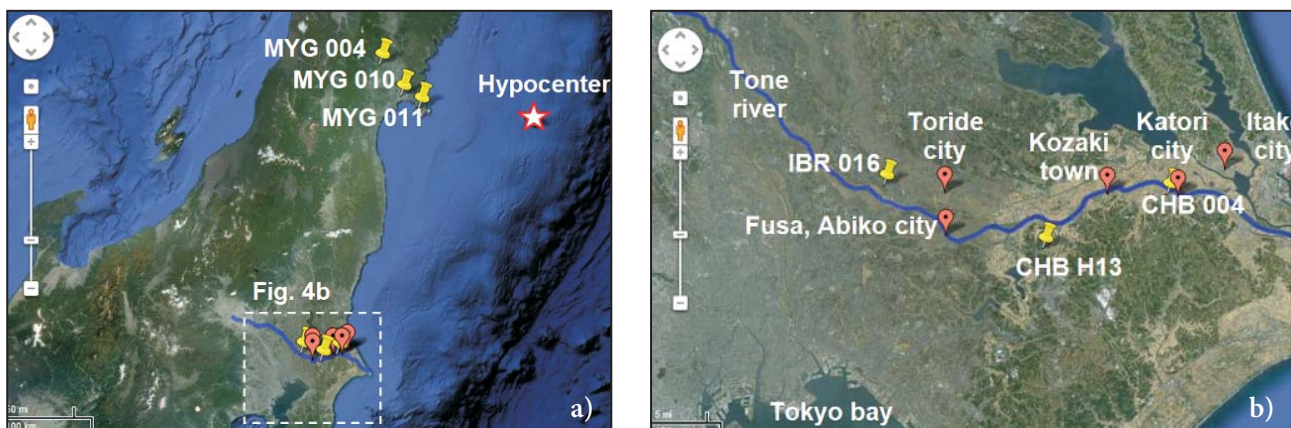
Although the damage due to the great Tohoku earthquake occurred at many places on the east part of Honshu island, only five typical sites with liquefaction occurrence in the Tone river basin are presented in this paper. Their locations are shown in Fig. 4b. Fig. 4a presents the overall location of the earthquake's hypocenter, the Tone river basin and the seismographs, the records of which are discussed in this paper.

Figure 4. Map of the sites discussed in the paper (a) and their detailed locations (b) along the Tone river (modified from <http://maps.google.com>).

nation-wide, strong-motion seismograph network. They are all installed on the ground surface. Seismograph CHBH13 is part of KiK-net, a Japanese, strong-motion, seismograph network, which consists of pairs of seismographs installed in a borehole as well as on the ground surface. Basic data about these seismographs are listed in Table 1. Their location is shown in Fig. 4a and Fig. 4b.

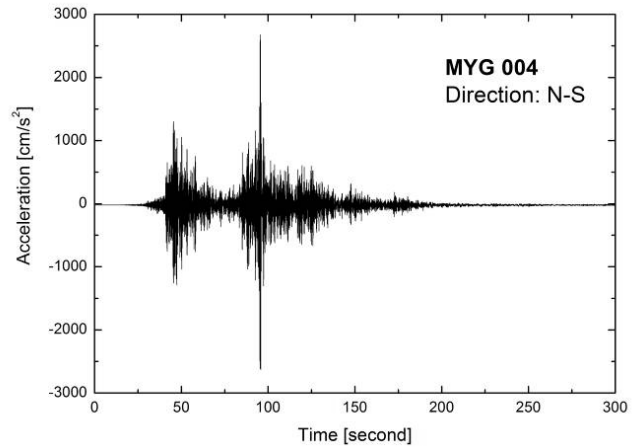
duration. If this spike is eliminated the maximum PGA of this record is reduced by more than half.

Figure 5. Ground-motion record with the largest observed peak ground acceleration $PGA=2699.9 \text{ cm/s}^2$ during to the 2011 earthquake off the Pacific coast of Tohoku, K-NET seismograph MYG 004.

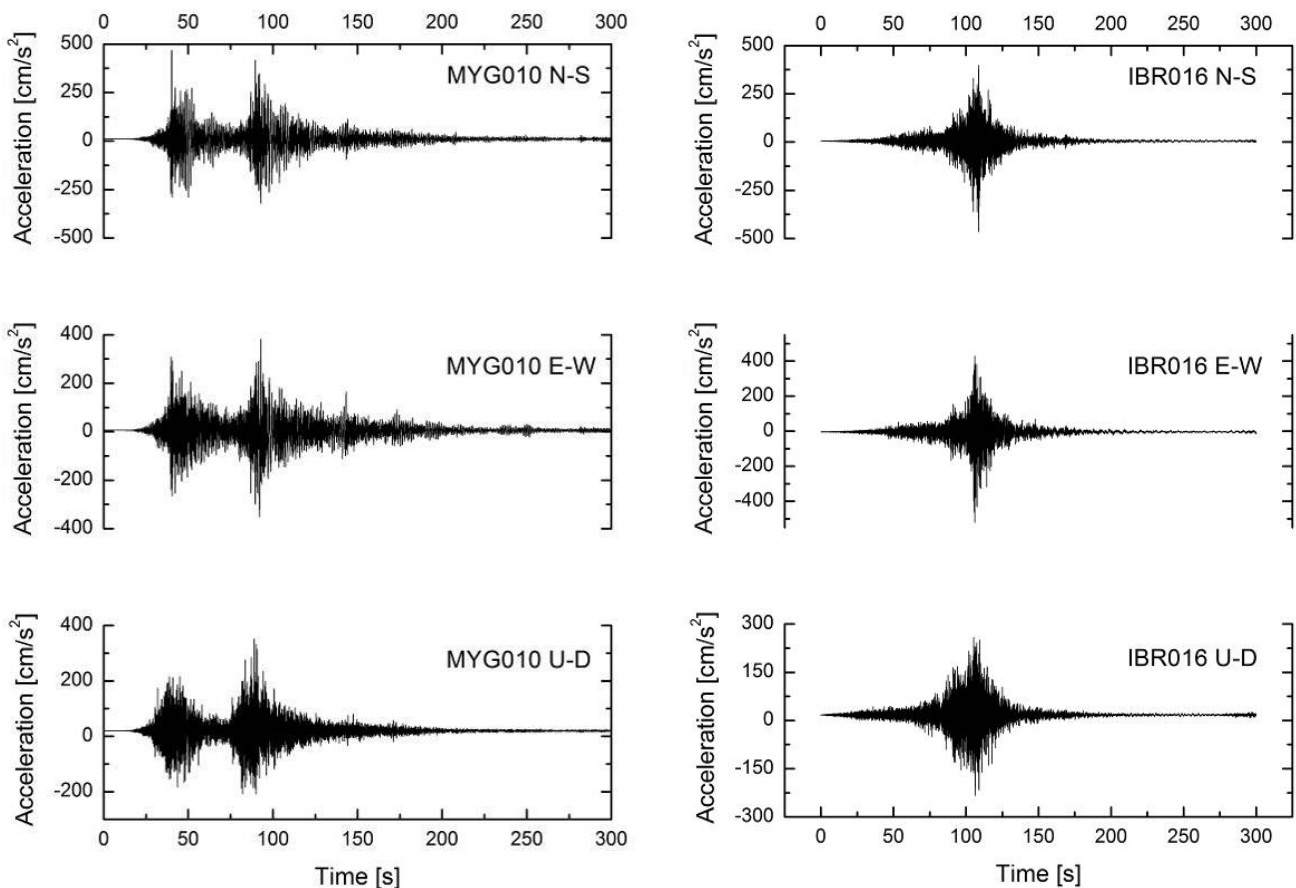
Figure 6. Ground-acceleration records at (left) the near-source K-NET seismograph (MYG 010) and (right) the K-NET seismograph near the Tone river (IBR 016).

The existence of two faults might be proved by the near-source acceleration waveforms. Two remarkable distinct phases of ground motion can be seen on the earthquake ground-motion records from seismographs in the north part of Honshu island [6], which are the closest to the epicenter, while on the acceleration waveforms recorded in the south, in the Tone river basin, the first phase is not visible at all (Fig. 6).

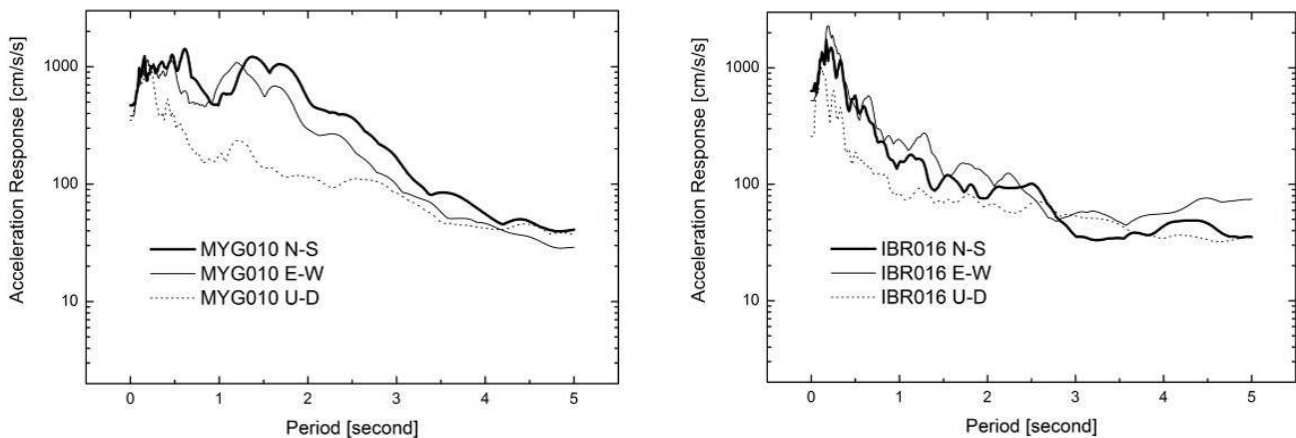
Spectral analyses of the ground acceleration records are shown in Fig. 7. It is clear that the dominant period ranges up to 2 s at the near-source sites in Miyagi prefecture, while the dominant frequency increases up to a period of nearly 0.2 s at sites near the Tone river.

Figure 7. Spectral analysis of ground-motion data (5% damping) at (left) the near-source K-NET seismograph (MYG 010) and (right) the K-NET seismograph near the Tone river (IBR 016).

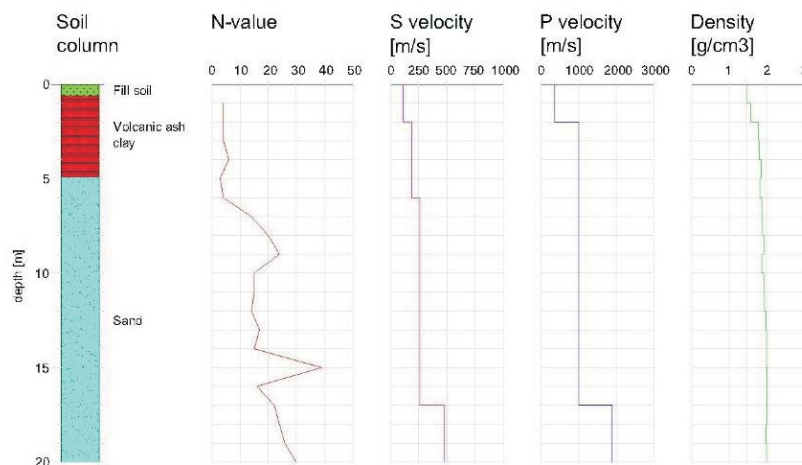
are similar, consisting of sand or sandy soil covered by volcanic ash clay (Fig. 8). Considering the high level of ground water, as the Tone river is near, these ground conditions combined with a large number of load cycles are sufficient for triggering the liquefaction.

Figure 8. Typical shallow (20 m) soil profile along the Tone river, K-NET station IBR 016 (data from [7]).

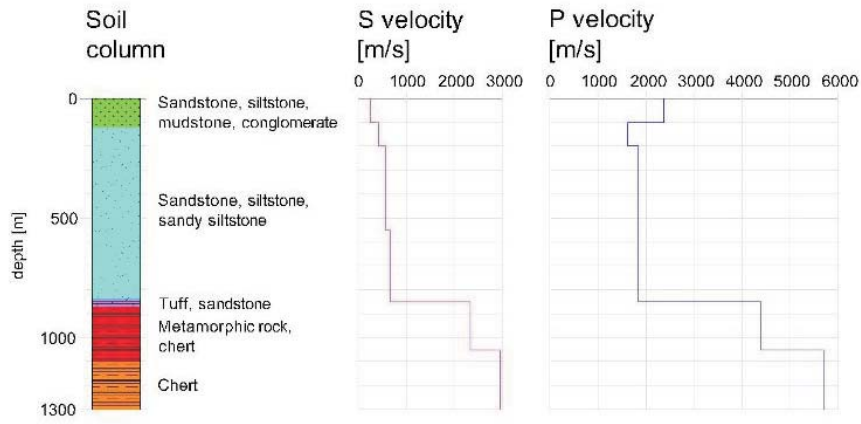
The seismograph CHBH13 is part of the KiK-net network, and the motion records at the surface and at the bedrock (1300 m deep) are available. Soil profile from deep borehole of seismograph CHBH13 is presented in Fig. 9, while Fig. 10 shows the effect of surface alluvium layers on the wave propagation. A clear amplification of the acceleration in the top soft soil layers can be seen. Results of spectral analysis of ground motion records at bedrock and surface are compared on Fig. 11. Besides the amplification, one can observe that surface record results dominant period close to 0.2 s which is very similar to those obtained in other locations near Tone river (Fig. 7), while slightly smaller dominant period ranges of nearly 0.1 s is achieved at the bedrock.

Figure 9. Soil profile from the deep borehole (1300 m) at the KiK-net station CHB H13 (data from [7]).

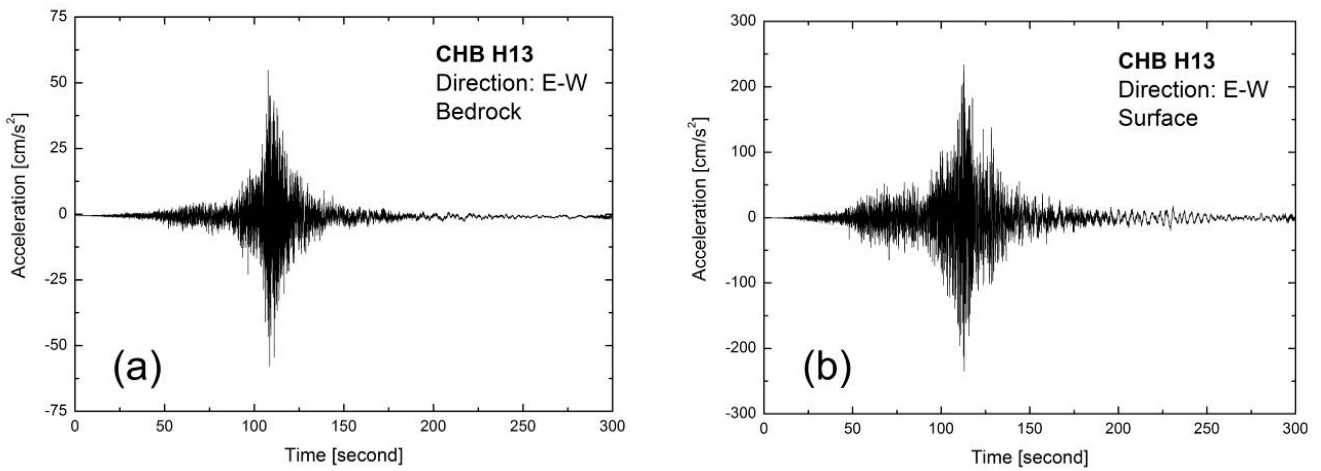
Figure 10. Amplification of ground motion as evidenced from (a) ground motion recorded at the bedrock and (b) ground motion recorded at the surface at CHB H13 location (KiK-net).

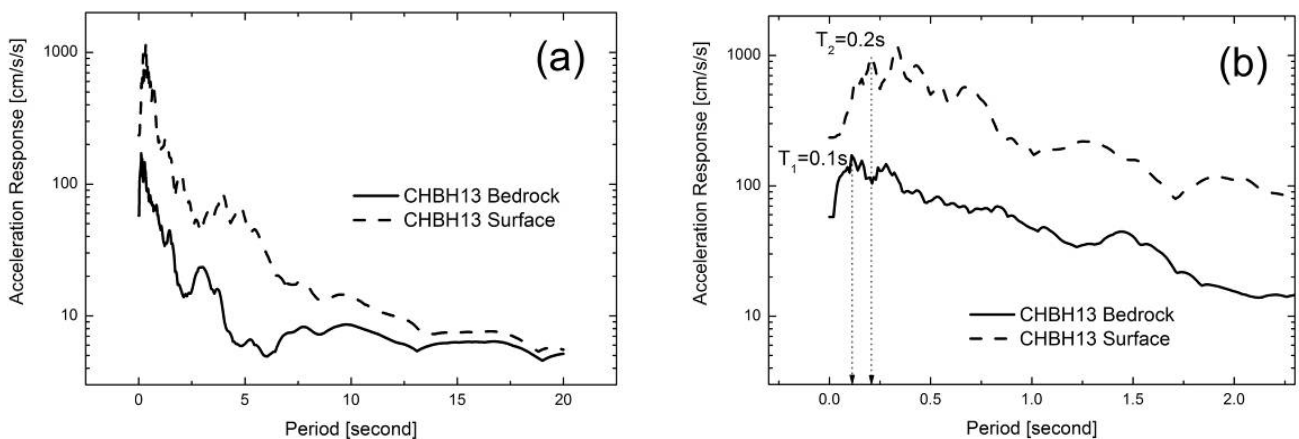
Figure 10. Comparison of the spectral analysis of ground motion data (5% damping) recorded at bedrock and surface at CHB H13 location: (a) overall and (b) close look (KiK-net).

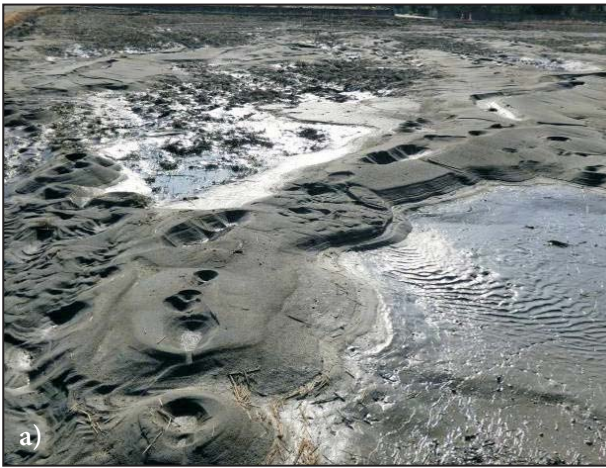
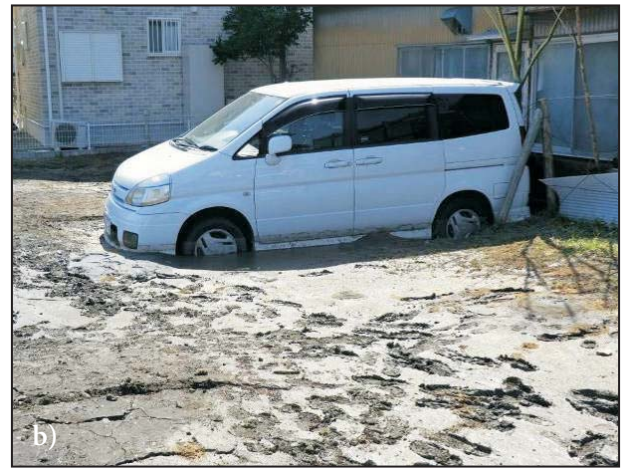
channels are formed to dissipate the seismically induced, excess pore-water pressure. The water velocity was sufficient in cases presented in Fig. 12 to carry fine sand to silt soil particles to the surface. The gradation curves of the samples from several locations of sand boiling are presented in Fig. 18.

Figure 12. Extensive sand boiling (a) at the rice field in Toride city and (b) between residential houses in Abiko city.

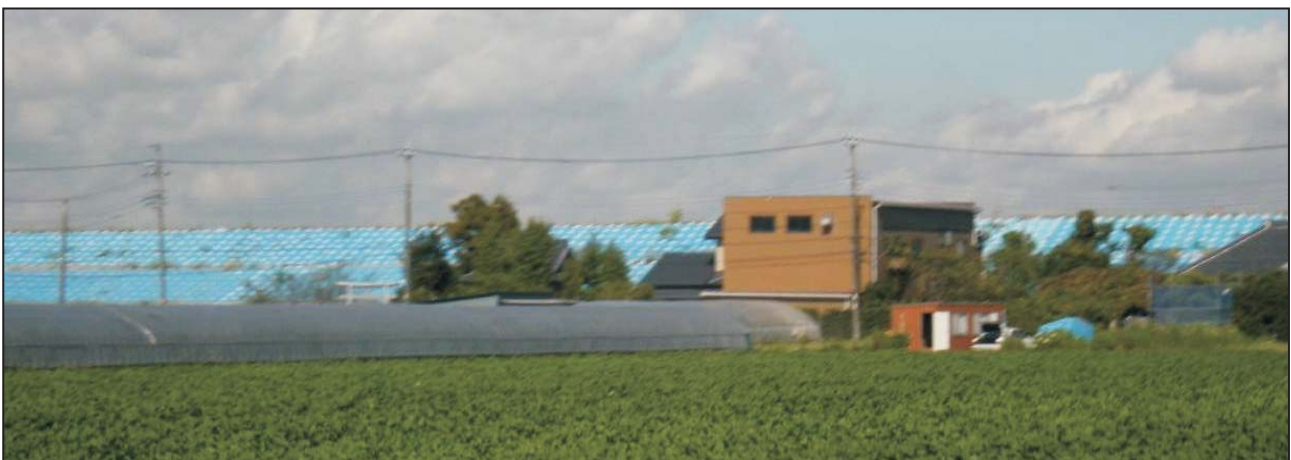
The settlement and cracking of the Tone river dike occurred at many places, mostly due to the shear failure of the slope itself or the liquefaction of subsoil layers and/or a submerged part of the dike itself. The damaged dikes were temporarily rehabilitated against possible high water and protected against rainfall infiltration (Fig. 13).

Figure 13. Extensive protection of the damaged Tone river dike (Sakae town) against rainfall.

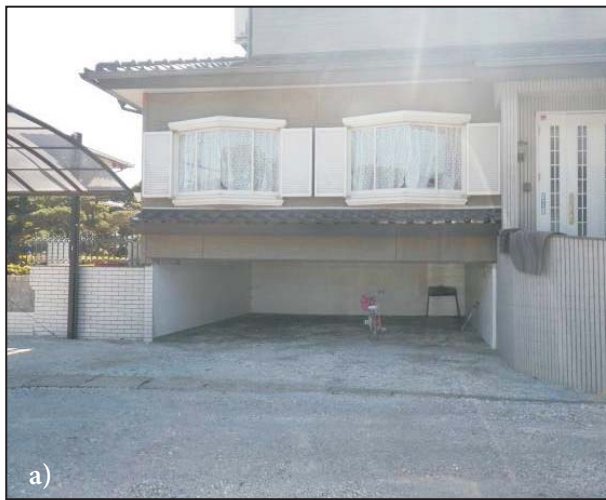
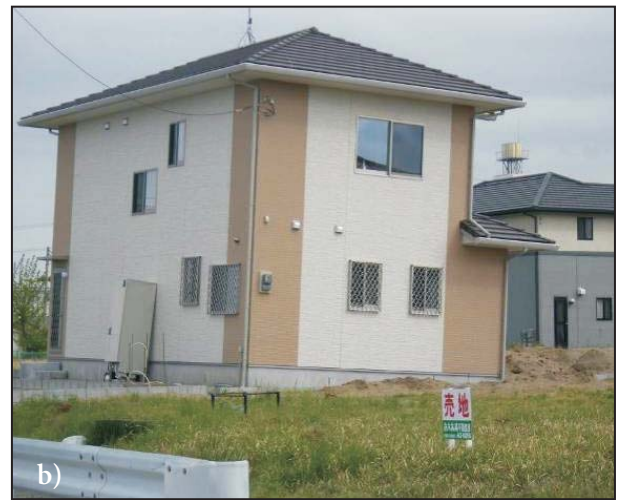
Liquefaction-induced ground-surface settlements are caused by the volumetric strain that develops as a consequence of sand boiling and the re-consolidation of the liquefied soil layers. As superstructures with shallow foundations are often of asymmetric self-weight or subsoil conditions are not perfectly uniform, settlements might be accompanied by tilt (Fig. 14b). The average range of settlements noticed at the described sites was between 10 and 30 cm, but might be up to 1 m in some extreme cases (Fig. 14a).

Figure 14. Residential houses in Itako city settled (a) evenly or (b) with tilting.

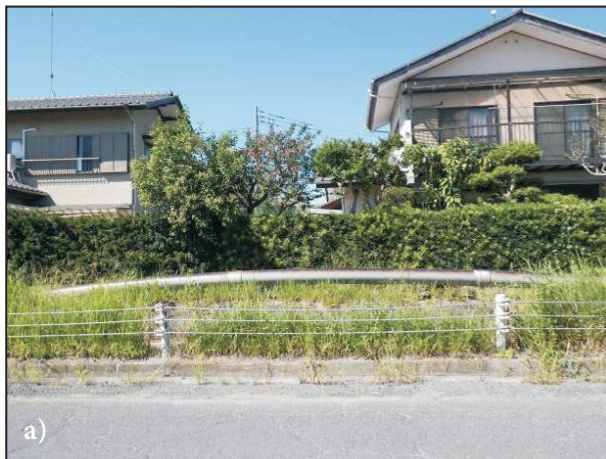
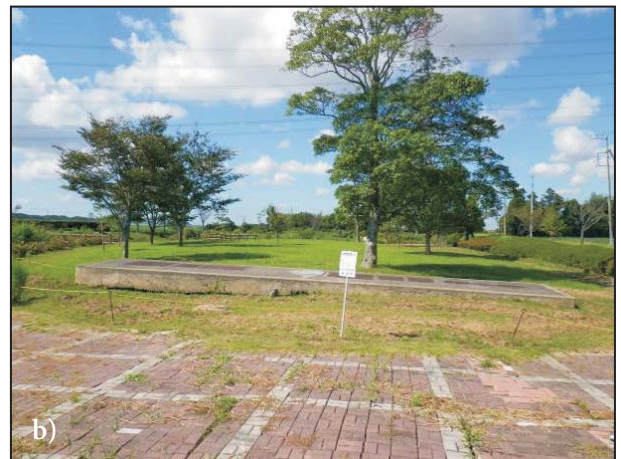
Many manholes, sewerage pipelines and other underground structures with small self-weight were popped out of the ground due to the upward buoyancy force generated by the liquefaction of the surrounding soil (Fig. 15). Based on the observed damage, we can see that good backfill material is needed to avoid the uplift of light underground structures due to the liquefaction of backfill material. Other kinds of countermeasures should be taken if this is not possible. Some sewage manholes have been protected by adding a mass to increase the self-weight, or adding a drainage capacity, among others.

Figure 15. Uplift of (a) pipeline in reclaimed land of Itako city and (b) underground tank in Kozaki town.

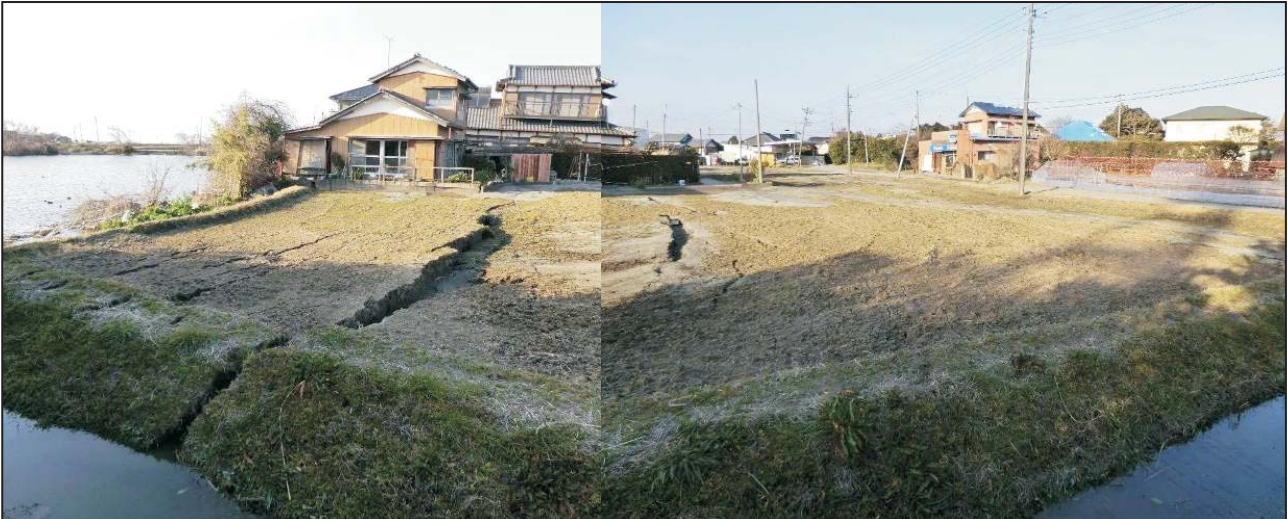
Figure 16. Lateral spreading with a maximum horizontal displacement of about 1 m in Katori city.

Lateral flow occurs in the case of very gently sloped ground underlain by a liquefied layer, or a liquefied soil layer at the back of a quay wall or a revetment that undergoes a residual outward displacement. It was observed to a limited extent in some areas facing towards a river or pond (Fig. 16).

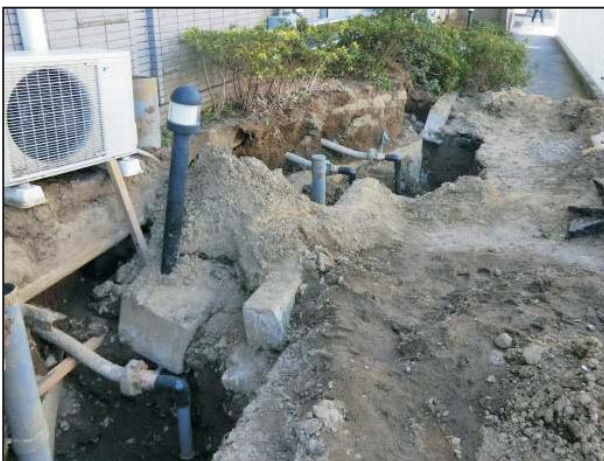
Figure 17. Settlements of the ground around buildings with deep foundations in Katori city.

fied. Many of these kinds of foundations were designed in Japanese practice by considering the possible effects of liquefaction. However, liquefaction-triggered uneven settlements of the surrounding ground caused a lot of damage to connecting pipes (Fig. 17).

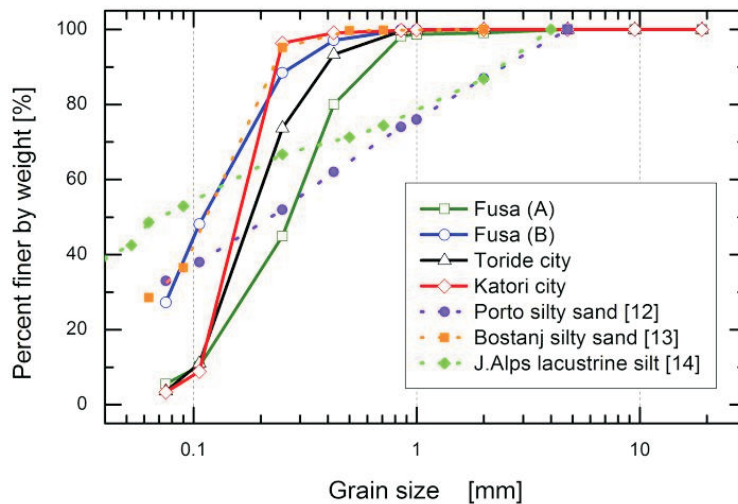
As stated above, samples from sand boiling at several places were collected and their gradation curves were defined. They were compared to three European soils with an estimated liquefaction potential [12, 13, 14]. The results are all presented in Fig. 18. It is clear that the gradation curve of the Bostanj silty sand [13] fits very well with the gradation curves obtained from the sand-boiling samples, while gradations of other two soils noticeable differ from the gradation of sand-boiling samples.

Figure 18. Gradation of samples retrieved from the sand-boiling sites near the Tone river.

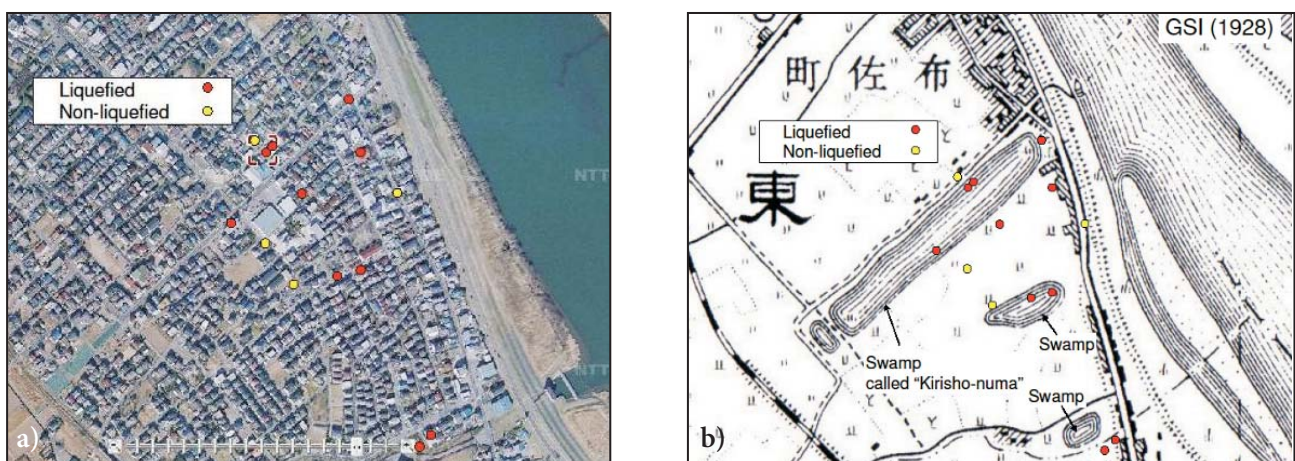
It is difficult to understand the existence of a liquefied site just next to a non-liquefied site, as shown in Fig. 19a in the case of Abiko city. Both of liquefied sites and non-liquefied sites were confirmed by the survey [11] and located on recent aerial photo (Fig. 19a). Their location was transformed from a current map into an old map, that was compiled based on survey results conducted in 1928 before the time of the reclamation of the "Kirishonuma" swamp (see Fig. 2) and the other swamps, the old river channels, etc., in the Tone river basin [2, 11]. The reclaimed land was later developed as residential area, where liquefaction occurred during the recent 2011 earthquake off the Pacific coast of Tohoku. From Fig. 19b it seems that the occurrence of liquefaction is greatly affected by the insufficient compaction of dredged soils during land reclamation.

Figure 19. Location of liquefied and non-liquefied sites confirmed by the survey in Abiko city are plotted on (a) recent aerial photo and on (b) old map made by GSI in 1928.
