# MONITORING OF THE BELCA ROCKFALL

**Aleš Lazar** (*corresponding author*)  
Geoservis, d.o.o  
Litijska cesta 45, 1000 Ljubljana, Slovenia  
E-mail: lazarales@gmail.com

*This paper reviews the monitoring of the rock block above the forest road of Belca Jepca near the village of Belca in the municipality of Kranjska Gora, Slovenia. A rockfall in part of the block occurred in autumn 2014. Both classic and some new measurement technologies were used. The new technologies were implemented according to new findings: an unmanned aircraft was used in the hazardous and hardly accessible areas of the observation, a terrestrial laser scanner was used for the comprehensive observation of the rock slopes and large cracks were observed with the installation of invar wires. The deformation analysis uses data between 2014 and 2017, among which airborne laser scanning (ALS) data from 2014 is included. The study also includes a comparison of the airborne laser scanning and the terrestrial laser scanning.*

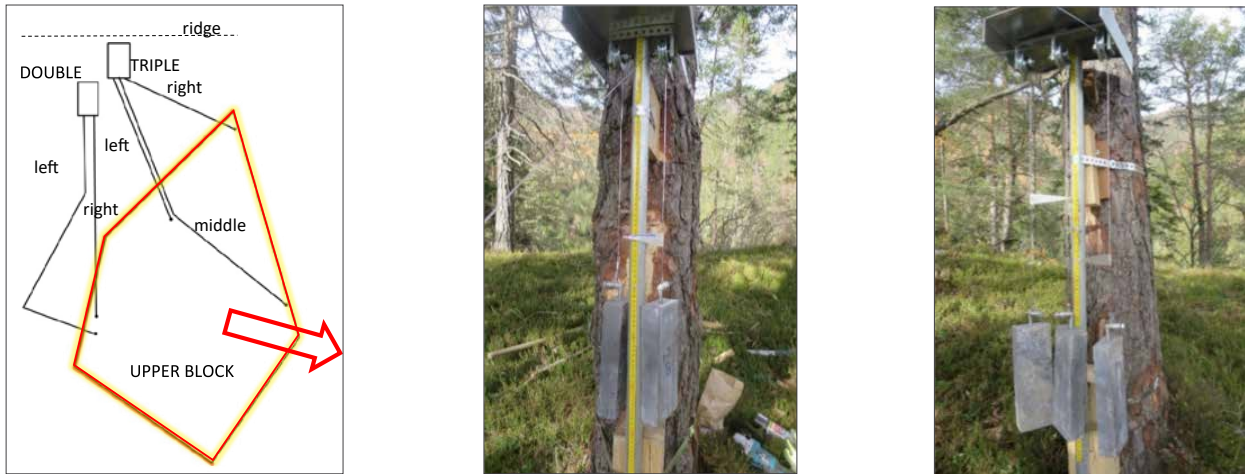
**Figure 3.** Left: schematic position of the wire extensometers, based on the upper block and based on the potential direction of movement; Right: a double and triple extensometer.

Wire extensometers were installed on five characteristic parts of the cracks that limit the upper rock block. They were used to transmit the potential movements on the block. We used invar wires, which largely compensated for the influence of temperature.

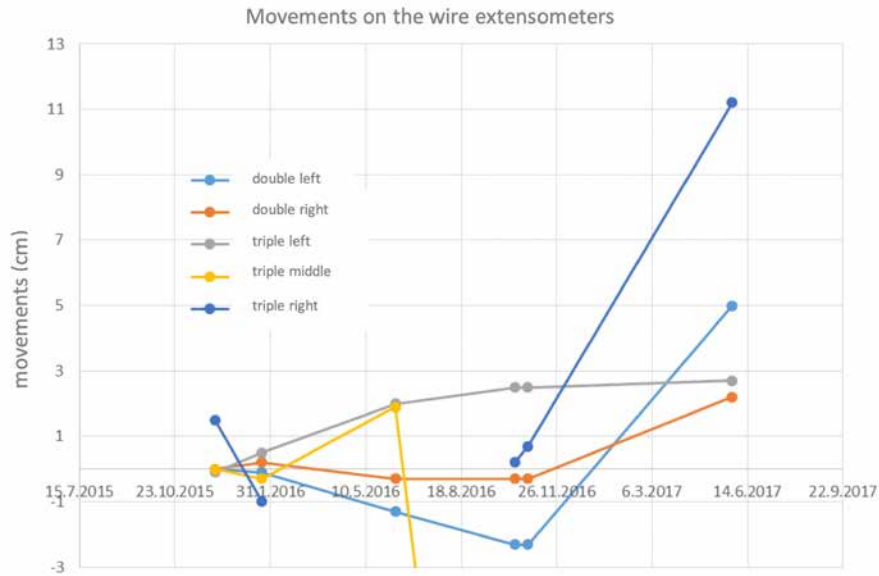
The measurements were carried out periodically. The results are shown in the table 1, as well as pictured in Figure 4.

The increased increment in 2017 is clearly visible. If we understand the values that are increasing or declining in a *trend* as values worth using, we can state the following:

- *Triple left* is increasing at a constant rate and reaches a value of 2.7 cm. We can conclude that the north

Figure 4. Graph of movements on the wire extensometers.

part of the rock block is moving towards the south at a constant speed.

- *Double left* and *triple right* increased to 5 and 11.2 cm in 2017; therefore, the rock block is moving away from the crack.
- A sudden value change for the extensometer *triple middle* also stands out. The point is directly above a turning point of the slope into a rocky overhang. Therefore, the slope can be so loose that the anchor holding the measuring wire gives way.

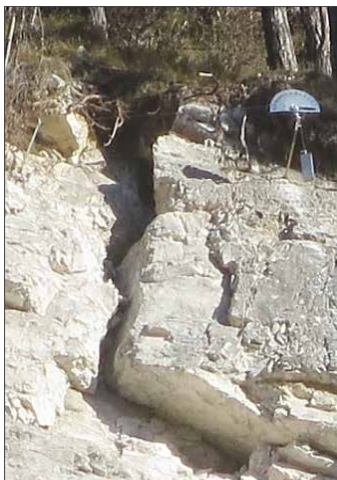
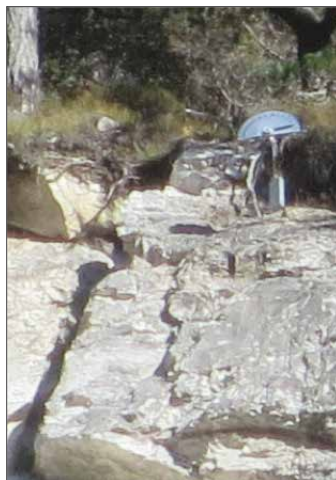
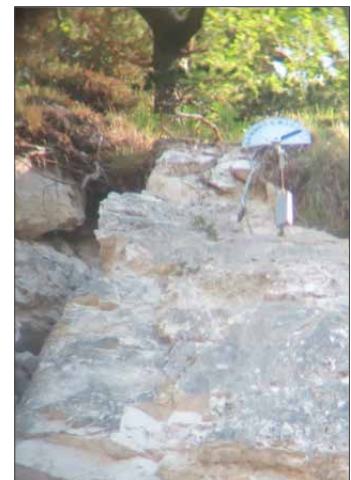
An extensometer for measuring the spreading of the larger crack of the rock is placed on the side block (the measuring scale shows movements of up to 65 mm).

The value increased to 5 mm between January and June 2016, after that (between June and November 2016) the value was constant. Between November 2016 and May 2017 the value increased to 11 mm.

Figure 5. Left: view of the extensometer in September 2015; Middle: view of the extensometer in June 2016; Right: view of the extensometer in May 2017. The difference is 11.0 mm. The increase of the value occurred between January and June 2016 (5 mm), as well as between November 2016 and May 2017 (6 mm).

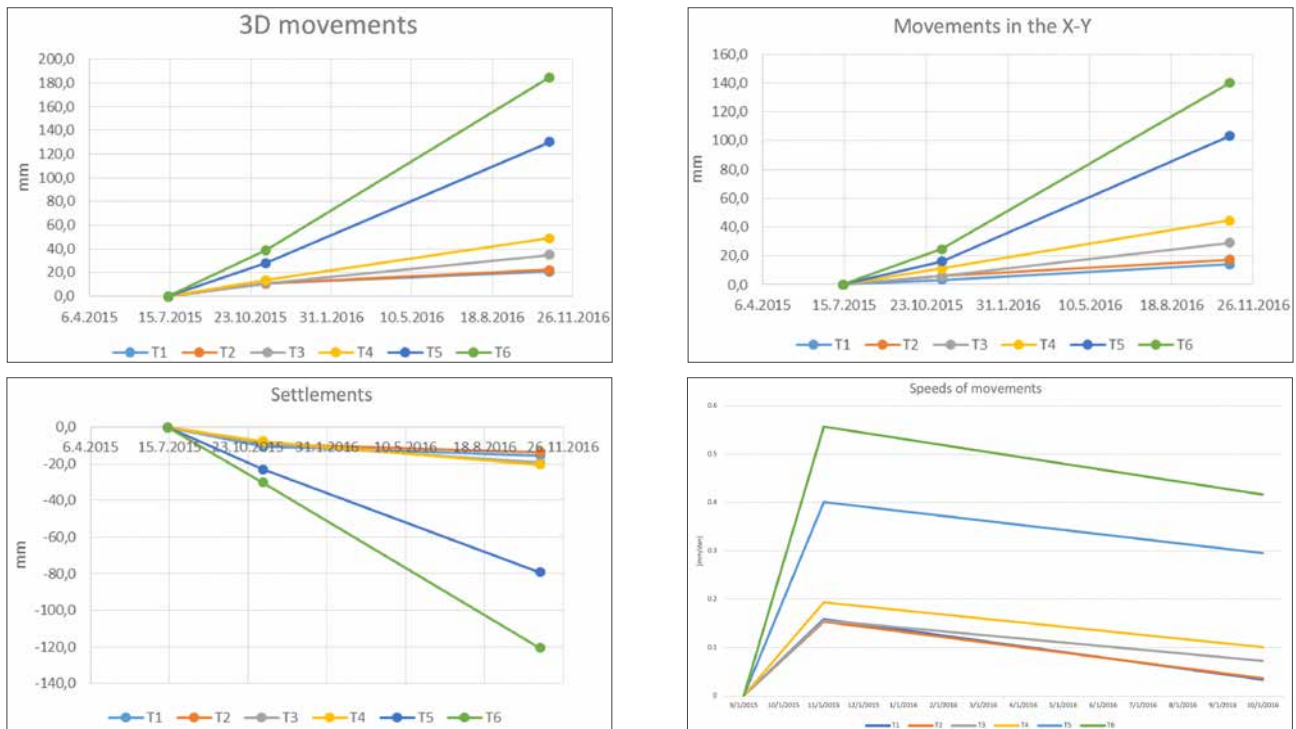
**Figure 6.** Graphs: size of movements – absolute (top left) and in the X-Y plane (top right); settlements (bottom left) and speeds of movements (bottom right).

Based on two or more periodic measurements of the observations of stabilized measurement points on the rock block with a classic polar method, we determined the size of the spatial movements of the object. Next, based on three or more periodic measurements, we determined the speed of the movements. The analysis of the results is shown in the graphs in Figure 6 (previous page).

The graphs show that the points in the upper part (T5 and T6) clearly stand out while looking at the sizes of the movements. This indicates the intensity and ever-present events on and near the upper rock block. The movement direction clearly shows the possibility of further rockfall around the upper rock block. The values of the other points (T1–T4) also show the movement of the block.

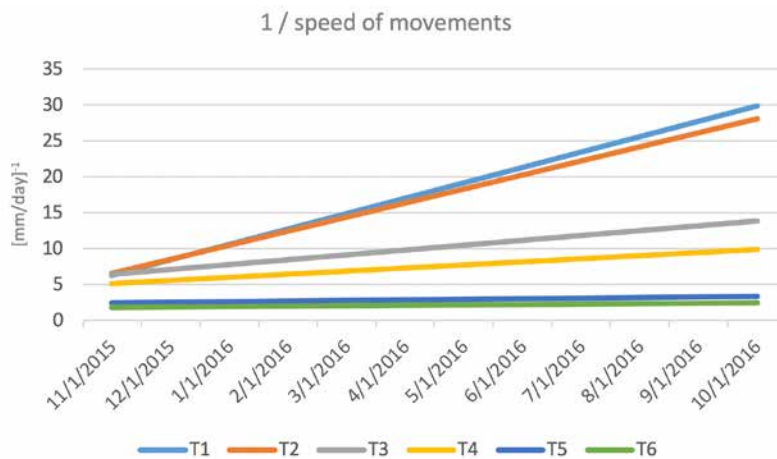
Often, a graph of the reverse velocity and time values is used to estimate the launching time of a landslide. The launch time is the time when the value of the speed-1 is approaching 0. In the case of all the points from T1 to T6, the values do not asymptotically fall towards the value 0 (Figure 10). However, we must warn of the fact that the upper block is made up of pieces of dolomite, which are clearly separated between themselves with open cracks. Therefore, the falling of free blocks can still occur. Moreover, the conclusions are derived from three series of measurements, which can be a too small number of repetitions for a credible assessment.

Figure 10. Projection graph of the reverse speed values.

There is a risk of a rockfall for the whole block of rock in the direction of the river Belca, in the worst case damming the river with the rockfall material. To assess the possibility of the further falling of either parts of the rock block (upper block) or the whole rock block, it is necessary to continue the monitoring process and adapt it per the results.
