COASTAL CLIFF BEHAVIOUR: THE CASE STUDY OF DEBELI RTIČ (SW SLOVENIA)

Coastal cliff behaviour has been studied in five sites along the Slovenian coast, in the north-eastern Adriatic Sea, through the comparison of 2515 images collected at the sites and more than 4500 additional pictures collected since 1998. Moreover, a detailed characterization of the geomechanical properties and the quality of rock masses together with the rockfall susceptibility have been studied to determine the geomechanical properties of the studied sites. Significant modifications of the cliff face are located in particular in sites showing poor or very poor rock mass quality. Moreover, photographic surveying suggests that cliffs are affected by a complex behaviour with respect to coastal retreat: during long stable-weather periods, cliff modifications are very low, while major changes in the cliff face occur after great storm events owing to the interaction of both marine and non-marine factors.

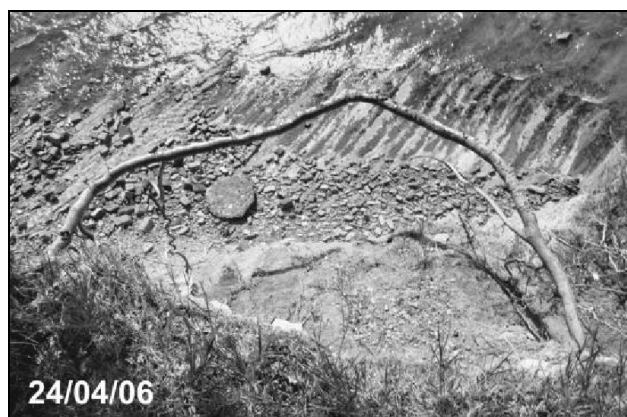
Fig. 3: Morphological changes at site B.
Sl. 3: Morfološke spremembe na točki B.

Examples of major cliff modifications are reported in figures 3, 4, 5 and 6. Regarding site B (Fig. 3), few modifications occurred at the cliff foot, but large amount of beach pebbles are moved, covering and uncovering respectively the shore platform. In site C (Fig. 4), the cliff is undercut. Occasionally, the cliff is threatened by stonefall and the shore platform is covered and uncovered both by beach or collapsed material. In site D (Fig. 5), between January and April 2006, rockfall occurred in the notch. The material at the cliff foot protects the notch from erosion. In site Ec (Fig. 6), at the beginning of 2007, a tree fell from the cliff onto the shore platform and blocked larger rocks for a year.

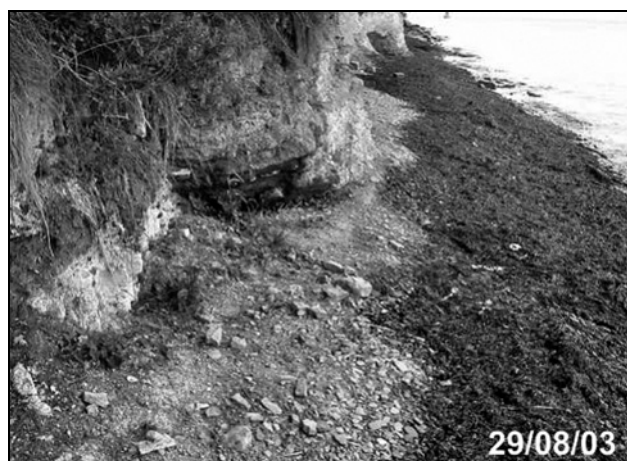
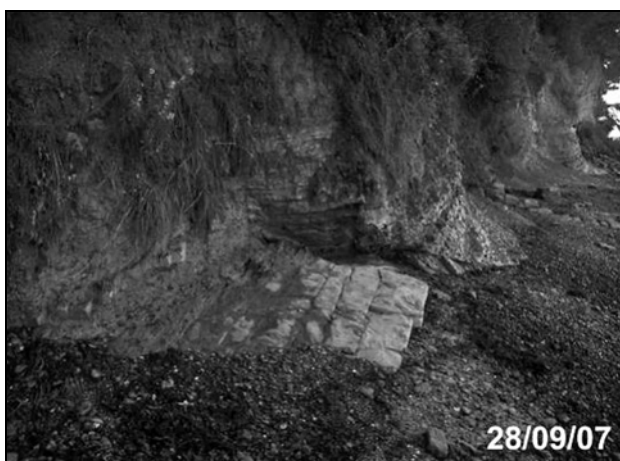
Fig. 4: Morphological changes at site C.
Sl. 4: Morfološke spremembe na točki C.

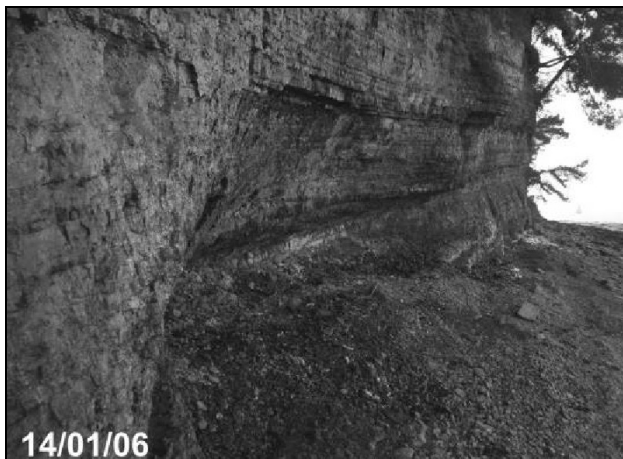
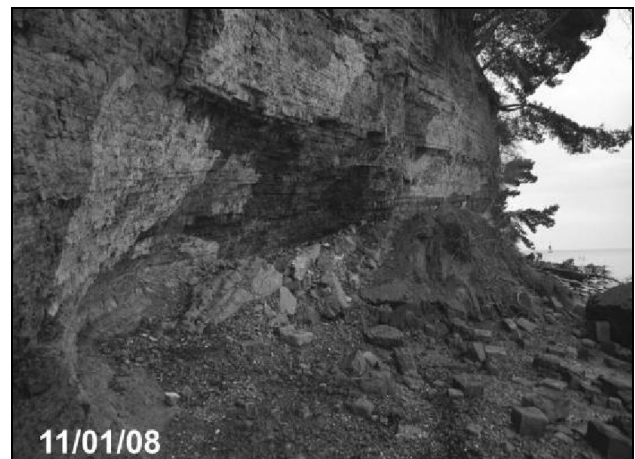
Fig. 5: Morphological changes at site D.
Sl. 5: Morfološke spremembe na točki D.

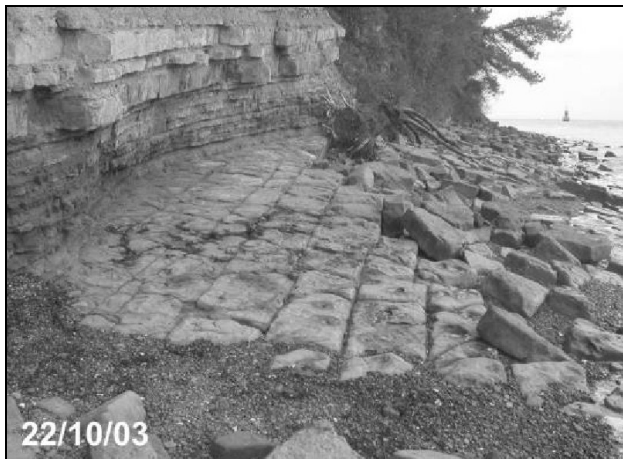
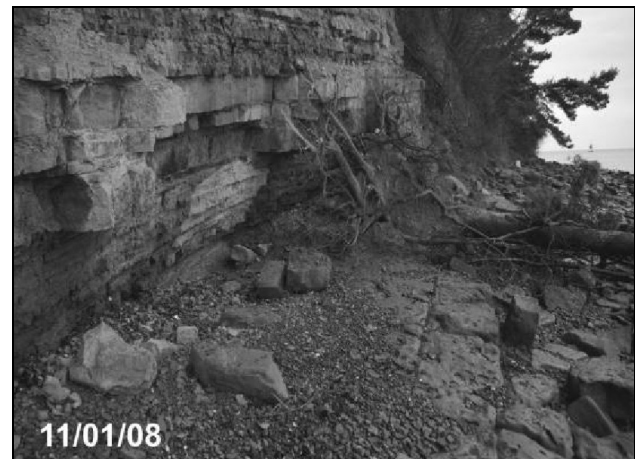
Fig. 6: Morphological changes at site Ec.
Sl. 6: Morfološke spremembe na točki Ec.

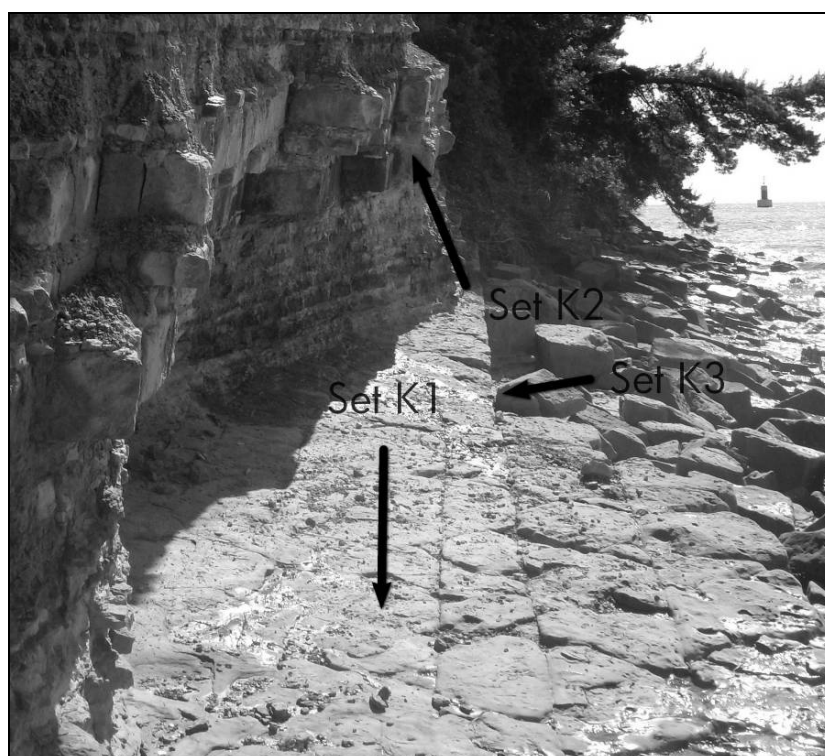
**Fig. 7: Joint system at the cliff-platform junction.****Sl. 7: Razpoklinski sistem na stiku klifa in police.**

The three discontinuity systems formed boulders of cubic decimeter dimension on the walls. In addition, many sandstone blocks, already collapsed, are located on the shore platform, near steep cliffs (Fig. 7).
