# OPPORTUNITIES TO REUSE FENCE POSTS USING METAL FOOTINGS

Daniel WONG<sup>1</sup>, Rod STIRLING<sup>2\*</sup>

(1) FPInnovations, Canada, daniel.wong@fpinnovations.ca

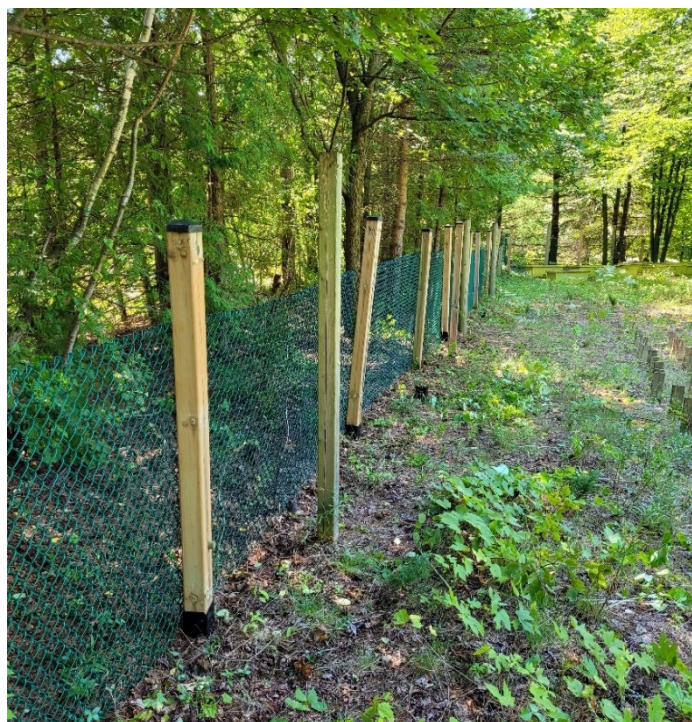
**Fig. 1:** Test fence installation in Kincardine, Ontario, Canada

All materials were installed at FPInnovations' field test site in Kincardine, Ontario, Canada (Fig. 1). The site is a residential lot within the Lorne Beach termite management area north of the town of Kincardine. It has a humid continental climate (Köppen Dfb) and hosts a population of the subterranean termite *Reticulitermes flavipes* (Kollar). It has sandy, well-drained soil and is home to several species of decaying basidiomycetes. The area receives an average of 998 mm of precipitation annually. Average annual temperature is 6.2°C, with mean daily maximum and minimum temperatures of -2°C and -10°C in January, and 24°C and 13°C in July (Stirling and Mankowski, 2022).

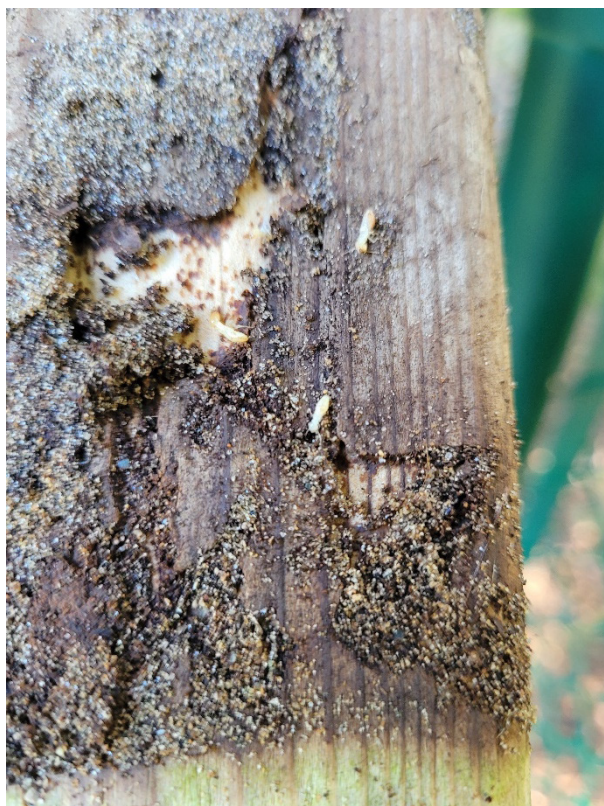
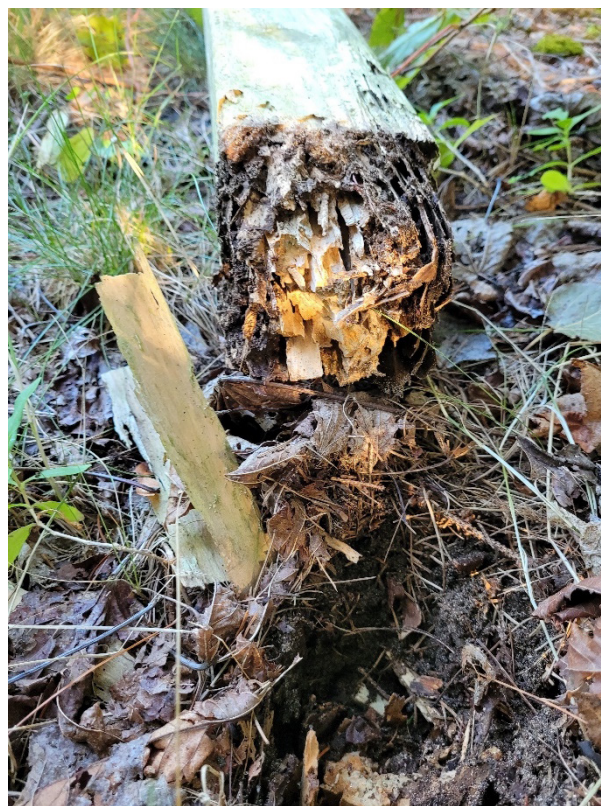
**Fig. 4:** Termite attack on an untreated red pine post installed in a boot (left) and failure of an untreated red pine post exposed in direct soil contact after 6 years (right)

contact between the soil and the post. Termite attack and post failure are visible in the images shown in Fig. 4.
