Acoustic Emission Investigation of Cracks on Engraving Tool Steel Inserts

Dragan KUSIĆ, Aleš HANČIČ, Rajko SVEČKO, Tomaž KEK, Janez GRUM

Key words: Acoustic emission, tool steel insert, cracks, test specimens, PZT sensors.

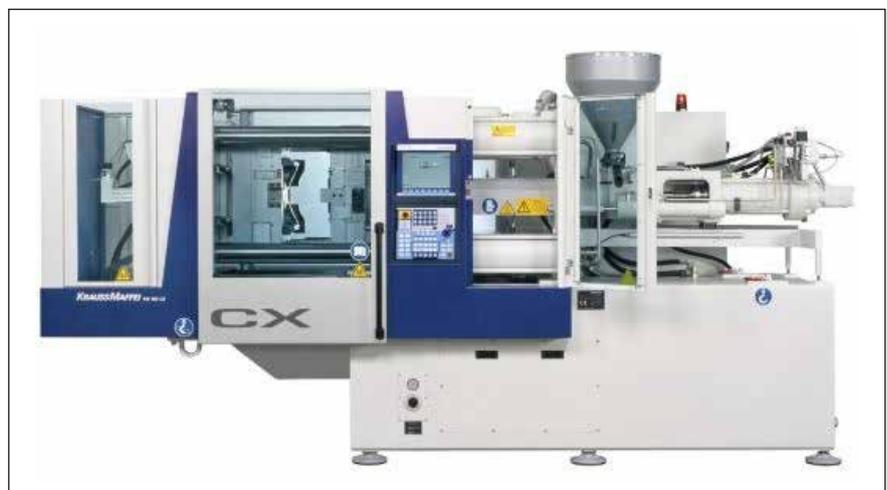
Figure 1. Example of a typical injection molding machine

is shown in *Fig. 1*. Like in all today's industrial manufacturing processes, the injection molding process can produce plastic parts which have poor quality and therefore are characterized as bad ones. In the field of injection molding, the first signs of micro-cracks can occur on the mold during long term production, and that usually causes the production of bad parts. In such cases, if a proper inspection inside the com-

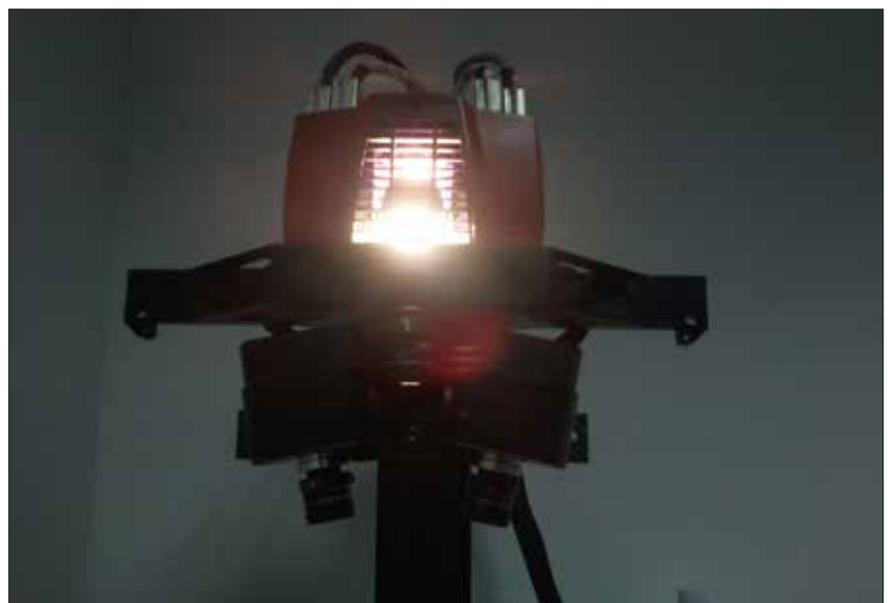
Figure 3. Optical 3D digitizer ATOS II SO with two high-resolution CCD cameras

In the first part, we carried out the experiments on a brand new tool steel insert. In the second part, a tool steel insert with visible signs of a macro-crack was used. To provide similar processing conditions in both cases, we used the same polypropylene material from Sirmax manufacturer (H40 C2 FNAT) which is mainly used in the automotive industry. After the test specimens were produced, they were scanned after 24 hours with an optical 3D digitizer ATOS II SO. This industrial 3D optical digitizer has two high-resolution CCD cameras (1280x1024 pixels), as shown in Fig. 3.
