TERRACED LANDSCAPE AS CULTURAL AND ENVIRONMENTAL HERITAGE
AT RISK: AN EXAMPLE FROM PORTOFINO PARK (ITALY)*Guido PALIAGA*University of Genova, Department of Earth, Environmental and Life Sciences, Corso Europa 26, 16132 Genova, Italy
e-mail: gpaliaga@gmail.com*Paola GIOSTRELLA*National Research Council (CNR), Research Institute for Geo-hydrological Protection (IRPI), Via Madonna Alta 126, 06100 Perugia, Italy
e-mail: paogios@gmail.com*Francesco FACCINI*University of Genova, Department of Earth, Environmental and Life Sciences, Corso Europa 26, 16132 Genova, Italy
e-mail: faccini@unige.it

Keywords: terraced landscape, geomorphological risk, San Fruttuoso di Camogli, Portofino Park, sediment yield

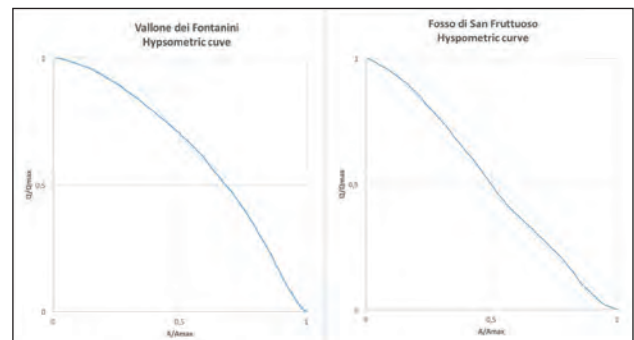
Figure 3: Hypsometric curves of the studied catchments.

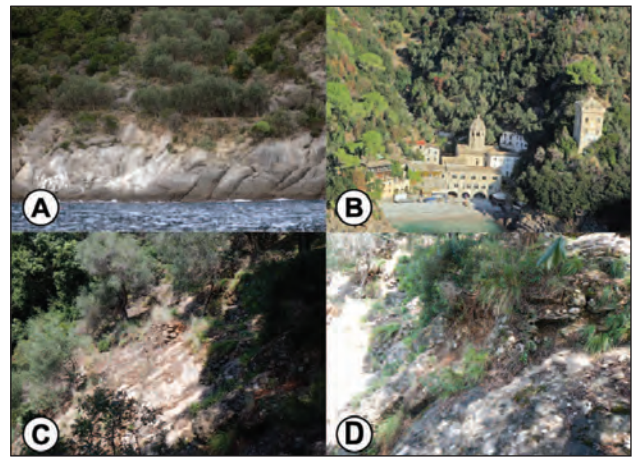
Figure 5: Terraces of olive groves close to the sea (A) San Fruttuoso Abbey, (B) incidents of collapse and other cases of geo-hydrological deterioration such as soil erosion and landslides in the wake of abandonment or poor maintenance of dry-stone walls, (C), (D) Photo by: A. Girani, F. Faccini.

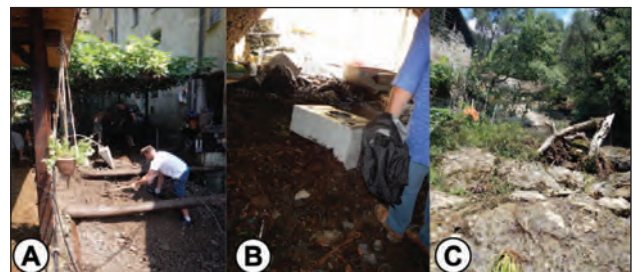
Figure 6: Damages due to the recent flood event in 2014 (A), (B), (C) Photo by: A. Girani, F. Faccini.

2014: the ARPAL rain gauge on Mount of Portofino registered 70 mm of accumulated rainfall/2 hours. The effects on the ground included earth flows along the gully behind the western sector of the inhabited area (behind the building housing the hotel and restaurant called “Giovanni”), at the mouth of the stream on the eastern front of the Bay, under the “Casa dell’Arco” and especially at the end section of the Vallone di San Fruttuoso, where the channel of loose soil damaged parts of the building (Figure 5). Basing on the long time data series of the Chiavari and University of Genoa weather station analysis, the 1915 exceptional precipitation should have a return time longer than 100 years. Nonetheless, the geomorphological characteristics of the basin, in relation to the climatic changes underway, make the statistical approach difficult to reconcile with the actual phenomena. In fact, while the actual rainfall does not show significant changes, the average temperature and the days without rain are showing a positive trend; the subsequent rise in the rate of daily precipitation causes an effect of

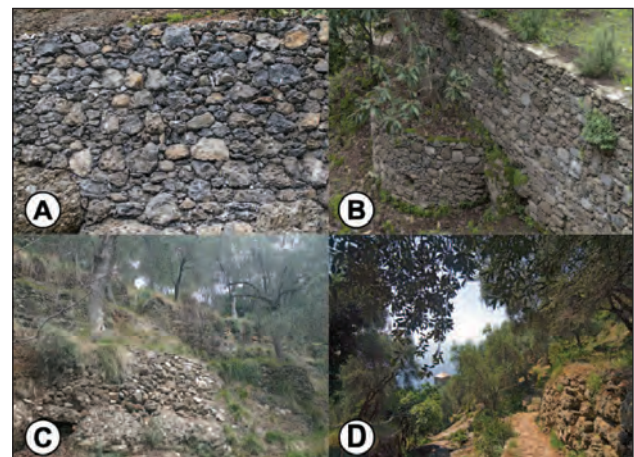
Figure 8: Dry-stone walls in conglomerate:
 (A) dry-stone walls in conglomerate mixed to limestone
 (B) olive grove
 (C), (D) San Fruttuoso’s environment and terraces
 Photo by: A. Girani.

are found in documents from 1800 on, whereas earlier terraces more commonly used a system of embankments. The embankments were preferable for allowing livestock to crop grass and bushes, keeping the area clean around the terraces. The dry-stone wall terraces of San Fruttuoso are distinguished by the use of conglomerate of Portofino (Figure 8), comprised almost entirely of limestone-and-marly pebbles. Terraces built on conglomerate have great resistance and durability and consist of elements of sizeable dimensions, sometime several meters in length; this feature indicate a social and territorial organization that was capable of involving a sizeable amount of manpower. The agrarian landscape and the cultivation techniques typical of the area around San Fruttuoso remained relatively unchanged from the Middle Ages to modern times until the 1950s, when a major shift in the uses of the terraced landscape took place as the inhabitants abandoned the most isolated buildings and subsequently the land as well, to move to more accessible areas. The exodus from the terraced areas was the result of changes in social and economic conditions causing entire generations to search for a better and more comfortable life. Low economic returns, years of poor olive harvests, and the effort required to reach the terraced areas and transport their produce were determining factors in this population shift, (Pedroli et al., 2013). In 1999, interviews with farmers in Portofino Park (Mosconi, 2000), revealed the following problems: the average age of the farmers was between 60 and 80 years; they remembered that their own parents had labored under the ancient emphyteutic (sharecropping) system; their children were unable to continue to work the land. In addition, the restrictive rules of the park itself no longer allowed them to keep livestock; the rule, dating back to the 1960s, was aimed
