INTEGRATION OF THE MEASUREMENT TECHNIQUES USED FOR MONITORING THE LAZE LANDSLIDE IN SLOVENIA

Aleš Lazar

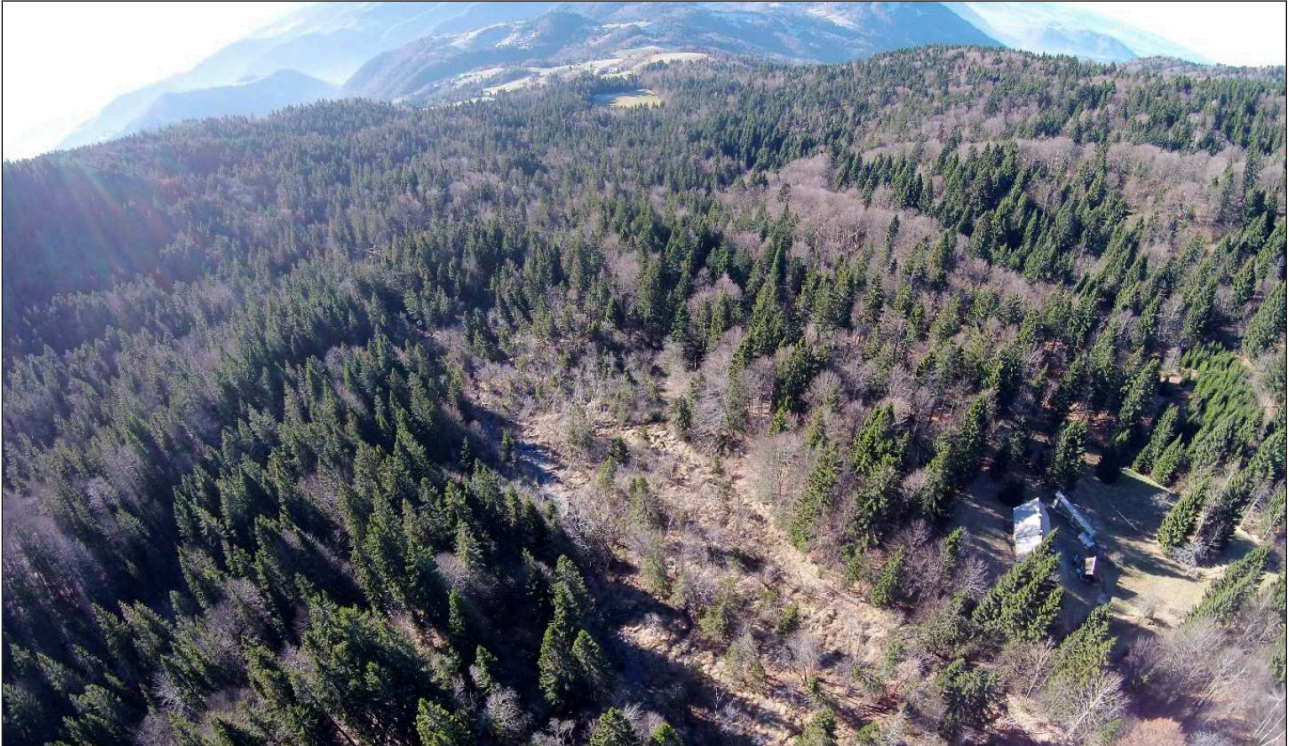
Figure 4. Landslide in the Slug Valley. Laze in the background. Looking south.

- The **upper landslide** in the Slug valley is a mud stream 600 m long, 130 m wide and is characterized by scattered trees and clearly visible movement of the terrain. Sliding has been active for a long time (at least 20 years). The size of the area was estimated to be 4.8 ha and is several meters thick,
- The **landslide in Laze village** is 550 m long and 250 m wide and is characterized by marked cracks that extend in the direction of the slope, especially at the edges of the movement. They occurred in January and February 2014 as a result of intense rainfall [26]. The size of the area was estimated to be 10.5 ha and is several meters thick.

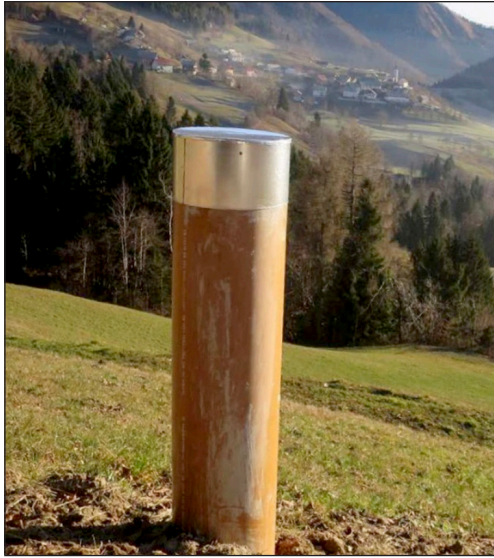
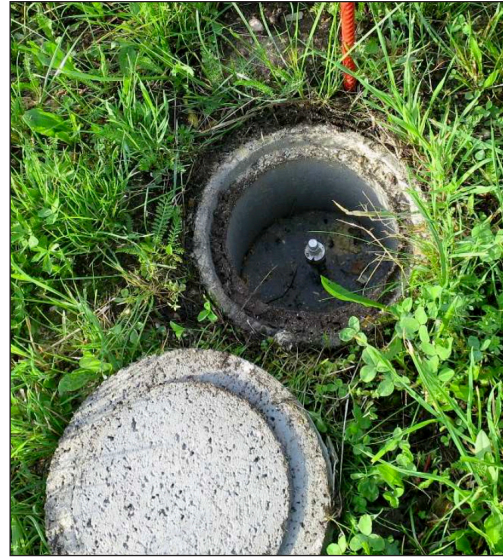
Figure 5. On the left, a measuring column on stable ground, in the background Leskovica, where a measuring prism is placed on the bell tower. Right, polygon point in the ground under a protective cover.

In 2016, the movement-monitoring network was systematized and extended to the entire area of the Laze landslide. The system is based on seven cross-sections on the landslide, which determine those parts of the landslide that are moving faster. There are 95 measuring points. The network is based on eight fixed geodetic points outside the landslide area, the position of which is determined by precise GNSS observation. The fixed points are the starting points for each observation. The obtained data are millimeter precision. The heights are absolute.

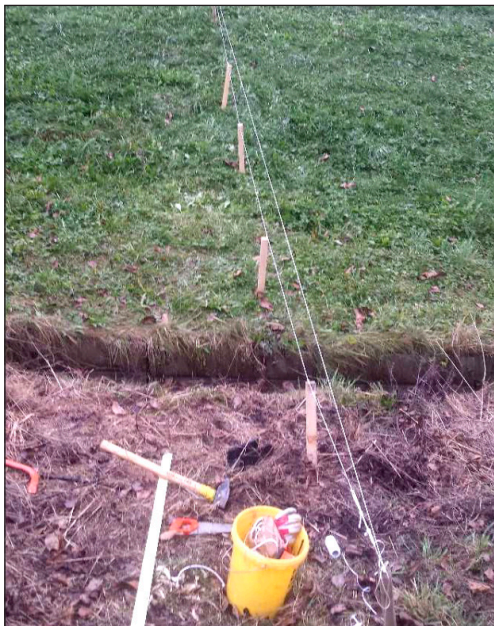
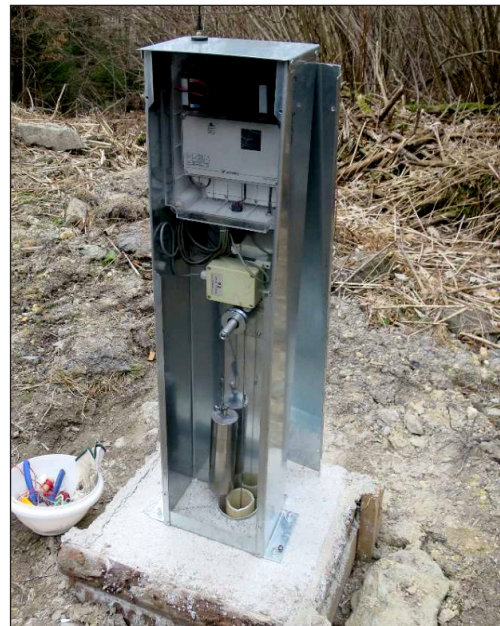
Figure 6. On the left, searching for a movement detector location through a clearly pronounced lateral crack. Right, measuring station to monitor the movement in the borehole. Station MS1.

Displacement sensors were initially set on the lateral portions of the landslide to monitor the movements in real time. In the event of major sudden movements, an alarm is triggered and the appropriate municipal emergency department is notified. The results did not show a clearly pronounced movement that could be registered. Therefore, a landslide displacement-measurement system was set up at the landslide, which is then transmitted to

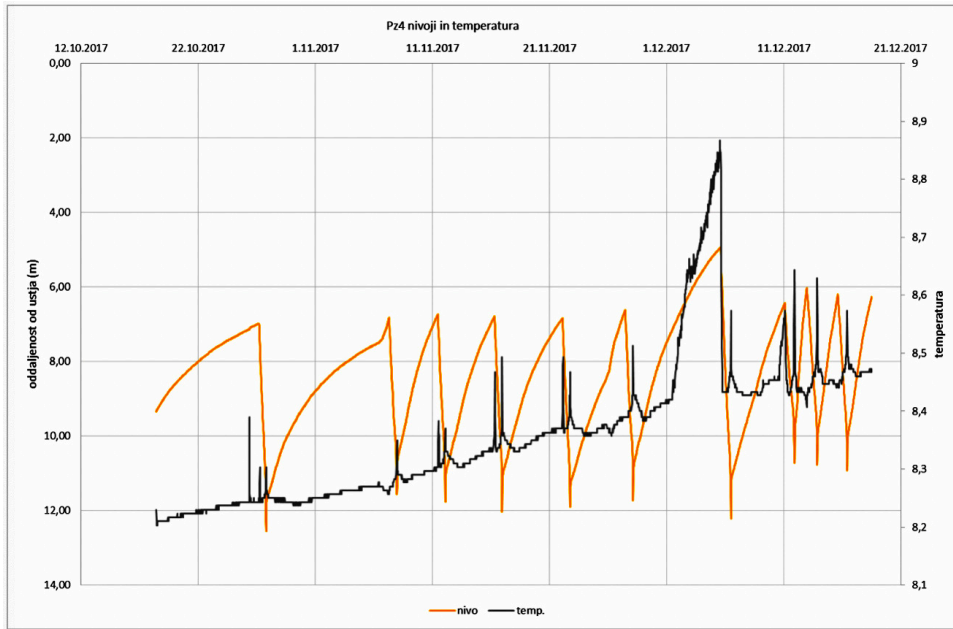
Figure 8. Influence of pumping water in well 4/16 on the level in the Pz4 piezometer.

The effect of the pumping water in Platoon 4/16 on the level in Pz4 is clearly visible.

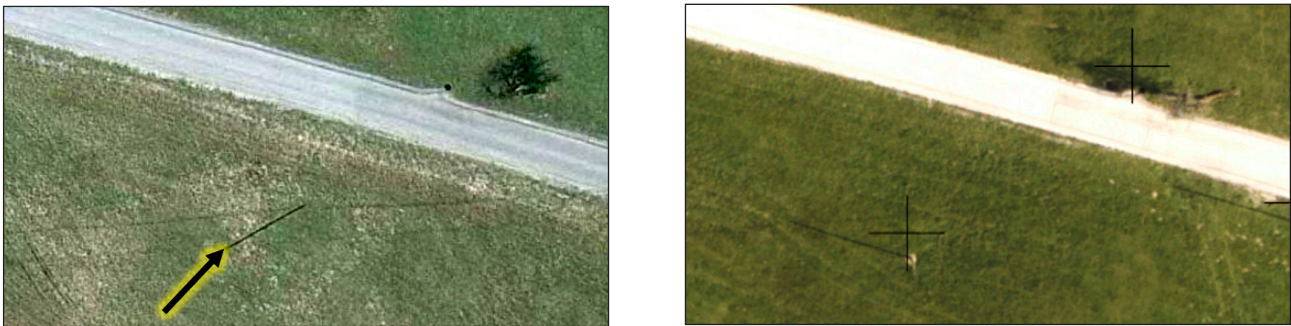
Figure 10. The left image shows a 2004 photo where the position of the power line pole on the ground (arrow) is clearly visible. The right image shows a 2014 photo of the same pole marked with a cross. The displacement is obvious and is 2.1 m.

We performed a comparative analysis between the orthophotos from 2005 and 2014. We identified the same elements on both orthophotos. The older type of orthophotos do not have our own observation points, so we monitored objects and their position in space. As the most reliable object in nature, we recognized the power line in combination with its visible shadow. Although the power lines on the orthophotos are projected differently, their contact with the earth is well defined by the

onset of the shadow (example in Figure 10). The elevation data is related to the digital terrain model that was generated when creating the orthophotos.

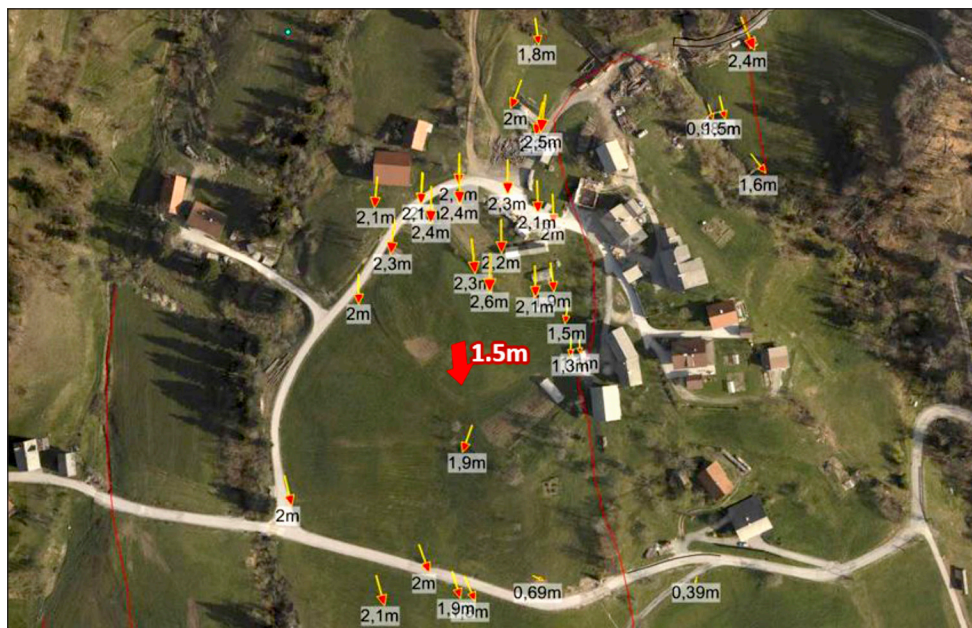
Figure 11. Graphical display of the displacements between 2005 and 2014.

During a period of 9 years (between 2005 and 2014) the landslide in the village Laze has moved approximately 1.5 to a maximum of 2.5 meters. The graphical representation of the movements during this period is illustrated in Figure 11, where the average displacement is emphasized (the graphical basis is DOF 2014).
