CAVES AS POTENTIAL KARST GEOHAZARDS ON HIGHWAYS  
IN SW SLOVENIA

Stanka ŠEBELA

Karst Research Institute ZRC SAZU, SI-6230 Postojna, Titov trg 2, Slovenia

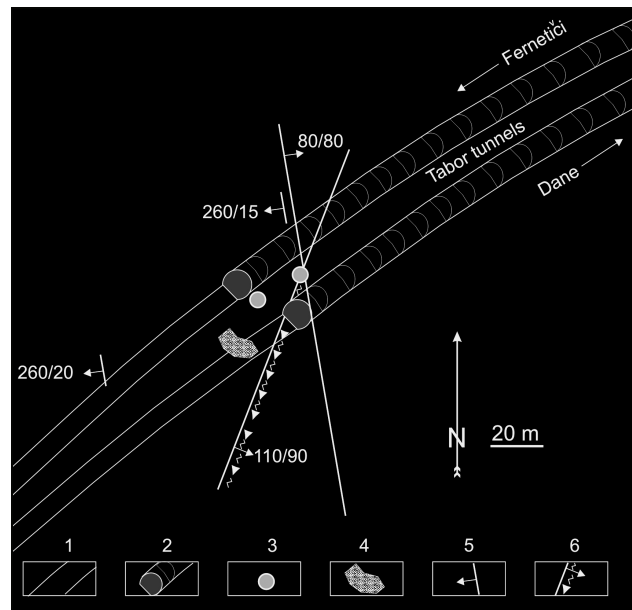
**Fig. 3: Tabor tunnel. Legend: 1 = highway; 2 = Tabor tunnel; 3 = shaft opened during highway construction; 4 = cave opened during highway construction; 5 = strike and dip direction of bedding-planes; 6 = strike and dip direction of fault zone.**

Two tunnels (240 and 260 m long) were constructed in the 4.8 km long Dane–Fernetiči highway (Fig. 3). Just at the exit of the southern tunnel, a bigger (5x10 m) cave opened with collapse due to blasting. The cave was filled with block material and protected by concrete plate. Just between both tunnels, two vertical shafts of up to 30 m deep were discovered. One of them had been formed along a well-expressed fault (Fig. 3).

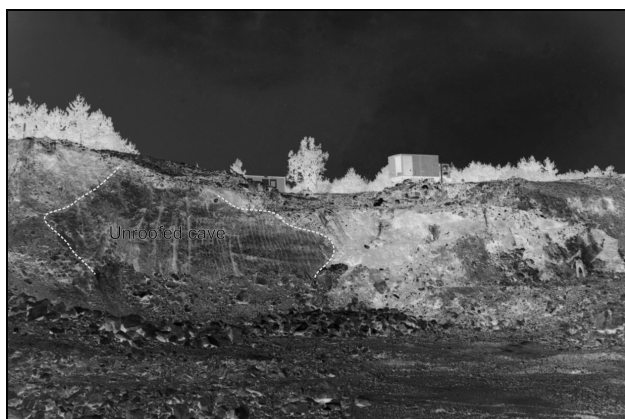
**Fig. 5: Cave filled with sediments at NE entrance to the Kastelec tunnel. (Photo: S. Šebela)**

During the excavation of the NE entrance to the Kastelec tunnel, some unroofed caves were discovered (Knez & Slabe, 2002, 2005b). The biggest cave had a diameter of 18 x 9 m and was filled with cave sediments (Fig. 5). Individual portions of the caves, which were unroofed and resembled dolines, were clearly evident on the surface before the construction work began. During the excavation of the Kastelec tunnel, the largest cave complex (LC-S647) was discovered in the tunnel near the cave Brezno na Škrklovici (Fig. 4). In the tunnel, three

All four caves (Brezno na Škrklovici, Udor na Škrklovici, the cave in the left pipe of the Kastelec tunnel LC-S647, and the old cave filled with sediments at the NE entrance to the Kastelec tunnel in Figure 5) formed in Eocene Alveolinid-nummulitic limestone. Although Brezno na Škrklovici and the cave in the left pipe of the Kastelec tunnel LC-S647 are no longer connected,

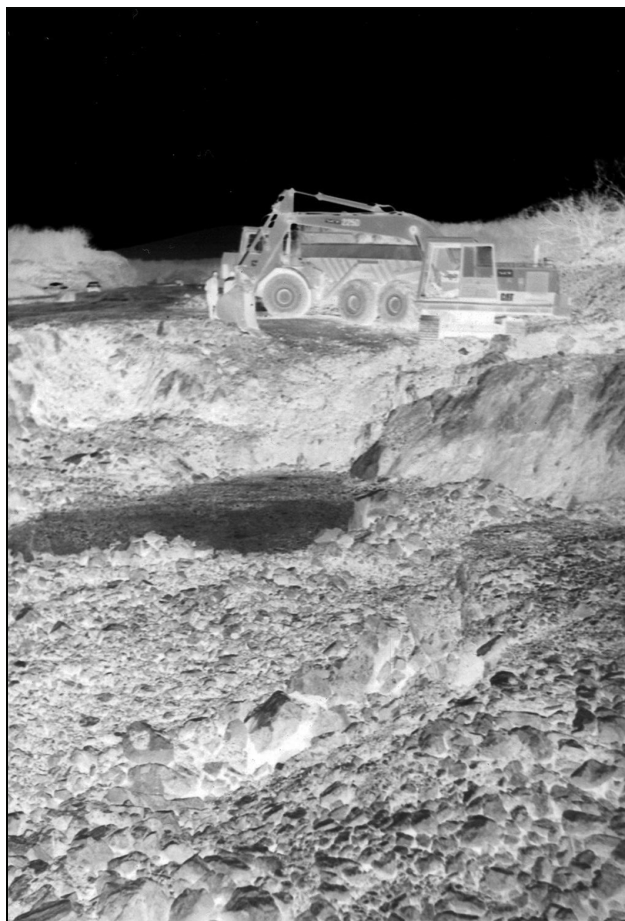
**Fig. 6: Doline remediation on Divača–Kozina highway, early spring 1995. (Photo: S. Šebela)**

The karst features within the road construction must be suitably treated. From the dolines and the caves all sediments are removed and the bottom is filled by carbonate rubble, later grouted by the concrete (Fig. 6). The experience acquired during previous highway constructions, when the treatment was similar, indicate good results.

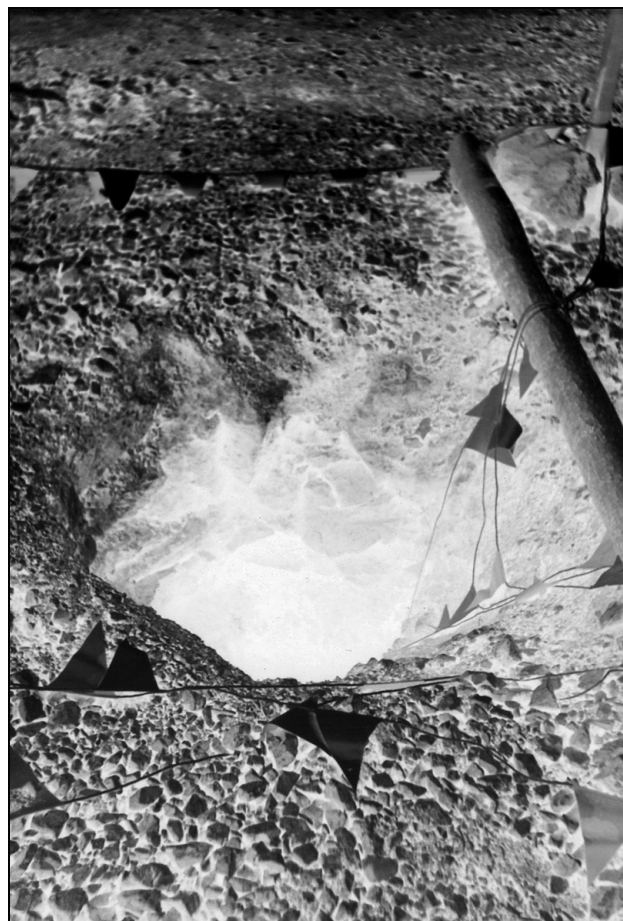
**Fig. 7: Unknown cave opened on Divača–Kozina highway, early spring 1995. (Photo: S. Šebela)**

Almost 40 years of experience with studies of karst surface and underground features across SW Slovenia are showing good mechanical stability of highways (Kranjc, 1983; Kranjc *et al.*, 1991; Knez *et al.*, 2008). Some collapses occurred near or between highway lines. On the other hand, on highways, which are still under construction, collapses (Fig. 7) occur even during the last consolidation of gravel roadway by vibration rollers.
