## ROOT-CAUSE ANALYSIS OF SUPERHEATER-TUBE FAILURE

Martin Nad', Jiří Buzík, Tomáš Létal, Pavel Lošák

Brno University of Technology, Faculty of Mechanical Engineering, Institute of Process Engineering, Technická 2,  
616 69 Brno, Czech Republic  
nad@fme.vutbr.cz*Prejem rokopisa – received: 2016-07-15; sprejem za objavo – accepted for publication: 2016-09-15*

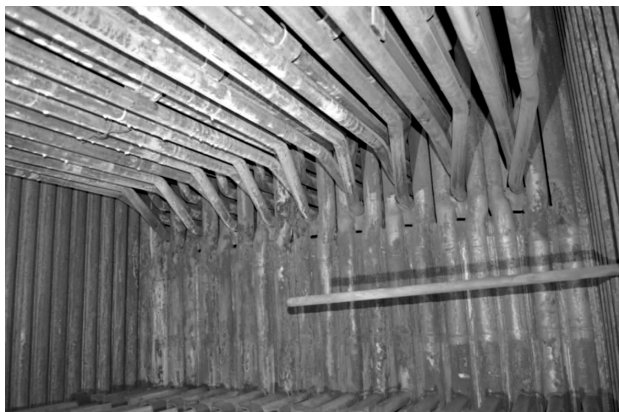
Figure 1: Part of superheater P1 and the membrane wall  
Slika 1: Del super grelca-pregrevalnika P1 in stena membrane

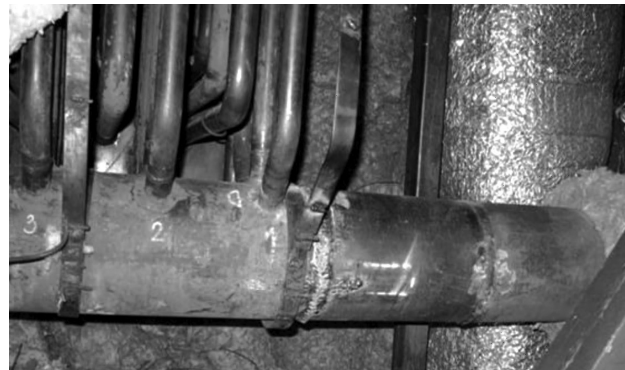
Superheater collectors are supported by two fixed strap iron profiles (Figure 2).

Figure 2: Support of the superheater collector  
Slika 2: Del zbiralnika v pregrevalniku

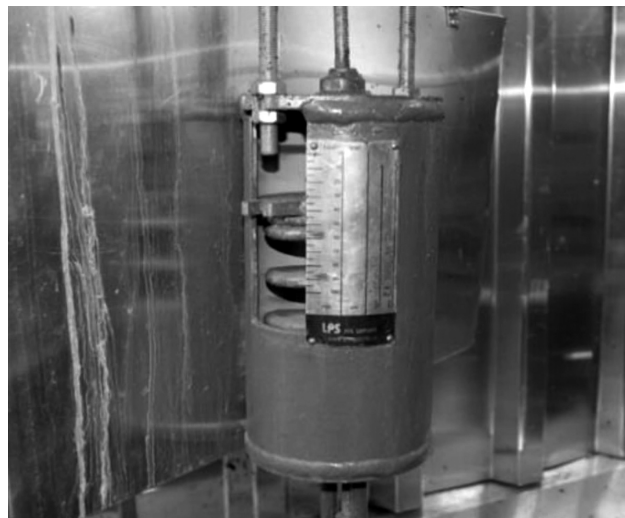
The U-shaped transition pipe has spring supports on three locations (Figure 3). Two of them are at the upper

part with displacements of 15 mm and 23 mm and one at the bottom part with a displacement of 75 mm.

Figure 3: Spring support of the transition pipe  
Slika 3: Vzmet v pretočni cevi
