Main damages on upper die in industrial hot forging

LEJLA LAVTAR^{1,*}, MILAN TERČELJ¹, MATEVŽ FAZARINC¹, GORAN KUGLER¹

¹University of Ljubljana, Faculty of Material Science and Engineering, Department of Materials and Metallurgy, Aškerčeva cesta 12, SI-1000 Ljubljana, Slovenia

Abstract: An analysis of main damages on industrial hot-forging die, made of Dievar hot-working die steel is presented. Die was previously gas nitrided, sectioned and examined after its service life. The measurements of microhardness depth profiles and optical microscopy of nitrided layers were applied in analysis of wear, cracks and failures on the most loaded sections of tool. In order to prolong die service life some improvements were suggested.

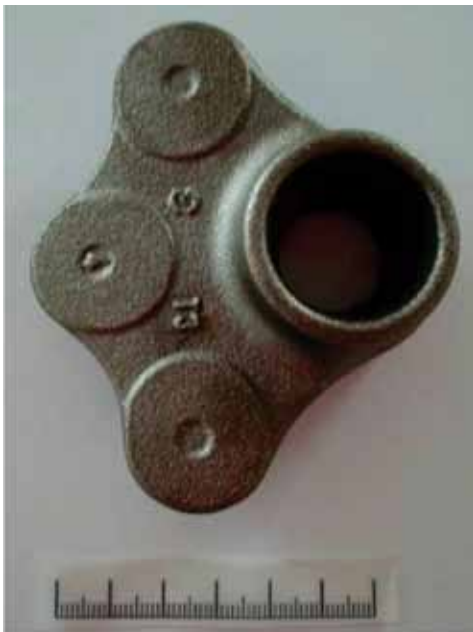
Initial billet made of C35E steel for forging the steering mechanism had diameter of $\varnothing = 32$ mm and weight of 930 g, and was heated to temperature interval of 1230–1280 °C. Geometry of forged product is adapted for steering mechanism in car that is a relatively simple 3D-geometry (Figure 2).

Figure 2. Shape of steering mechanism after the last hot forging operation
