Application of Ultrasonic C-Scan Techniques for Tracing Defects in Laminated Composite Materials

Theodoros Hasiotis – Efstratios Badogiannis* – Nicolaos Georgios Tsouvalis

School of Naval Architecture and Marine Engineering, National Technical University of Athens, Greece

In this paper practical ultrasonic C-scan techniques for NDT of laminated composite materials are developed and applied, with an aim to trace specific artificial defects. Two types of materials are examined; an advanced carbon/epoxy system and a typical marine type glass/polyester system. Both were constructed with two manufacturing methods (Hand Lay-Up and Vacuum Infusion). Several artificial defects were embedded into the test plates, varying in shape, magnitude and through thickness position. Test plates were C-scanned using ULTRAPAC II ultrasonic system with ULTRAWIN software and typical examination techniques (layer to layer examination, full width examination, etc.) were used to determine and characterize defects. In addition, appropriate software tuning procedures and examination strategies were applied, which further developed and optimised the scanning procedure. These efforts resulted in effective C-s

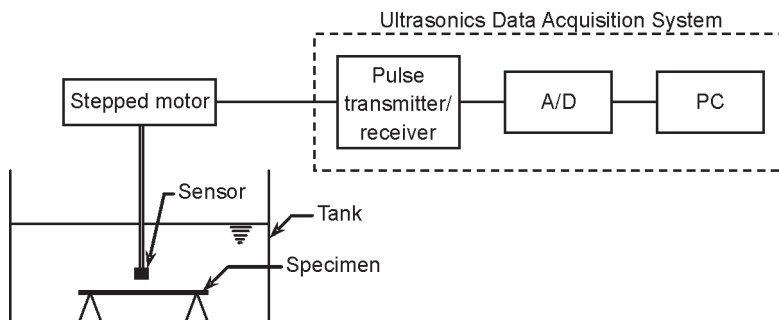
Fig. 2. Schematic view of the ultrasonics system

The ultrasonic inspection of the specimens was made by applying the Pulse – Echo method. A ¼" diameter single crystal pulse-receiver flat transducer of 5 MHz from PANAMETRICS was used and the inspection was made with the specimens immersed in distilled water. The ultrasonic device used is ULTRAPAC II system (automated immersion system), in association with ULTRAWIN software for data acquisition, control and imaging. It is an automated immersion system, equipped with high speed computer-controlled stepped motor drivers. X-Y axis scanning speed exceeds 20 in/s (500 mm/s), with a resolution of 0.0027 in (0.07 mm). The direct vertical axis driver has a maximum speed of 1 in/s (25 mm/s) and a resolution better than 0.001 in (<0.025 mm). ULTRAPAC II system uses a heavy duty Plexiglas tank supported by an also heavy duty aluminium framing system. A classic PC controls ULTRAPAC II system, which employs a Pulse/Receiver card for the generation and receiving of the ultrasonic waves. A different card is also used for the analog to digital conversion of

the incoming signal (A/D). A schematic view of the whole ultrasonics system can be seen in Fig. 2.

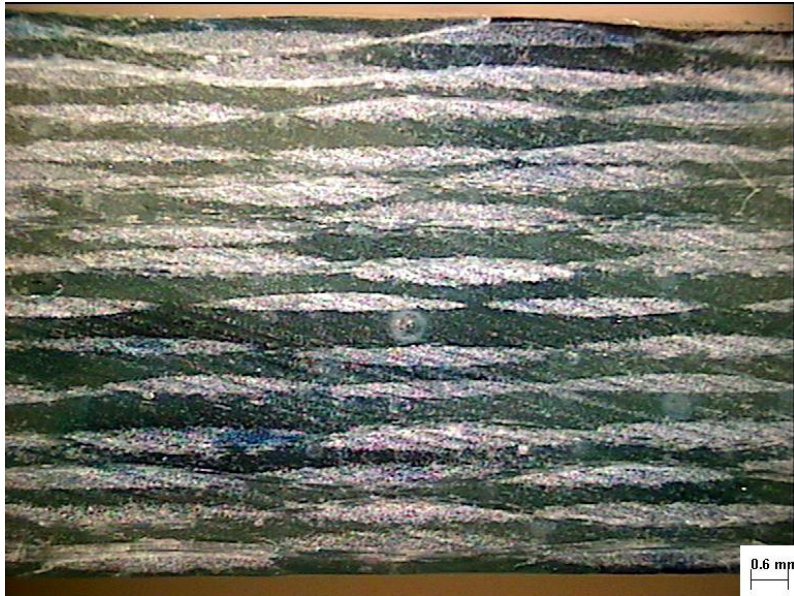
Fig. 8. Cross section ($\times 100$) of GFRP specimen showing the elliptic shape of the fiber yarns

It must be noted that, in general, the echoes coming from the fibers are more intense compared to the echoes coming from the defects or other areas. This is due to the reported elliptic shape of the glass yarns' cross section (see Fig. 8). As [7] mention, a convex or a concave shape reflects a big portion of ultrasonic energy.
