Passivation of welded AISI 316L stainless steel

MIRKO GOJIĆ¹, DRAŽEN MARIJAN², MARIJAN TUDJA², STJEPAN KOŽUH¹

Abstract: The paper deals with the results of passivation of welded AISI 316L austenitic stainless steel. The effectiveness of passivation in a volume fraction 6.0 % HNO₃ solution containing the mass fraction of CuSO₄·5H₂O 2.0 % was tested by potentiodynamic polarization. Polarization was carried out in demineralized water before passivation and after it. At 80 °C demineralized water induced pitting corrosion and passivation was undertaken to protect the steel surface. As a result of passivation the pitting potential decreased. The satisfactory protective properties of the passive film on steel surface were found to agree with the high value of the pitting potential. After passivation, the presence of white dotted agglomerations of copper atoms was observed on the surface in the proximity of the melted zone.

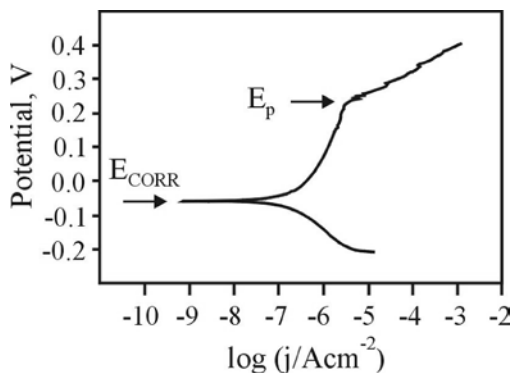
Figure 1. Anodic potentiodynamic polarization curve for AISI 316L steel weld in demineralized water before passivation, at the potential scan rate of 5 mV s^{-1}

Before testing the capability for passivation of the 6.0 % HNO₃ solution containing the mass fraction of CuSO₄·5H₂O 2 % with the help of a potentiodynamic polarization curve we first investigated how demineralized water (real medium), at 80 °C, affected the surface stability of the AISI 316L steel weld (Figure 1). We then determined the corrosive properties of the steel in demineralized water after passivation (Figure 2) and in the passivation solution (Figure 3). The general and pitting corrosion parameters as read from the potentiodynamic polarization curves are listed in Table 2. In practice, to be considered corrosion-resistant, steel is expected to have achieved the corrosion potential (E_{CORR}) before use. Defects on the steel surface due to long-term use will initiate porosity and roughness. A rough and porous structure will facilitate oxidation and dissolution of the surface layers, in other words it will become more susceptible to pitting corrosion. The instability of the steel surface will produce as a result a lower pitting potential (E_p). By undertaking a timely protective treatment i.e.

the reason why the surface of the welded AISI 316L steel needed to be passivated (Table 2). The chief reason for passivation was the onset of pitting corrosion. The pitting potential (E_p) at the steel surface was 0.228 V (Figure 1, Table 2). From Figure 1 it is evident that the E_p value was too low and the $E_p - E_{\text{CORR}}$ difference too small for the weld surface to resist pitting corrosion. The susceptibility to pitting corrosion of AISI 316L steel was the main reason why it was necessary to protect the steel surface by passivation.

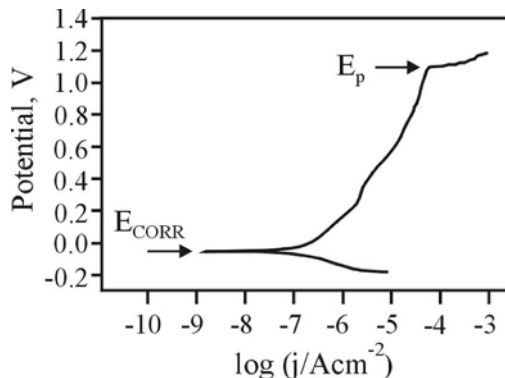
Figure 2. Anodic potentiodynamic polarization curve for AISI 316L steel weld in demineralized water after passivation, at the potential scan rate of 5 mV s^{-1}

The passivation effectiveness of the volume fraction 6.0% HNO_3 solution containing the mass fraction of $\text{CuSO}_4 \cdot 5\text{H}_2\text{O}$ 2.0% was evaluated using the parameters from the potentiodynamic polarization curve recorded in demineralized water after passivation (Figure 2, Table 2). The values of general corrosion parameters after passivation indicated that the corrosion

rate decreased (from $4.530 \cdot 10^{-3} \text{ mm a}^{-1}$ to $1.204 \cdot 10^{-3} \text{ mm a}^{-1}$), i.e. that general corrosion resistance increased. The pitting potential at the passivated surface was higher (1.098 V) than the one at the nonpassivated surface (0.228 V). A rise in the E_p value led to a higher $E_p - E_{\text{CORR}}$ value (from 0.287 V to 1.063 V). The E_p and $E_p - E_{\text{CORR}}$ values indicated that the chosen passivation treatment provided effective protection against pitting corrosion to the AISI 316L

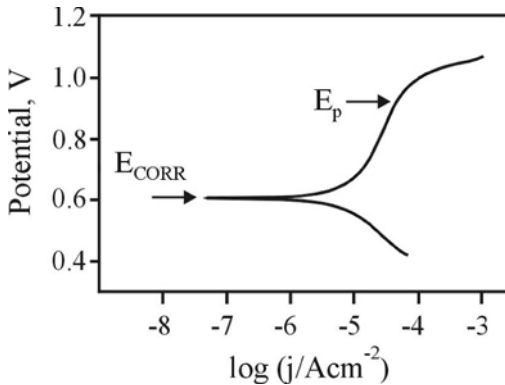
Figure 3. Anodic potentiodynamic polarization curve for AISI 316L steel weld in passivation solution, at the potential scan rate of 5 mV s^{-1}
Slika 3. Krivulja anodne potenciometrične polarizacije zvara jekla AISI 316L v raztopini za pasivacijo pri hitrosti menjave potenciala 5 mV s^{-1}

of the results obtained from the potentiodynamic polarization curve recorded in the passivation solution demonstrated that the passivation solution was more aggressive

than demineralized water (Figure 3, Table 2). The aggressiveness of the passivation solution was as expected because, were it not so, the protection against pitting corrosion provided by the solution would not have been effective. However, the adverse effect of the passivation solution was still not strong enough to cause the steel surface to dissolve, i.e. to induce general corrosion (Table 2). A general corrosion rate of over 0.127 mm a^{-1} was considered to be hazardous to the steel surface^[10]. The pitting potential value (0.900 V) was taken to prove that the passivation medium was well chosen.

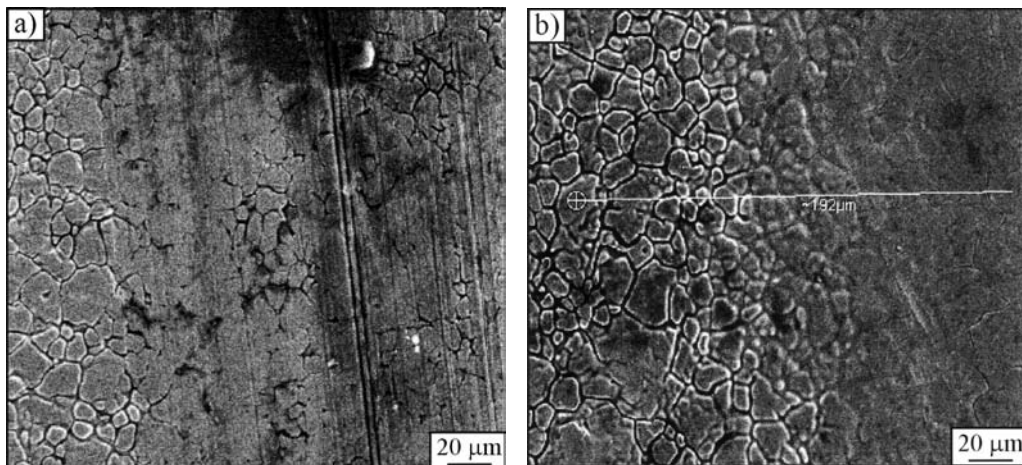
Figure 4. SEM micrograph of the initial surface of AISI 316L steel base metal (a) and weld joint (b)

Analysis of surface morphology of the AISI 316L base metal and weld joint was carried out before and after polishing, and also after passivation (Figures 4–6). Initially, the base metal surface showed the presence of grooves as well as of impurities, cracks, and dimples (Figure 4a). In the weld two zones could be distinguished: the melted zone and the zone adjacent to the melted zone (Figure 4b). The melted zone morphology was characterized by an even and compact struc-

ture (Figure 4b, right). The adjacent zone, contrariwise, exhibited cracks and grain boundaries (Figure 4b, left). Despite morphological differences, a quantitative linear analysis demonstrated equal proportions of individual elements in the two zones (Figure 7). Chemical cleaning helped reduce the cracks' width and achieve a more uniform structure of the welded surface.

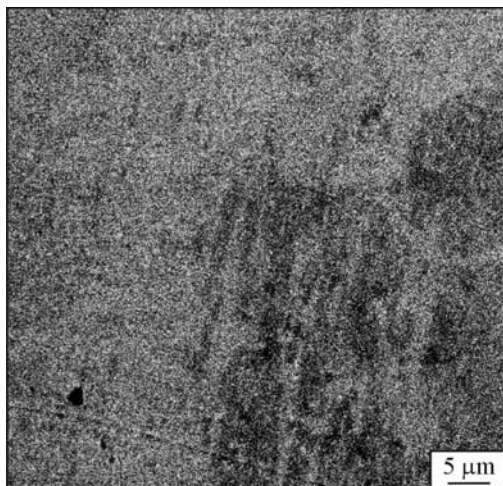
Figure 5. SEM micrograph of the surface of AISI 316L steel after polishing

The polished surface of AISI 316L steel was characterized by a smooth and uniform structure (Figure 5). After polishing there were no signs of cracks or impurities on the steel surface. The passivated surface of the base metal exhibited an irregular distribution of indentations (with a maximum diameter of up to 5µm) (Figure 6a). Quantitative linear analysis showed the chemical composition of the steel surface inside and outside indentations (dimples) to be identical (Figure 8). The appearance of dimples was the result of dissolution of unstable surface sulphur in the acidic me-

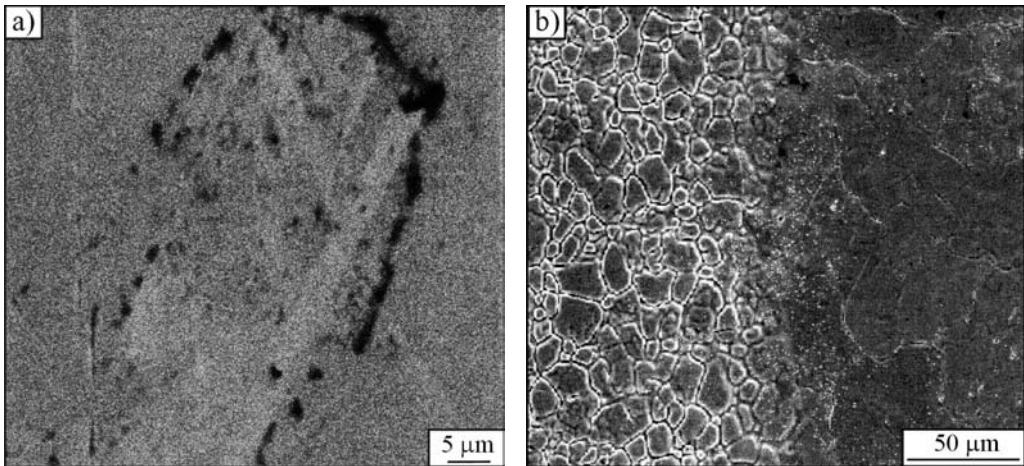
Figure 6. SEM micrograph of the surface of AISI 316L steel base metal (a) and weld joint (b) after passivation

The passivation process is known to reduce not only localized sulphur concentration in AISI 316L steel but also its total concentration thus increasing steel resistance to pitting corrosion^[10]. Increase in the pitting resistance of the weld following passivation was established by analysis of the parameters obtained by potentiodynamic measurements (Table 2). The passivated surface in the close proximity of the melted zone exhibited white dotted agglomerations and slightly less pronounced grain boundaries in comparison with the nonpassivated

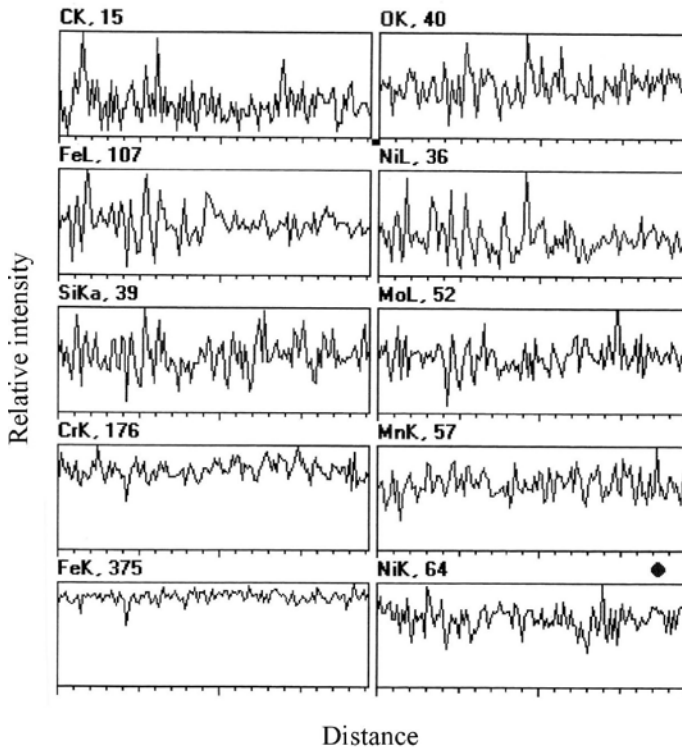
Figure 7. Quantitative linear analysis of the initial surface of AISI 316L steel weld joint

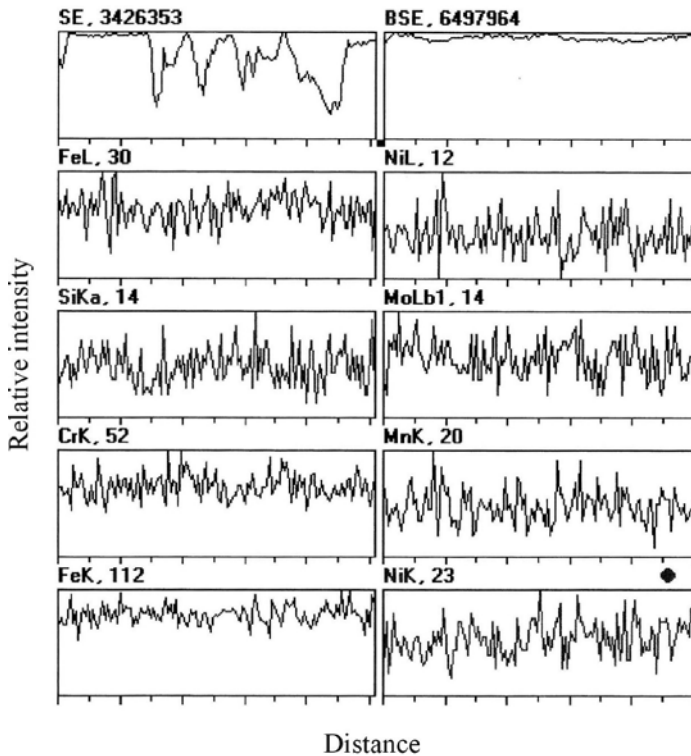
Figure 8. Quantitative linear analysis of the passivated surface of AISI 316L steel base metal

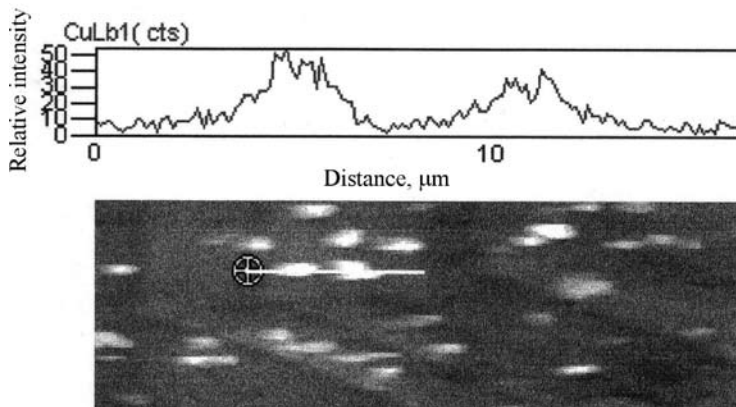
Figure 9. Quantitative linear analysis of small agglomerations on the surface of AISI 316L steel weld joint

surface. The structure was granular, with grains having a smooth surface. Surface analysis showed the granular agglomerations to consist of copper atoms (Figure 9). Quantitative linear analysis of the steel surface following passivation failed to show a major difference in the content of individual elements between the melted zone and the adjacent zone (Figure 10). It may therefore be concluded that the passivation medium “attacked” the steel weld surface in a uniform manner. As a result of passivation all steel constituents formed oxides without prior dissolution. On the other hand, had

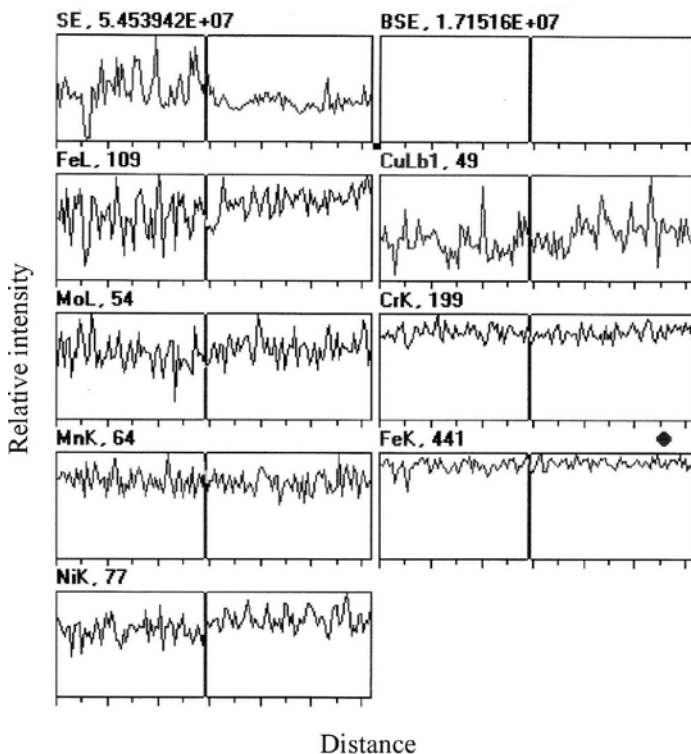
Figure 10. Quantitative linear analysis of the passivated surface of AISI 316L steel weld joint
