REVITALISATION OF VINEYARDS IN THE TERRACED
LANDSCAPE ON THE KARST RIDGE OF TRIESTEOŽIVLJANJE VINOGRADOV V TERASASTI POKRAJINI TRŽAŠKEGA KRAŠKEGA
ROBA**izvleček**

This article is based on the landscape report we elaborated for the Province of Trieste in 2010. The report was prepared for the application for approval of the project "Infrastructuring the Karst ridge of Trieste - First Phase" in accordance with the Italian law of 2005. The mentioned project proposed a way to recover the hillside of Contovello, Trieste, giving this area the infrastructure deemed necessary for accessibility and irrigation.

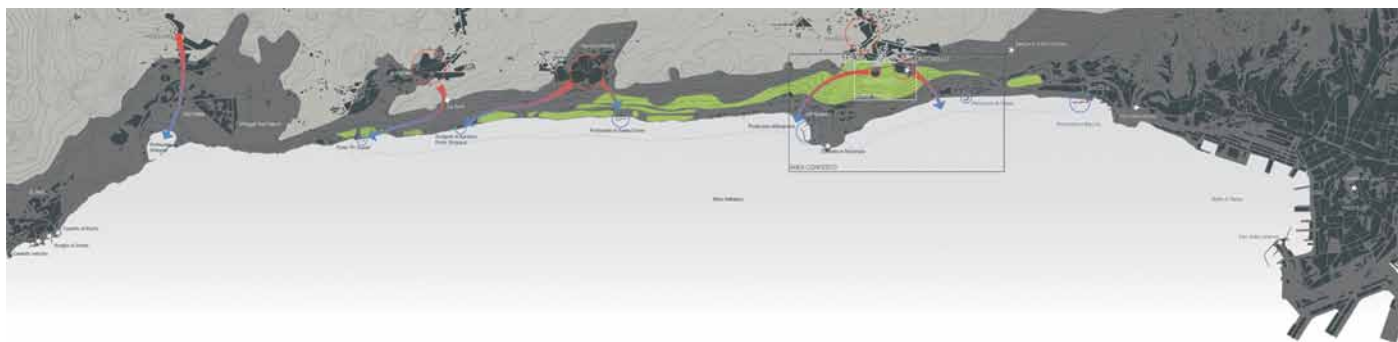
Figure 1: Terraced vineyards are associated with the villages on the edge of the Karst ridge. The area of context and the area of study are highlighted in the drawing.

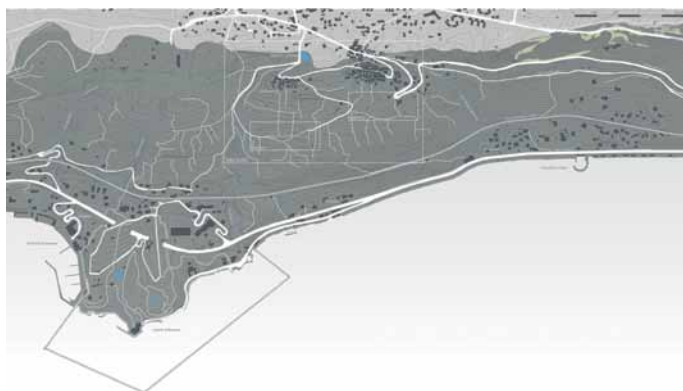
Figure 2: The network of paths shows a few connections between the Karst ridge and the sea, overcoming the barriers formed by the coastal road and the rail routes which have interrupted many of these connections.

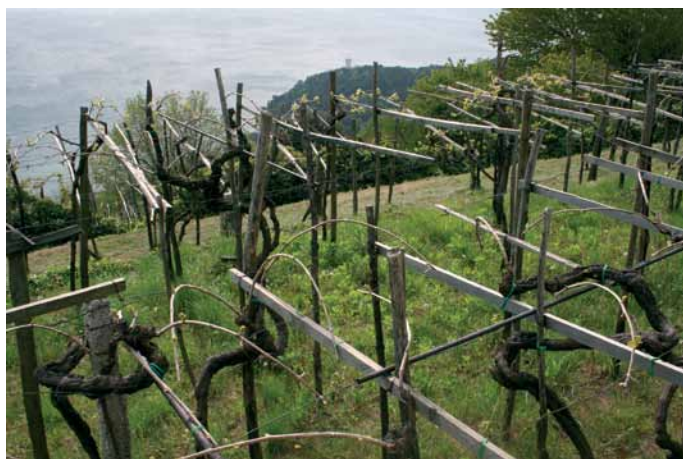
The landscape is characterised by widespread and extensive terraces testifying the presence of ancient agricultural cultivation. In the study the partition walls and support of the terraces are made of dry sandstone and host crops mainly of vine. Among the terraces there is a network of access paths, also bordered by stone walls. The project proposes the recovery of these artefacts related to the landscape features of the area.

Figure 3: View of vineyards on the terraces above the Miramare Castle and Park.

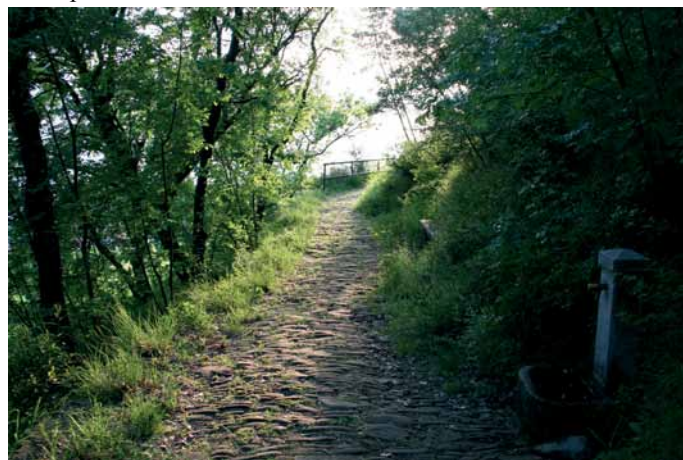
Figure 4: Authentic path paved in stone connecting the Karst ridge to the Adriatic coast.

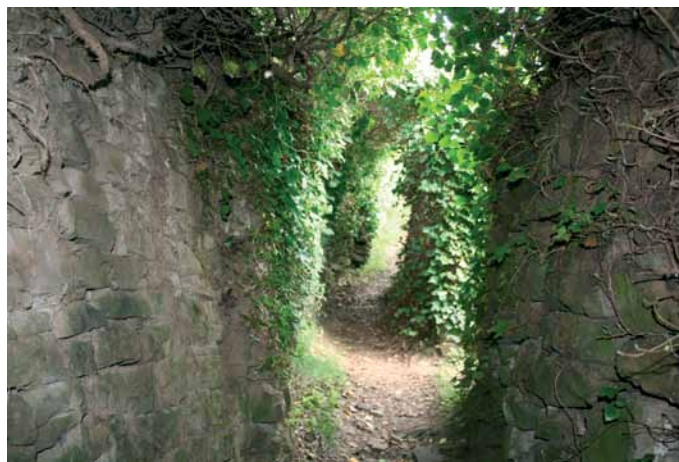
Figure 5: The height and proximity of the bordering stone walls form narrow and shady corridors in some sections of the paths.

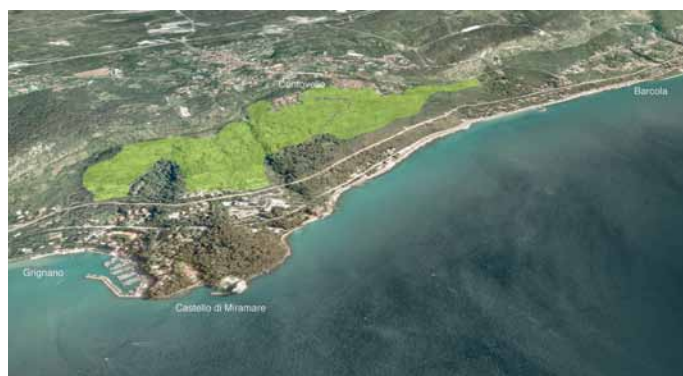
In the aerial photo the extension of the terraces in Contovello is shown, above the railway line. From the sea they form the backdrop to the Park of Miramare, since the plateau behind is not visible.

Figure 6: The vineyards on terraces located between Contovello and Miramare are visible from the sea, from some points of the coast and from panoramic viewpoints in the city of Trieste.

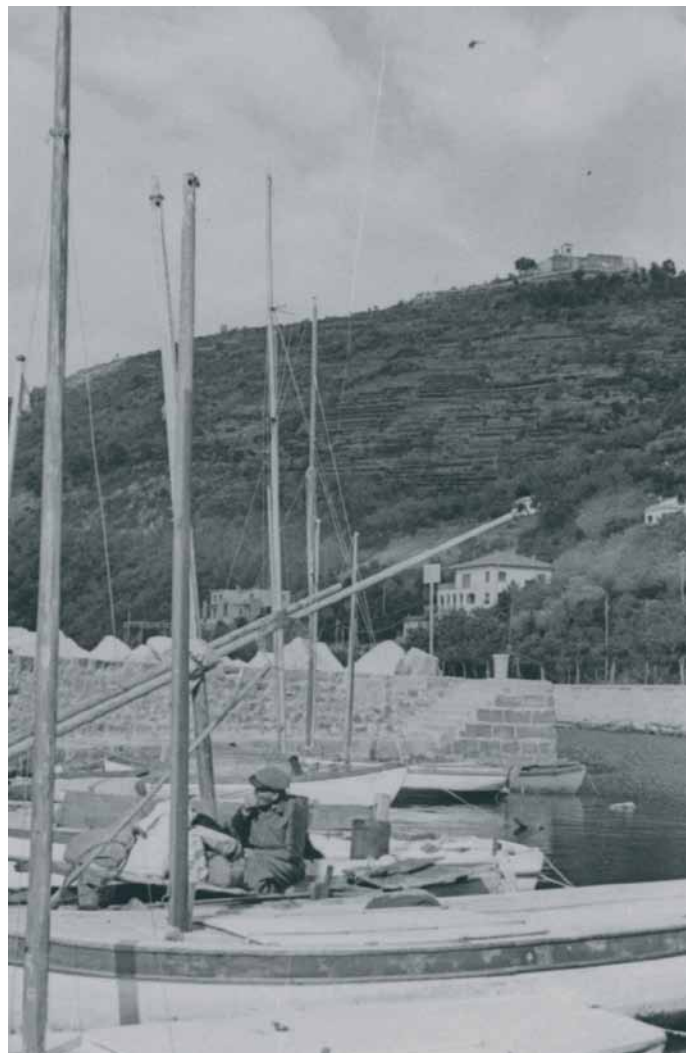
Figure 7: Terraces of Contovello seen from the port of Cedas. (around 1950, M. Magan).

to the coast, while today you see the effects of overgrowth and urbanisation. The second case is a historical picture from a viewpoint at Contovello in 1952: the terraces are plenty and the border between urban and rural area is clear, a number of houses and a mass of cedars planted after World War II capture the view, weakening the identity of rural simplicity of the site (see Photo 6).

If you compare two photographs, one from 1952 and one from 2010, transformations undergone in the area during about sixty year emerge. In particular, the loss of the definition of boundaries is noted, the disorderly building growth, the overgrowth, the loss of identity of the historical settlement of Contovello and the consequent weakening of the hierarchy between buildings and open spaces. Through the juxtaposition of two images taken near the Strada Napoleonica, the phenomenon of overgrowing is evident: the terraces which once extended to the sea are hardly visible (see Photo 6).

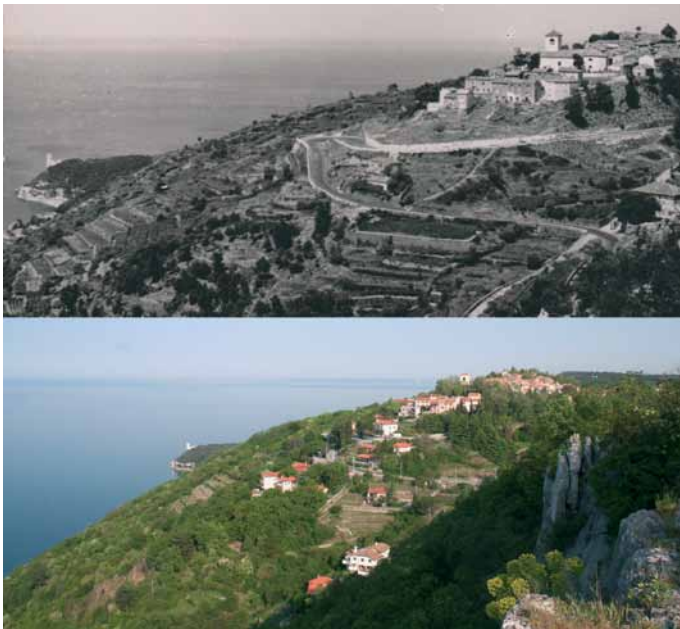
Figure 8: Comparison of a historical photo and a current photo from the lookout Trmadevec. The settlement of Contovello dominates the underlying areas with vineyards. (1952, M. Maganji). In the current image the urban sprawl is reducing the quality of the cultural landscape and a grove of cedars hides the settlement of Contovello partially.

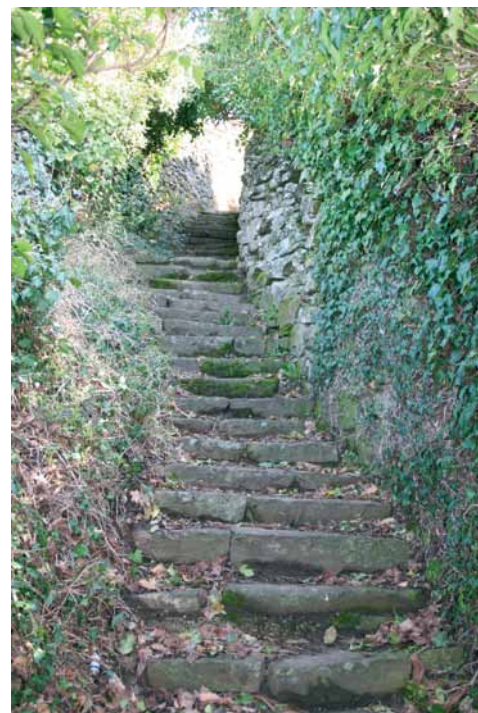
Figure 10: Long stone stairs between the dry stone walls of the terraces.
Slika 10: Dolge kamnite stopnice med suhozidi teras.

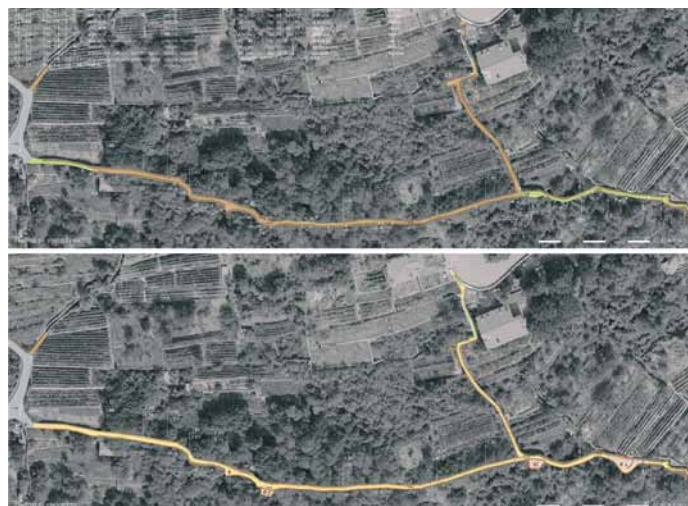
Figure 11: Comparison between the existing situation and the proposal. The visual impact of the pitches is clear.

The project provides some pitches for operation of mechanical equipment, pitches that also serve as a resting place and panoramic terrace. These points now have a form dictated primarily by functional requirements, in contradiction with the topography of the territory.

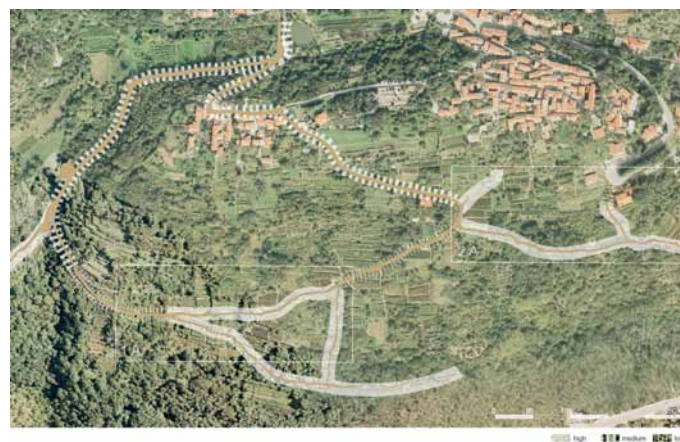
Figure 12: The authenticity of the current network of paths is high.
 Slika 12: Današnja mreža poti je zelo podobna prvotni.

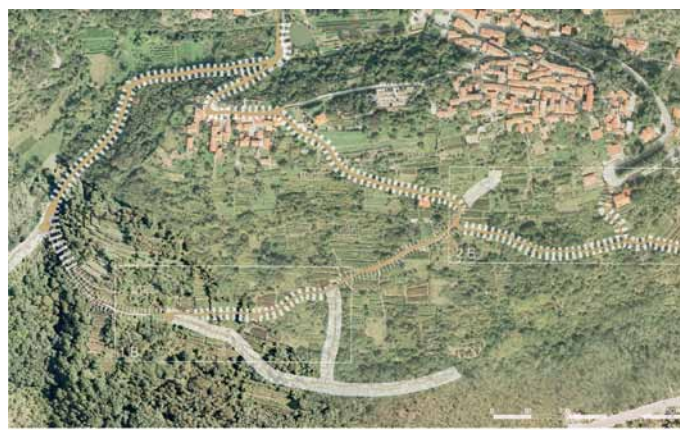
Figure 13: The authenticity of the network of paths will be reduced following the implementation of the project.

sections where it is necessary to widen the roadway to achieve the width of 1.5 m which is considered necessary. According to an audit of the project it was noted that in phase 1 approximately 60% of existing walls are maintained, while in the area of phase 2 around 54%.

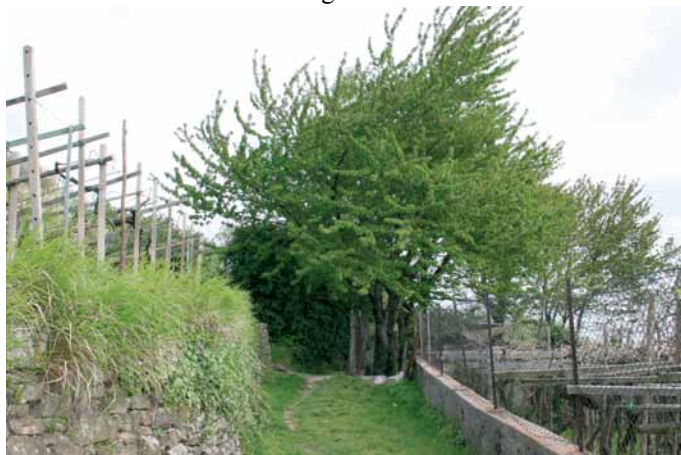
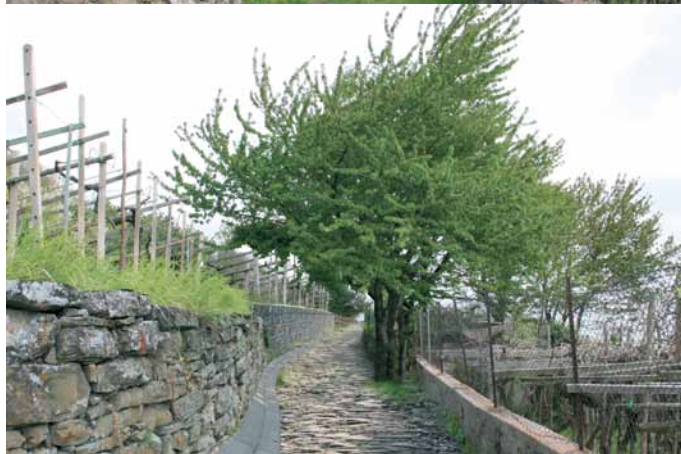
Figure 14 and 15: Comparison between the existing situation and the proposal. Simulation based on photographs showing the visual impact of the intervention. Sliki 14 in 15: Primerjava med obstoječo situacijo in predlogom. Simulacija s pomočjo fotografij prikazuje vizualni vtis posega.

Thanks to the use of photomontages the effects of the realisation were compared with the current situation, both for phase 1 and phase 2. The images show the enhancement of the site as a result of maintenance, in particular recovery compared to the current situation of degradation with walls overgrown by weeds. The enlargement of the path alters the proportions between the path and the bordering walls.
