case report

Doppler ultrasound in the diagnosis and follow-up of the muscle rupture and an arteriovenous fistula of the thigh in 12 year boy

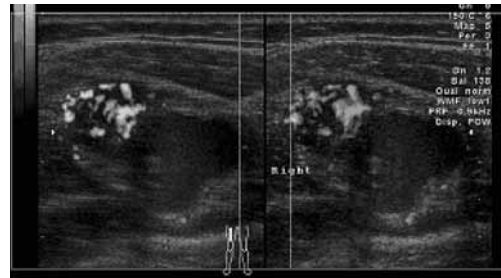
Figure 2. Hypervascularized area with sonographic characteristics of vascular malformation (hemangioma) positioned closely to the hematoma ventrolaterally in the proximal third of the thigh (horizontal orientation).

Hypervascularized area with sonographic characteristics of vascular malformation (haemangioma) was depicted near the haematoma, ventrolaterally in the proximal third of the thigh (Figure 2). Recidivous

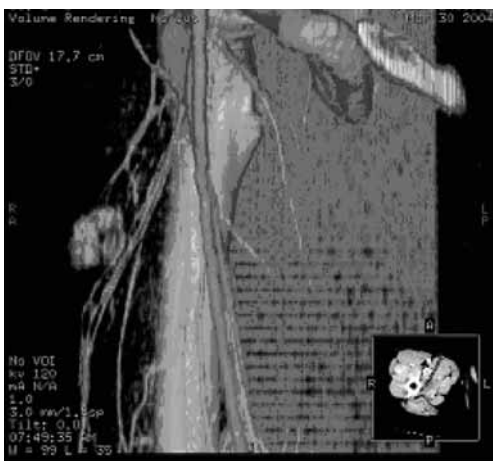
Figure 3a. Volume-rendering VR reformation – right femoral region-coronal plane (vertical orientation).

Hypervascularized lesion located ventrolaterally in right thigh proximal third, equally good opacified with contrast material in the arterial and venous phase, with one avascular zone ventromedially. A lesion receives arterial supply from the deep femoral artery muscular branches.
