The Influence of External Conditions on the Mechanical Properties of Resin-bonded Grinding Wheels

Albin Matavz¹ – József Mursics² – Ivan Anzel^{3,*} – Tina Zagar⁴

Keywords: resin-bonded grinding wheels, mechanical properties, ageing, microscopic analysis

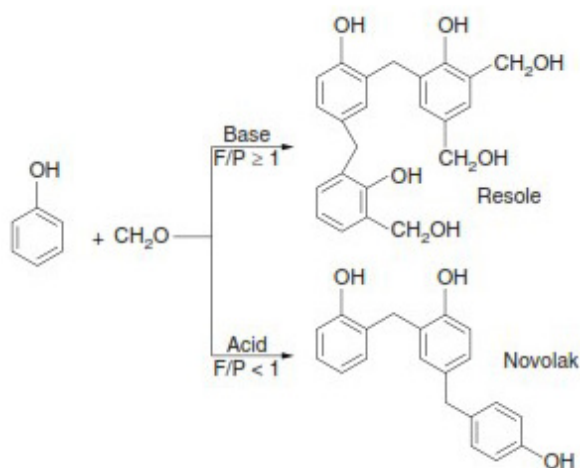
Fig. 1. Molecular structure phenol-formaldehyde resin

Fig. 1 shows the molecular structure of phenol-formaldehyde resins with regard to the F/P molar ratio and pH.

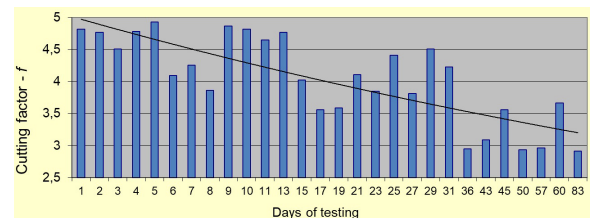
Fig. 2. Cutting factor by days for sample TYPE 04

To understand the concept better and to assess changes, more frequent measurements (from 1 day to 83 days) were initially performed on the sample TYPE 04 and a time diagram of cutting factor dependence was drawn, Fig. 2.

As can be seen from Fig. 2, there is a great dispersion of value by individual days. For that reason and for easier interpretation of results and monitoring of time dependence, the diagrams of cutting factor dependence were made for the 1st, 2nd, 15th, 45th and 60th day for all samples, Figs. 3 to 6.

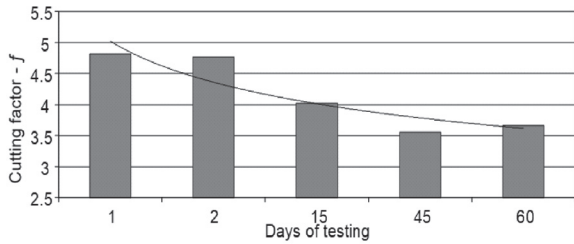
Fig. 3. Cutting factor by days for sample TYPE 04

- cutting factor in a time period of 45 days achieves the lowest value in all types of grinding wheels and is about 40 % lower;
- as the time period extends over 45 days, the ageing process stops and stabilizes, and the cutting ability slightly improves;
- repeated heat processing – i.e. drying of grinding wheels at an appropriate work temperature results in the mechanical properties (cutting ability) reversibly returning to original production values, Fig. 7;

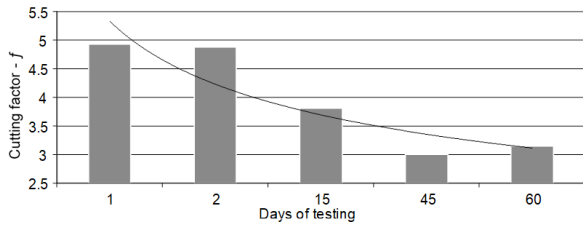
Fig. 4. Cutting factor by days for sample TYPE 03

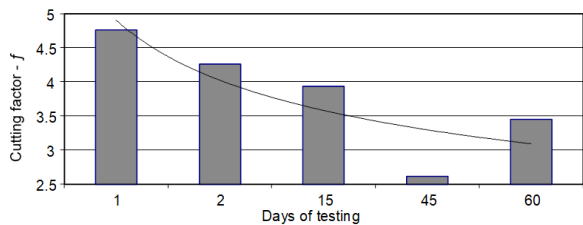
Fig. 5. Cutting factor by days for sample TYPE 02

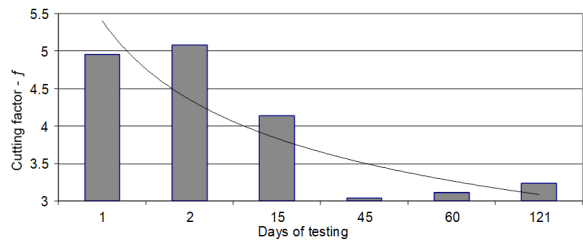
Fig. 6. Cutting factor by days for sample TYPE 05

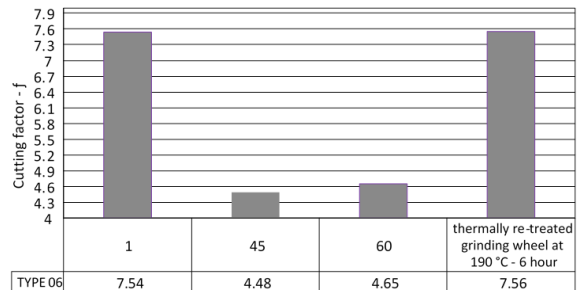
Fig. 7. Cutting factor by days for sample TYPE 06 (repeated heat processing)

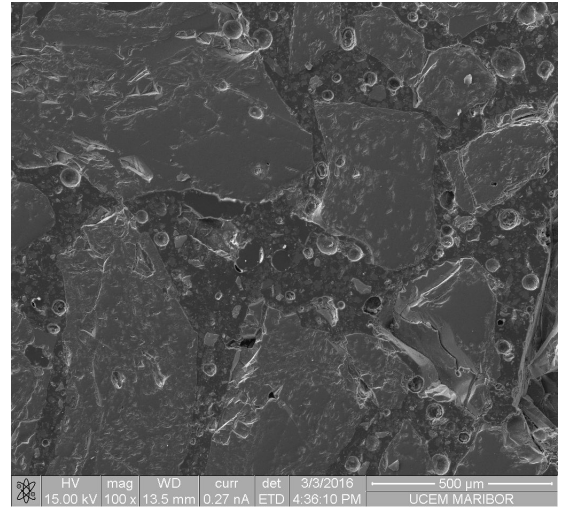
Fig. 8. Microstructure of grinding wheel sample A/07.02 [15]

Figs. 8 to 10 show images of different magnifications of the microstructure of grinding wheel sample A that was 5 days old. Grinding wheel had not yet been used. Images of the microstructure of grinding wheel served as a comparable measurement standard in observing the changes in the microstructure of grinding wheel samples, which are intended for cutting.

- microstructure of the grinding wheel matrix that was not used for cutting is significantly different from the grinding wheel matrix that was used for cutting (Figs. 8 and 15);

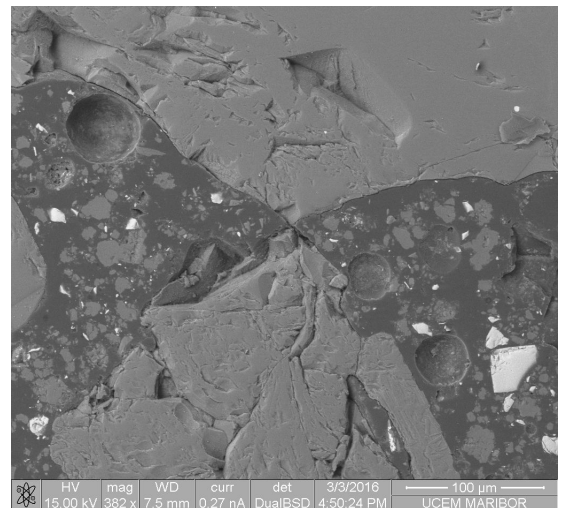
Fig. 9. Microstructure of grinding wheel sample A/07.02 [15]

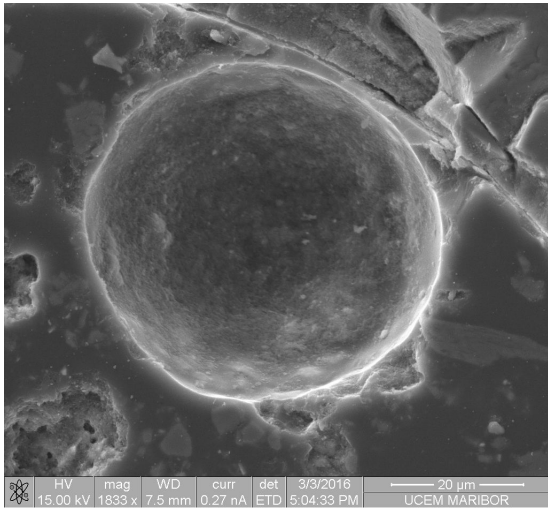
Fig. 10. Microstructure of grinding wheel sample A/07.02 [15]

- heat is generated during grinding and heats the water (atmospheric humidity), which is present in grinding wheel pores. It is transformed into a gas phase – water vapours, which causes a rise or increase of hydrostatic pressure of water vapours in pores (Figs. 10 and 16);

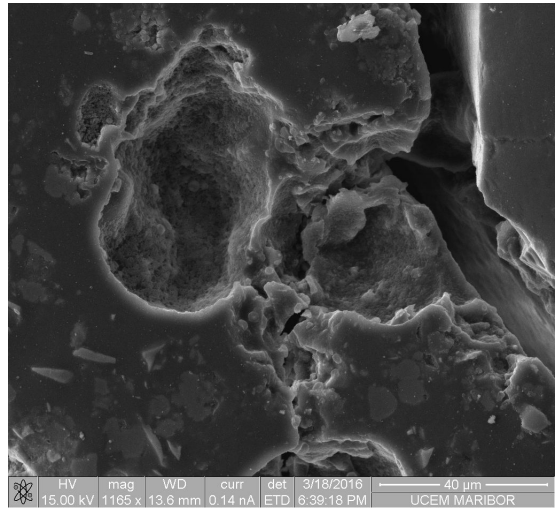
Fig. 13. Microstructure of grinding wheel sample C/03.03. [15]

Figs. 13 and 14 show images of the microstructure of grinding wheel sample C, 30 days old, at different magnifications. The grinding wheel was additionally aged (content of 1 % moisture) and already in use.

- with the accelerated ageing method, the authors successfully inserted a quantity of water (1 % of moisture) into the grinding wheel pores, which is similar to that of the grinding wheel, which is stored under normal conditions for a much longer period, but such procedure has a negative effect on the internal structure of polymer matrix (microstructure) of grinding wheel (Figs. 13 and 16);

- water vapour, which penetrates the wall and travels through the matrix, causes cracks in polymer binders. Cracks travel over the matrix and stop on the edge of grain (Figs. 13 and 16);

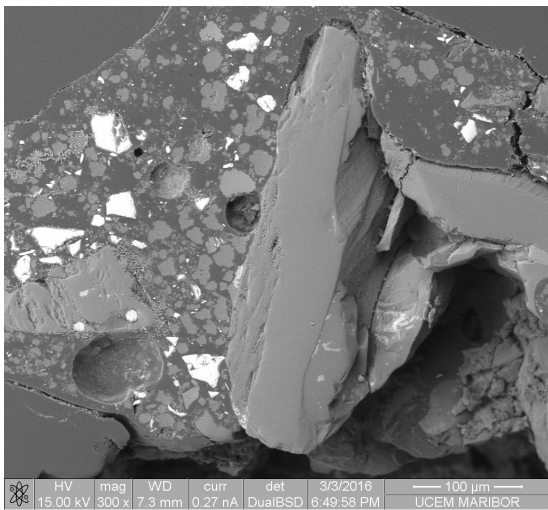
Fig. 11. Microstructure of grinding wheel sample B/07.02 [15]

Figs. 11 and 12 show the images of the microstructure of grinding wheel sample B, 5 days old. Grinding wheel is shown at different magnifications and had already been used.

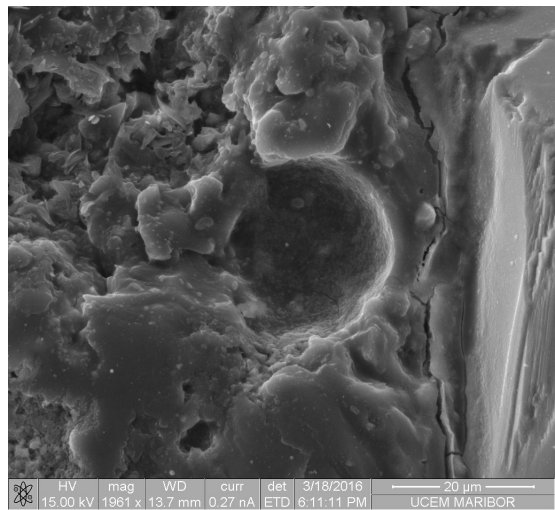
Fig. 14. Microstructure of grinding wheel sample C/03.03 [15]

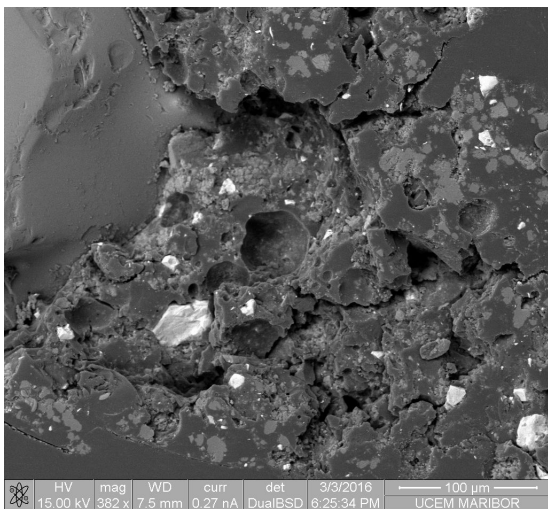
Fig. 12. Microstructure of grinding wheel sample B/07.02 [15]

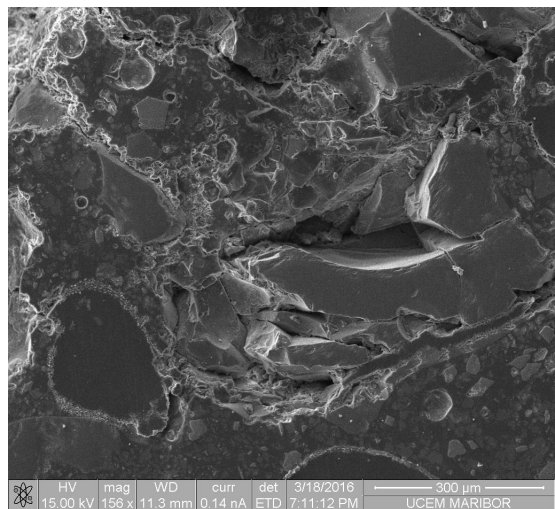
Fig. 15. Microstructure of grinding wheel sample D/03.03 [15]

Figs. 15 and 16 show the images of the microstructure of grinding wheel sample D, 140 days old, at different magnifications. The grinding wheel was stored under normal conditions (~40 % humidity and ~15 °C, moisture content of 1 %). The grinding wheel had already been used.

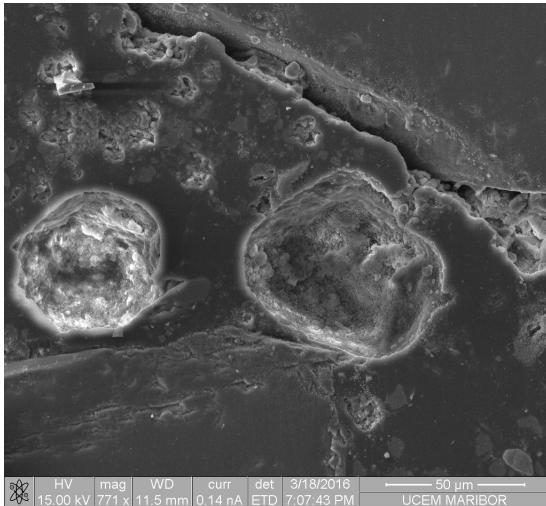
Fig. 16. Microstructure of grinding wheel sample D/03.03 [15] and [16]

- in critical threshold values of the increased hydrostatic pressure in grinding wheel pores, it was first noticed that the internal deformation of pores occurs and in the next phase the destruction of the material across the circumference of pores caught in the polymer binder matrix (Fig. 16);
