# THE BRITTLE TENSILE FRACTURE AND CLEAVAGE STRENGTH OF A STRUCTURAL STEEL WITH A SIMULATED WELD-AFFECTED-ZONE MICROSTRUCTURE

Gorazd Kosec<sup>1</sup>, Boris Arzenšek<sup>2</sup>, Jelena Vojvodič Tuma<sup>2</sup>, Franc Vodopivec<sup>2</sup>

<sup>1</sup>SIJ, d. d., Acroni, d. o. o., Kidričeva 44, 4270 Jesenice, Slovenia

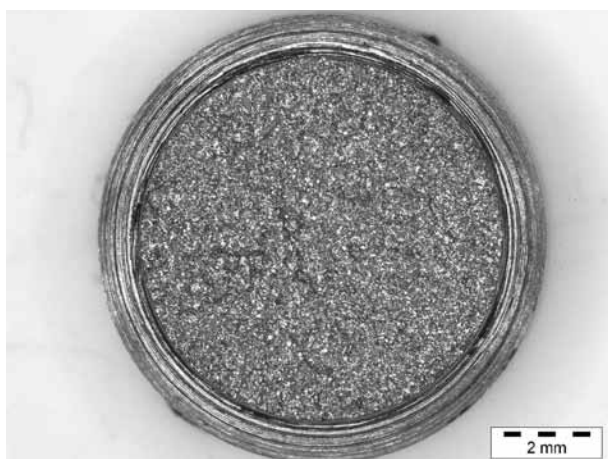
**Figure 5:** Fracture surface of a notched tensile specimen of steel quenched in water from 1250 °C. Microstructure: coarse-grained martensite

The fracture surface of all the specimens consisted of a ring of shearing at the notch tip of different widths and a central area of cleavage (**Figure 5**). On all specimens two or even three crack initials were found in the notch tip (**Figure 6**) that joined rapidly in a ring of plane shearing. On this surface an increasing number of dimples were found at greater distances from the notch tip. At the boundary of the shearing ring, the fracture changed sharply to cleavage with facets, the size of

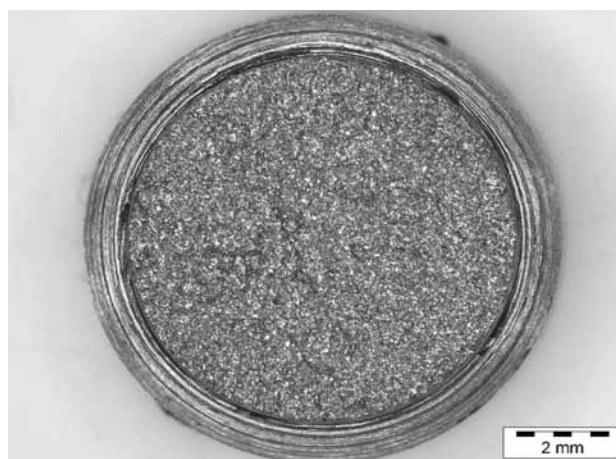
**Figure 7:** Fracture surface of a notched tensile specimen cooled in a lead bath from 1250 °C. Microstructure: coarse-grained bainite

which depended on the austenite grain size before the quenching (**Figures 7 and 8**). No difference in the cleavage morphology is found that could be attributed to the presence of secondary martensite after reheating at 750 °C.
